Revision Table			
Instance Number	Published Date	Version Number	Reason For Update
2070941/1	07/24/2023	91-23-03	Original publication.

91-23-03 - MIB3 Various Infotainment Concerns

Release date: 7/24/2023

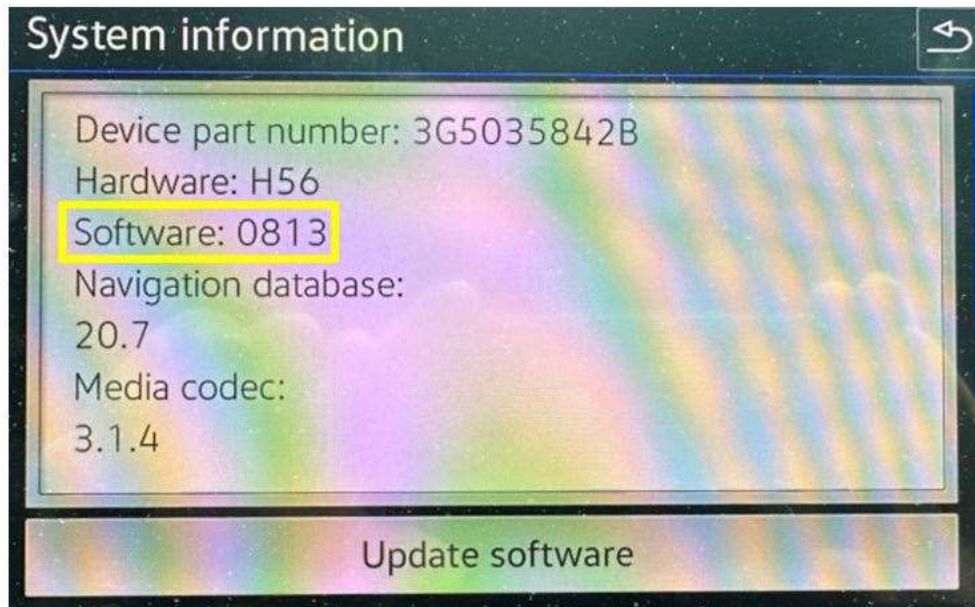
If the "Software" level is lower than **0841**, proceed with this Technical Bulletin.

If the "Software" level is equal to or greater than **0841**, this work procedure does not apply.
