GLOBAL SAFETY FIELD INVESTIGATIONS
DCS6627
URGENT - DISTRIBUTE IMMEDIATELY

Subject: N222375791-06 - Customer Satisfaction Program
Park Assist Retrofit
Population Update

N222375791 Park Assist Retrofit

Revision: 06

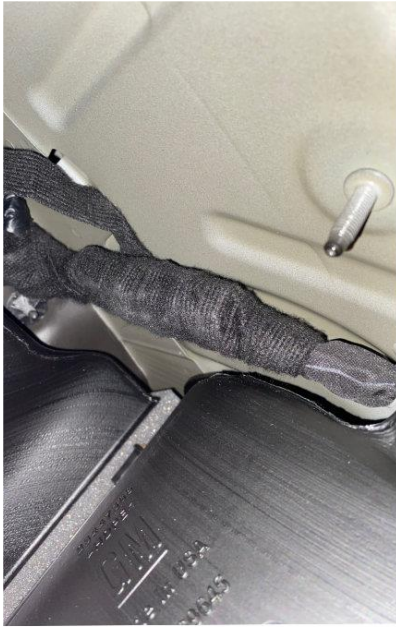
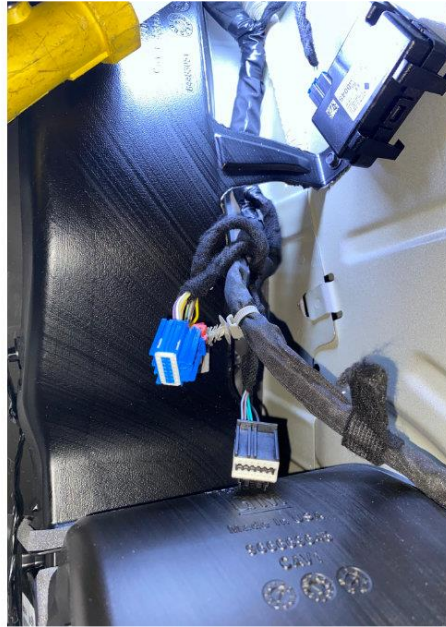
6288463

Note: The wiring harness for the Parking Assist Control Module may be wrapped around an adjacent wiring harness as shown above. Remove the attaching tape by unwrapping. Do NOT cut the tape as it could damage the wiring harness.

1. Install the new Parking Assist Control Module. Refer to *Parking Assist Control Module Replacement* in SI.

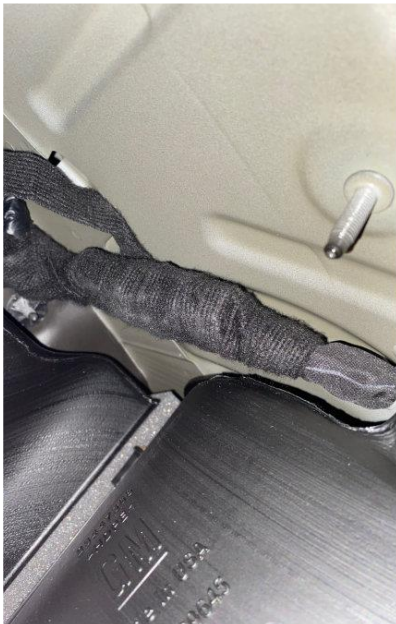
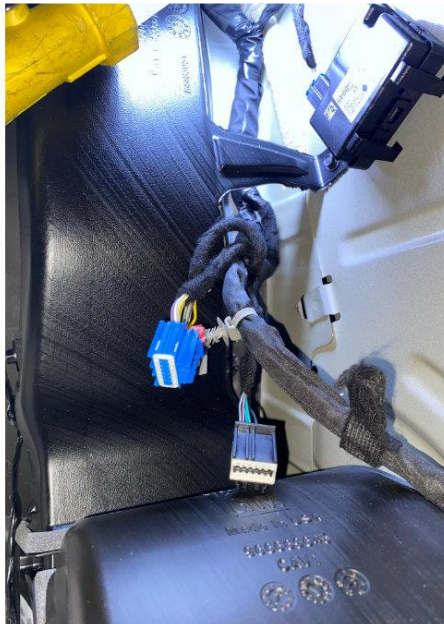
6288463

Note: The wiring harness for the Parking Assist Control Module may be wrapped around an adjacent wiring harness as shown above. Remove the attaching tape by unwrapping. Do NOT cut the tape as it could damage the wiring harness.

1. Install the new Parking Assist Control Module. Refer to *Parking Assist Control Module Replacement* in SI.

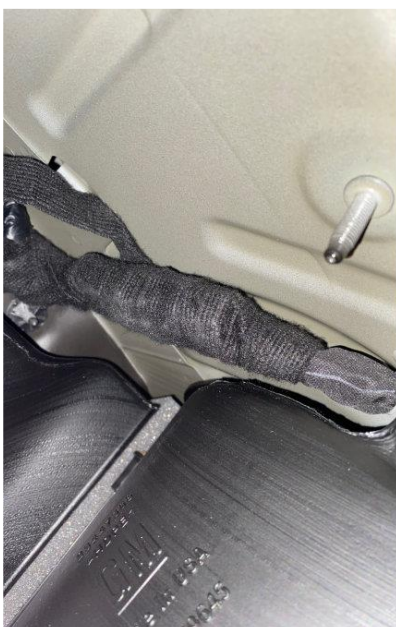
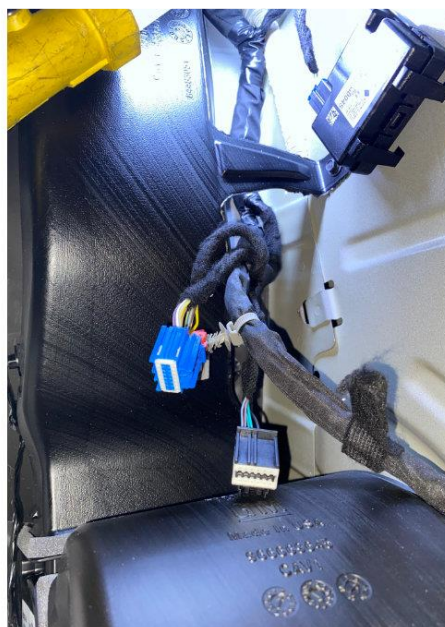
6288463

Note: The wiring harness for the Parking Assist Control Module may be wrapped around an adjacent wiring harness as shown above. Remove the attaching tape by unwrapping. Do NOT cut the tape as it could damage the wiring harness.

1. Install the new Parking Assist Control Module. Refer to *Parking Assist Control Module Replacement* in SI.
