7/13/2023

When applying the brakes at highway speeds the following symptoms may occur:

Transaction No: 2015173/32

46-19-02 - Brake Rotor, Vibration / Pulsation (U.S. Only)

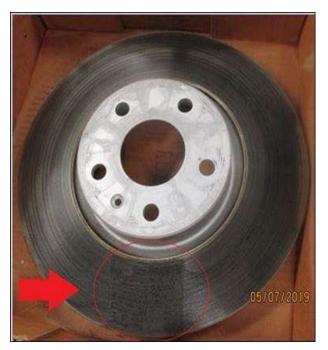
Figure 1: Brake pad imprint.

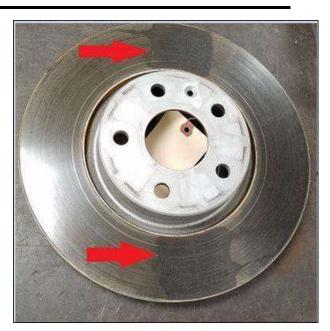
Figure 3: Brake pad imprint.

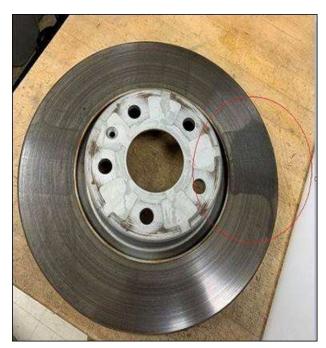
Figure 2: Brake pad imprint.

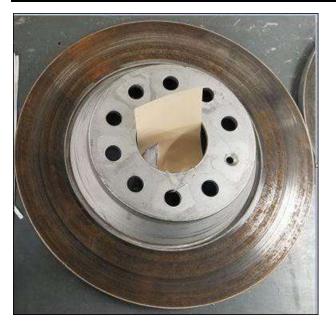
Figure 5: Corrosion.

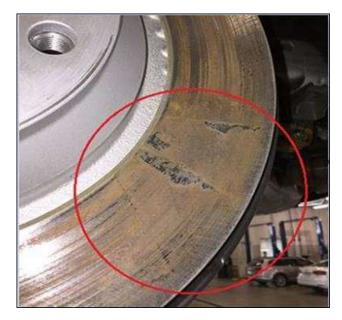
Figure 7: Corrosion, brake pad stuck to brake rotor.

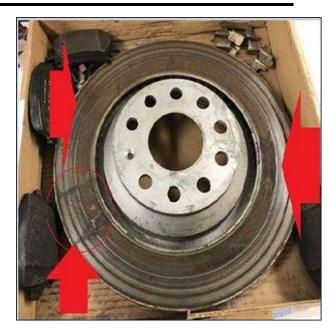
Figure 6: Corrosion, brake pad stuck to brake rotor.

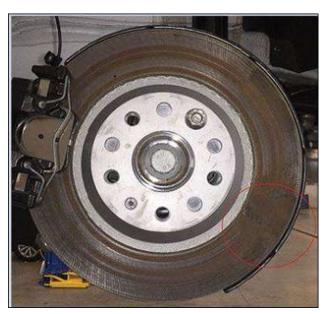
Figure 8: Corrosion, brake pad stuck to brake rotor.

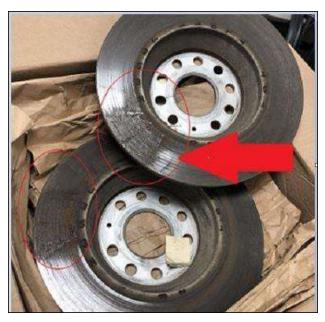
Figure 9: Brake pad stuck to brake rotor

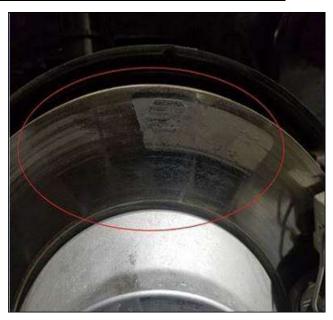
Figure 10: Brake pad stuck to brake rotor.

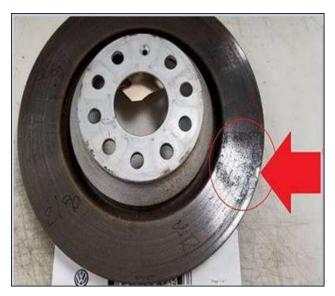
Figure 11: Brake pad imprint.
