Service Bulletin

Bulletin No.: 22-NA-209

Subject: Articulating Running Board Inoperable

Brand:	Model:	Model Year:		Build Date:		Engine:	Transmission:
		from	to	from	to		
Cadillac	Escalade Escalade ESV	2021	2023				
Chevrolet	Tahoe	2021	2023	—	—		
	Suburban						
GMC	Yukon Yukon XL	2021	2023

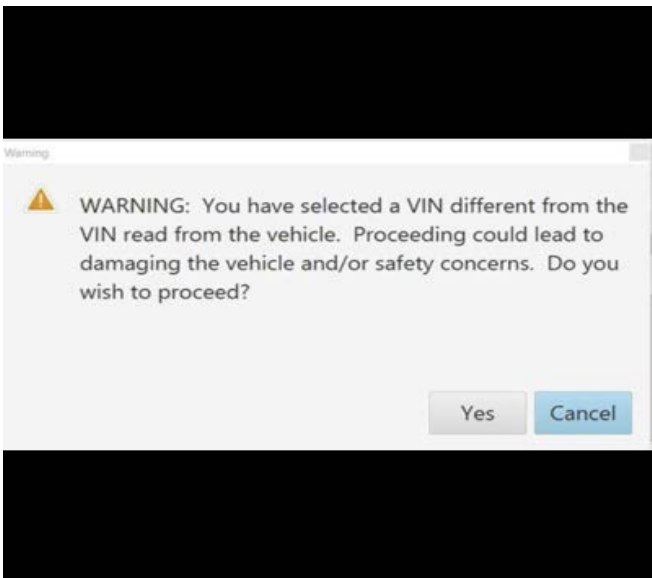
5877000

Important: If the vehicle VIN DOES NOT match, the message below will be shown

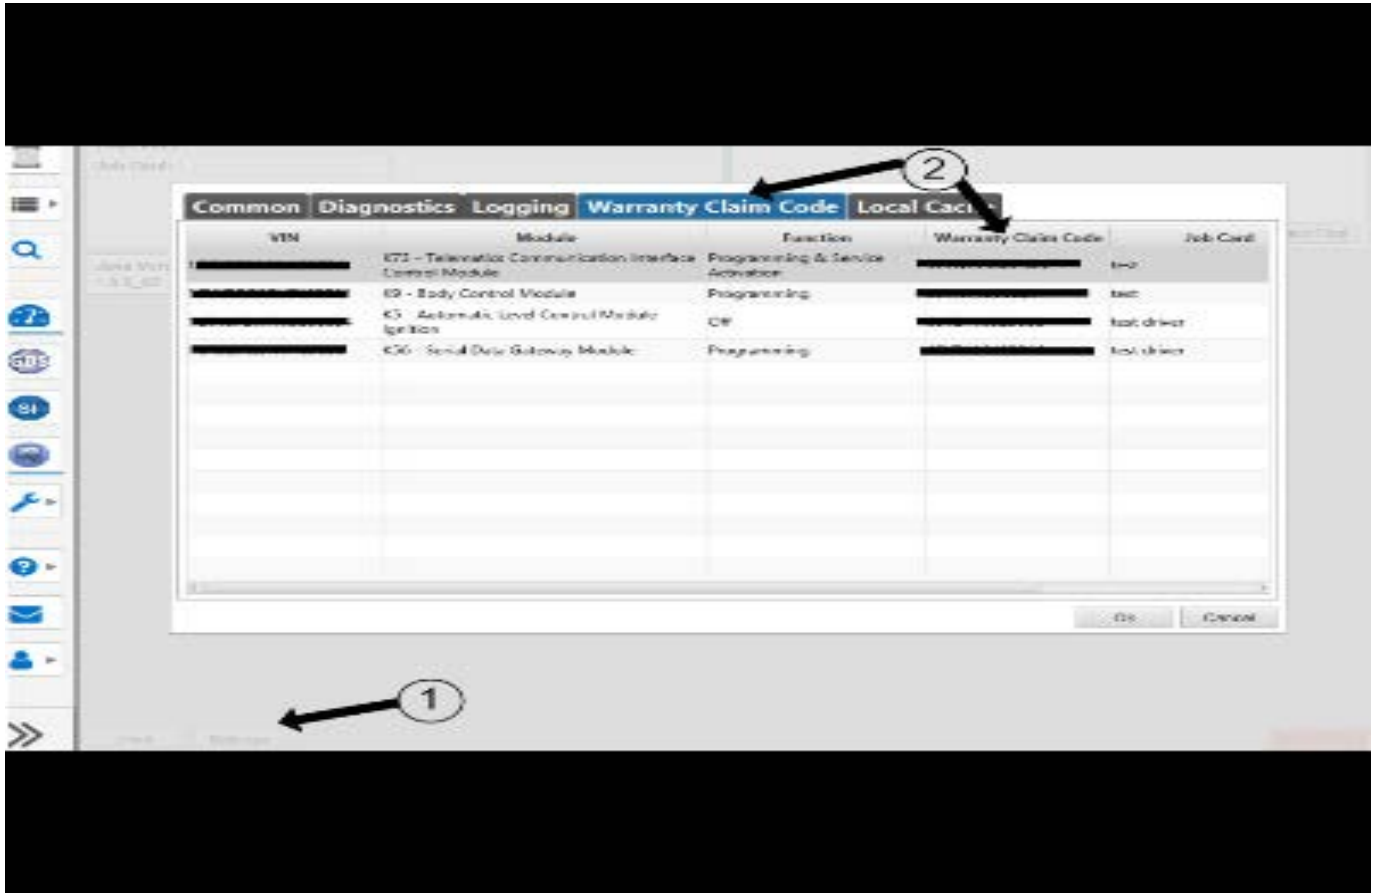
6125774

If the Warranty Claim Code was not recorded on the Job Card, the code can be retrieved in the SPS2 system as follows:

1. Open TLC on the computer used to program the vehicle.
2. Select and start SPS2.
3. Select Settings (1).
4. Select the Warranty Claim Code tab (2).
