# Service Bulletin

Bulletin No.: 23-NA-027

**Subject:** Poor Engine Performance, Engine Misfires, Malfunction Indicator Lamp (MIL) Illuminated - DTC P0201, P0202, P0203, P0204, P0205, P0206, P0207, P0208, P0300, P0301, P0302, P0303, P0304, P0305, P0306, P0307, and/or P0308 Set

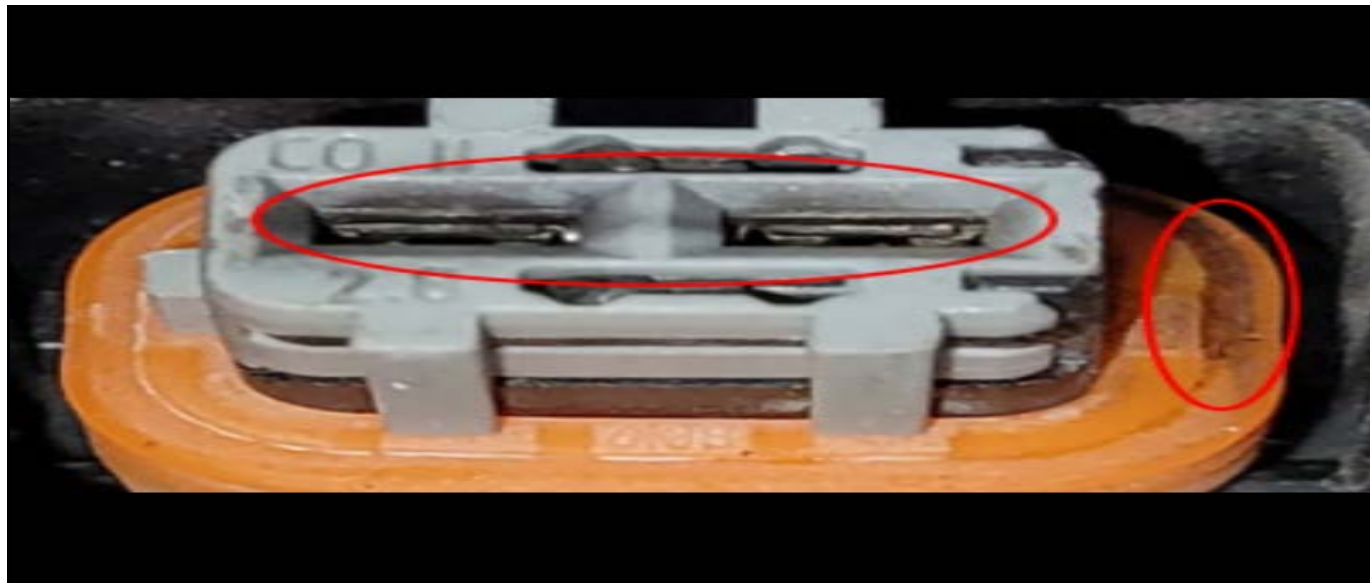
6279590

| Involved Region or Country | North America, Middle East, Iraq, Israel, Palestine, Australia/New Zealand |
|---|---|
| Cause | This condition may be caused by the engine vibration creating wear between the injector connector terminal and the high-pressure diesel fuel injector. |

1. Using Diagnostic Test Probe J-35616-35 (VT), test all the electrical connectors. Refer to *Probing Electrical Connectors in SI*.
  - ⇒ While testing these connectors, examine the connector for indications of fretting or black powder on the connector or connector seal as shown in the graphic above.
2. If any connectors fail the probe test or the visual inspection, replace that connector. Refer to *Wire to Wire Repair in SI*.

| Involved Region or Country | North America, Middle East, Iraq, Israel, Palestine, Australia/New Zealand |
|---|---|
| Correction | If SI diagnostics leads to fuel injector replacement, replace the effected injector. While replacing the injector, follow the procedure below. |
