Technical Service Bulletin

01 MIL on, DTC P040100 is stored in the ECM - TDI

01 23 63 2064398/2 July 25, 2023. Supersedes Technical Service Bulletin Group 01 number 23-60 dated July 7, 2023 for reasons listed below.

Model(s)	Year	VIN Range	Vehicle-Specific Equipment
A3 Sportback	2010 - 2013	Not Applicable	TDI

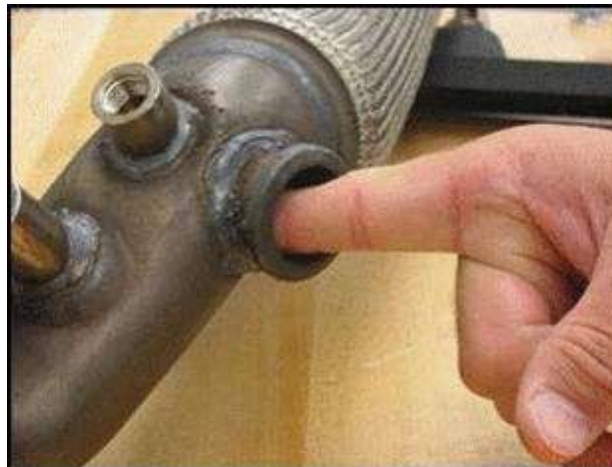
1. Remove the EGR filter from the Diesel Particulate Filter (DPF) and swipe the inside of the exhaust pipe at the EGR filter connection point using a clean cloth or your finger.

Figure 1. Checking for carbon.

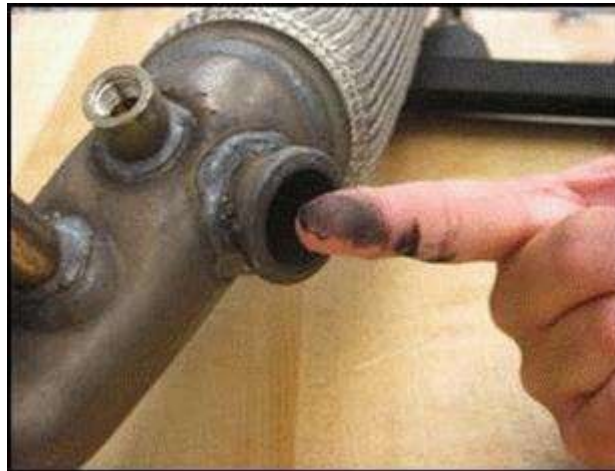
Figure 2. Verifying that there is carbon.

2. If your finger or the cloth comes out with black soot:
 - Replace the DPF & EGR filter together. **The engine must be running correctly with no faults stored to perform the next steps.**
 - **Read out 01 ECM control module OBD Basic Settings block 67 with engine at idle and at operating temperature. Select activate and monitor field 3 when EGR is in OFF position.**
 - **If the MAF actual value is equal to or greater than 540 mg/h, proceed to smoke testing below (there is likely a leak within the intake system).**
 - **If the value is less than 540 mg/h, proceed to the inspection of the snow flap and air filter (TSB attachment). There is no need to smoke test.**
 - Smoke test the charge air system for leaks if MAF value is 540 or great (see procedure below).
