Technical Service Bulletin

90 Instrument cluster driver information system display is blank

53 23 08 2071019/1 July 25, 2023.

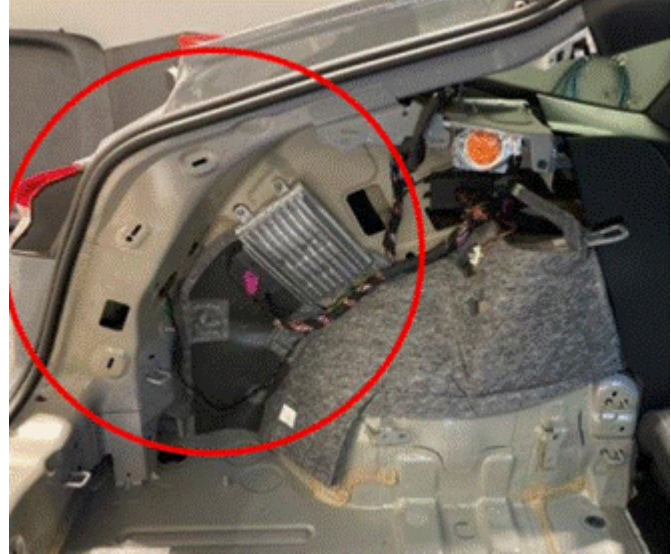
Workshop findings: The noises can be replicated in these driving conditions. The noises are diagnosed as originating specifically in the rear cargo area from the sheet metal overlap of the left rear side panel and the left rear cross panel.

Figure 1. Area of cargo area where noises are generated.

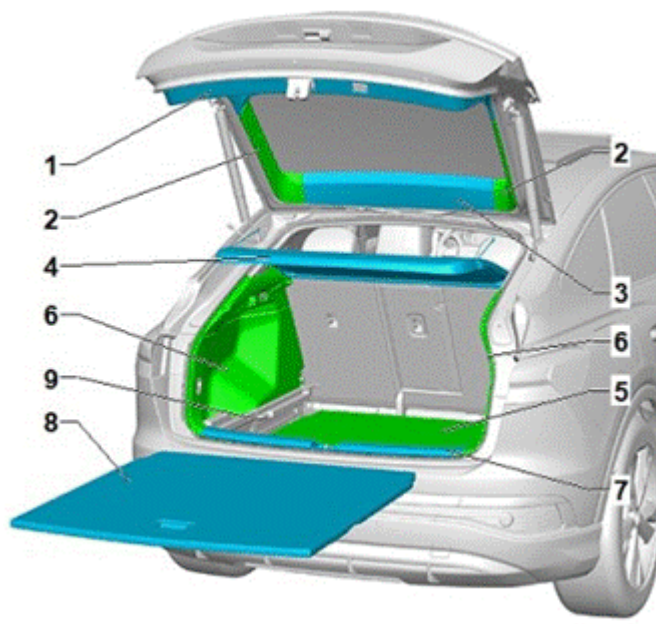
Figure 2. Luggage compartment trim.

1. Detach the left rear luggage compartment side trim panel according to the work procedure in Elsa: *Repair manual>>Body>>Body Interior>>70 Interior Trim>>Luggage Compartment Trim Panels>>Luggage Compartment Side Trim Panel, Removing and Installing.*

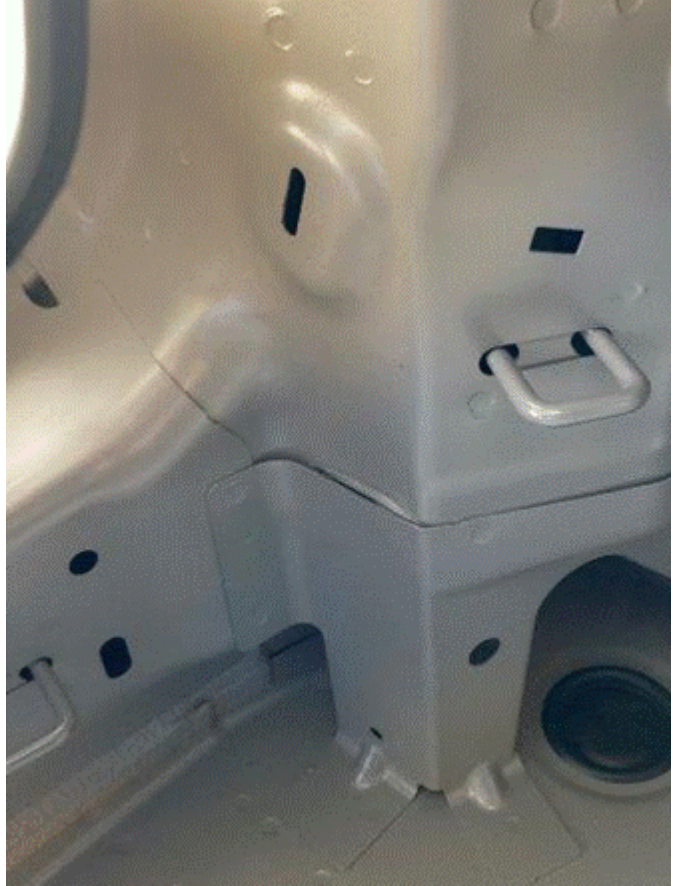
Figure 3. Area of left rear panel overlap to be repaired.

2. Figure 3 shows the exposed area where the work is to be performed.

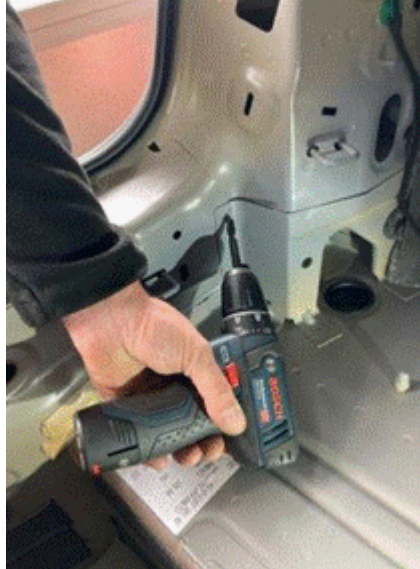
Figure 5. Location of the spot weld to be removed in the rear panel.

4. Attach the drill bit to a drill motor. Figure 5 shows the spot weld that need to be removed.

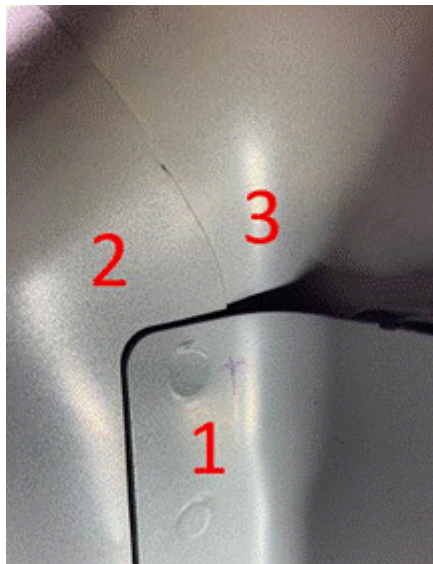
Figure 6. Overlapping panels in left rear of cargo area.

5. Figure 6 shows the 3 overlapping panels. For the purposes of illustration they are numbered 1 through 3 with 1 being the support panel, 2 being the left rear cross panel and 3 being the left rear side panel.

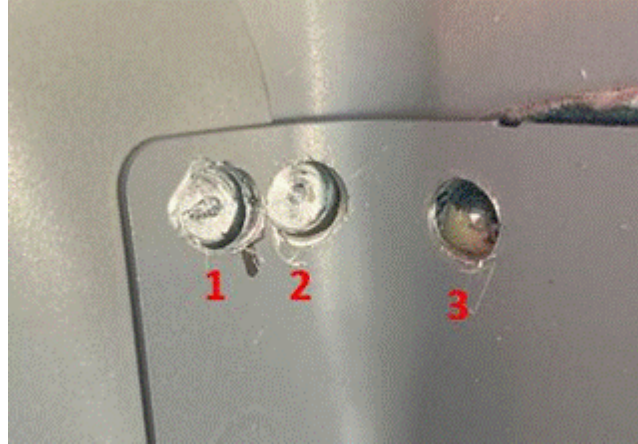
Figure 7. Holes to be drilled and their locations.

6. Drill the first hole directly into the upper spot weld. Drill the second hole just to the right of the first hole. Drill hole 3 on the other side of the radius of the support panel as shown in figure 7. All 3 of these holes must not penetrate panel 3 (left rear side panel).

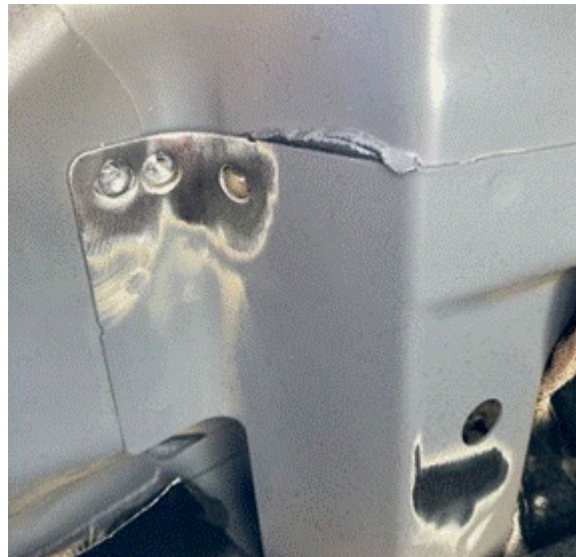
Figure 8. Surface prepared for welding.

7. Grind the area as these 3 holes will now be welded.

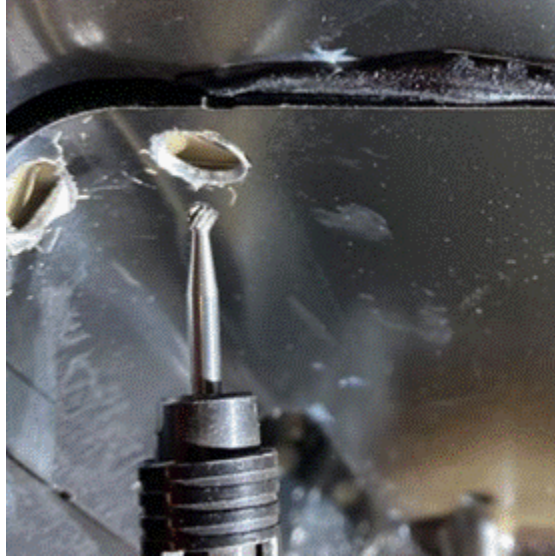
Figure 9. Removing residual primer from inside the drilled area.

8. Grind out the holes with a deburring tool to remove any residual primer from the surfaces to be welded.

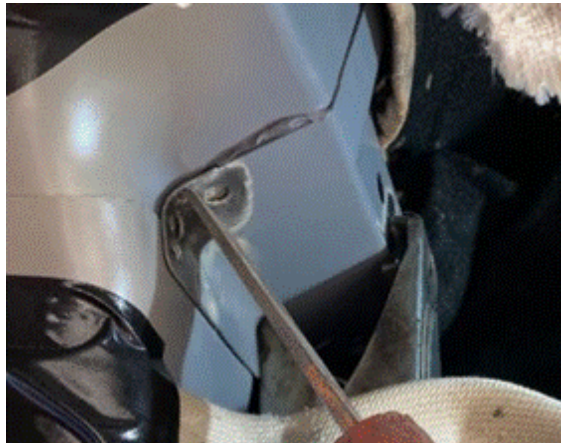
Figure 10. Eliminating any gaps before welding.

9. Push the support panel as close to the overlapping panels comprised of the left rear side panel and the left rear cross panel as possible using a drift. Isolate and protect the surrounding area to prepare for welding.

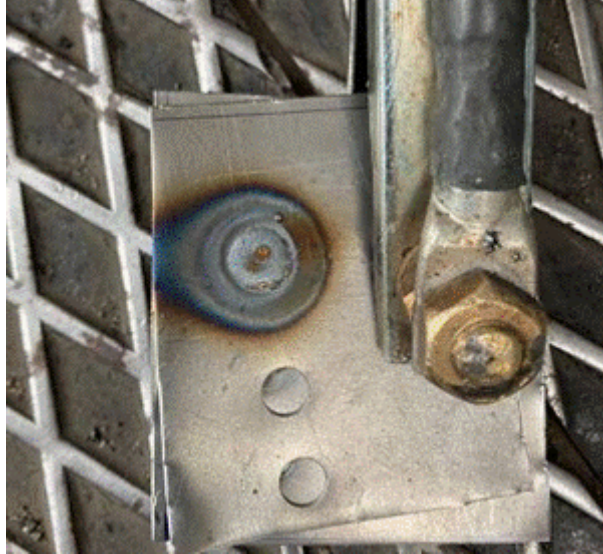
Figure 11. Performing a weld test.

10. If necessary, perform a test weld to ensure proper settings for an optimum weld application.

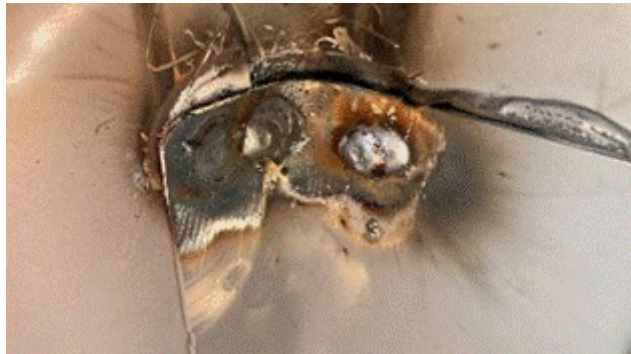
Figure 12. All 3 holes welded completely closed.

11. Weld all 3 holes such that they are completely closed.

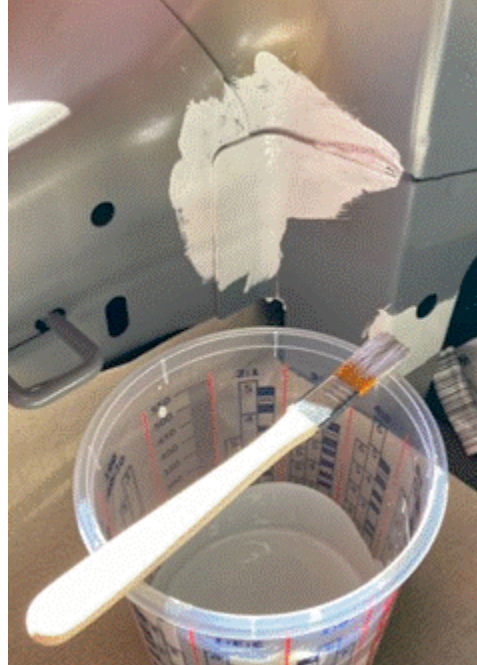
Figure 13. Welded surfaces cleaned and prepped. Corrosion protection restored.

12. Prepare and clean the welded surfaces as necessary. Thoroughly restore all corrosion protection appropriately. The corrosion protection will need to be applied using a brush.
