# Technical Service Bulletin

## 90 Instrument cluster driver information system display is blank

90 23 33 2063913/5 July 25, 2023. Supersedes Technical Service Bulletin Group 90 number 23-27 dated June 7, 2023 for reasons listed below.

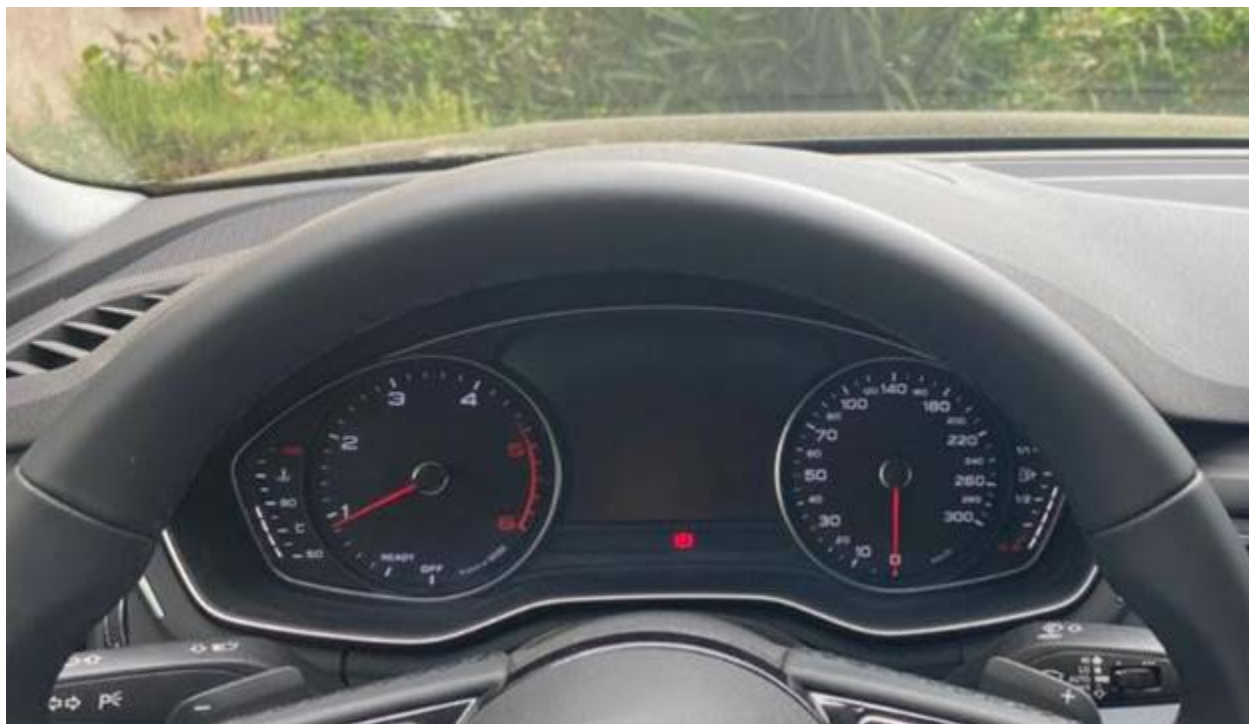
- The driver information system (DIS) in the instrument cluster (PR Code 9S7) is blank.
- The speedometer, tachometer, and bar graphs showing the fuel level and coolant temperature work normally (Figure 1).

**Figure 1.** Instrument cluster display is blank.

There is a hardware defect in the instrument cluster.

1. Follow all instructions in TSB 2011732: *00 Software Version Management (SVM), operating instructions*.
2. Update the instrument cluster, J285 (address word 0017) using the SVM action code as listed in the table below, if necessary:

The update can take multiple attempts. Please attempt the update **up to 12 times** before replacing parts. If an improvement to the update is available, this TSB will be updated.
