Service Bulletin

Bulletin No.: 23-NA-102

Subject: Drivability Concerns, Hesitation, Transmission Shifting Rough/Harsh, Malfunction Indicator Lamp (MIL) Illuminated - Multiple DTCs Set

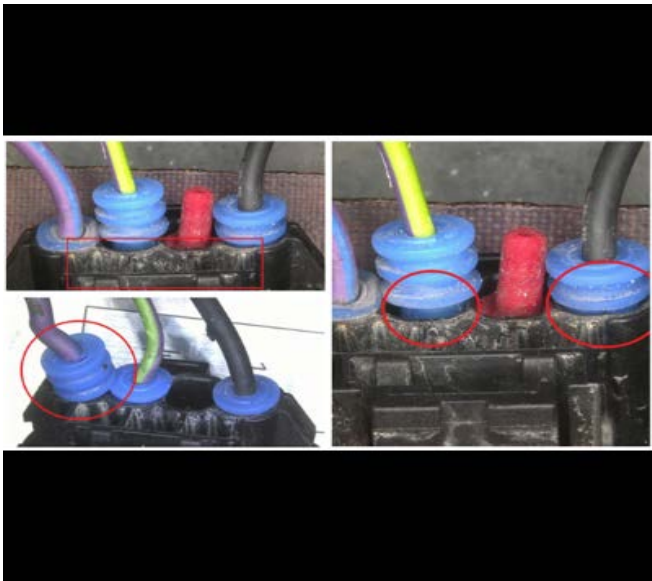
6219342

U02A9 might be set with or without U1345 (LIN BUS1 Failure).

An unsealed pump connector allowing water leakage into the (M10) charge air cooler pump electrical connector might be the root cause of the communication failure.

- Check the CAC Pump connector sealing and look for any corrosion at the pump due to water leakage.

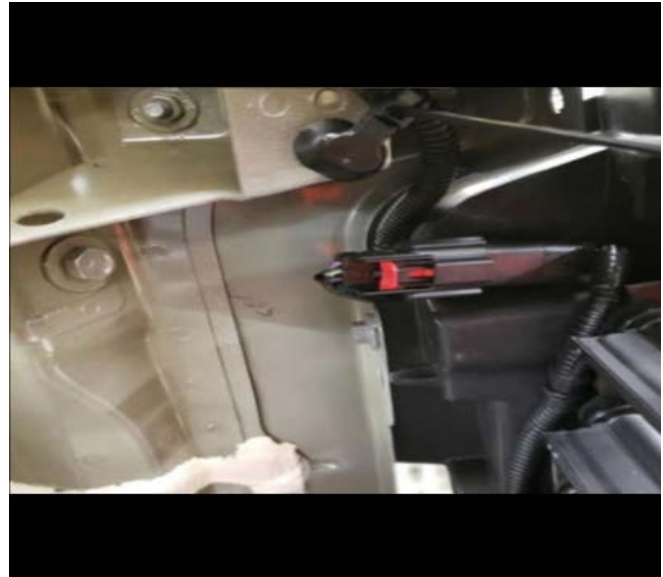
6219339

DTC U1345, U0284 and U0285 may be caused by the engine wiring harness to active grille air shutter actuator inline connector (X618 on the pickup and X604A On the SUV). Please check circuit 4621 which may be:

- Not properly connected
- Not properly hold by the rear clip
- Grounded on the radiator

The graphic above shows how the proper connection must be.

- Check the active grille air shutter actuator in-line connector for not being properly connected or grounded to the radiator.

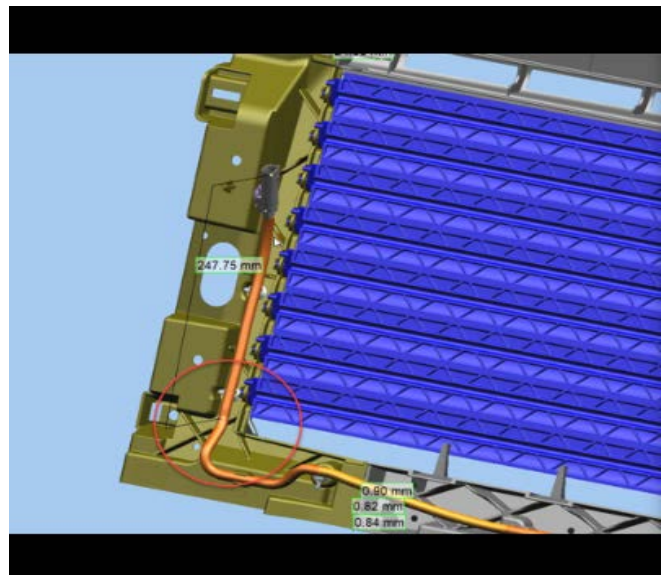
6219340

DTCs may be caused by the active grill air shutter wiring pinched at the radiator support.

The graphic above depicts where a pinching condition may be located.

- Check the active grill air shutter wiring route to identify possible damaged points in the wiring.

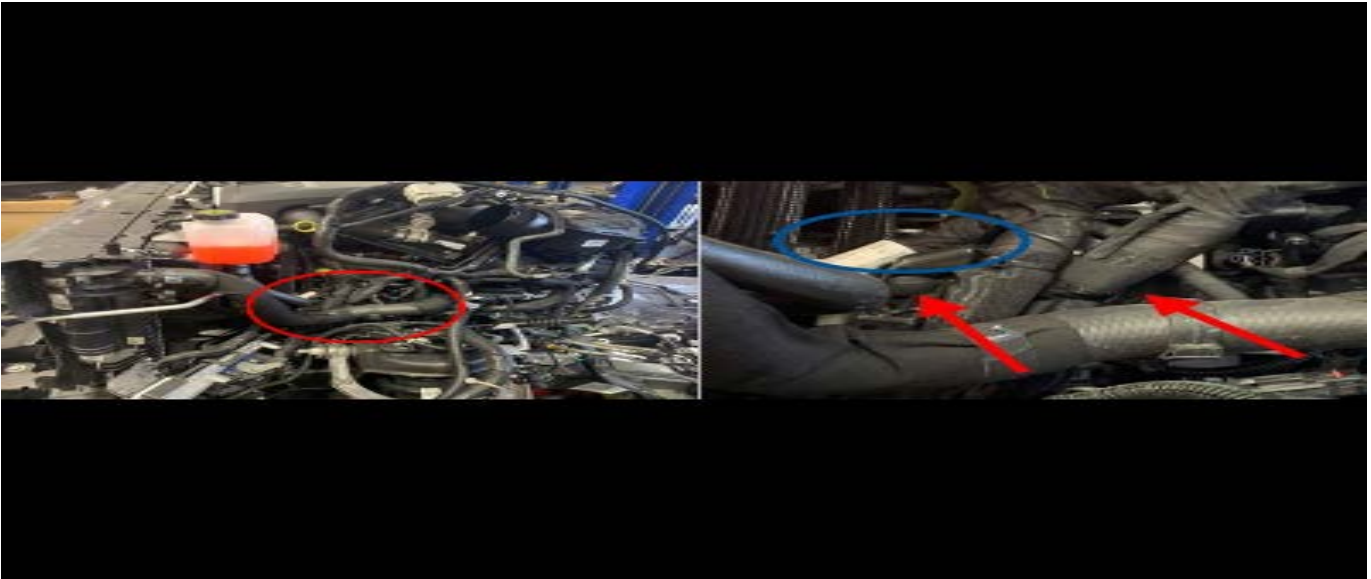
6357536

LM2/LZ0 – Area of Contact at Alternator Bracket.

- Arrows indicate location of retainer pins that were not properly installed.
- •Blue circle indicates where a chafe in the wiring has occurred. The mis installed bracket allowed the harness to lay on the alternator.

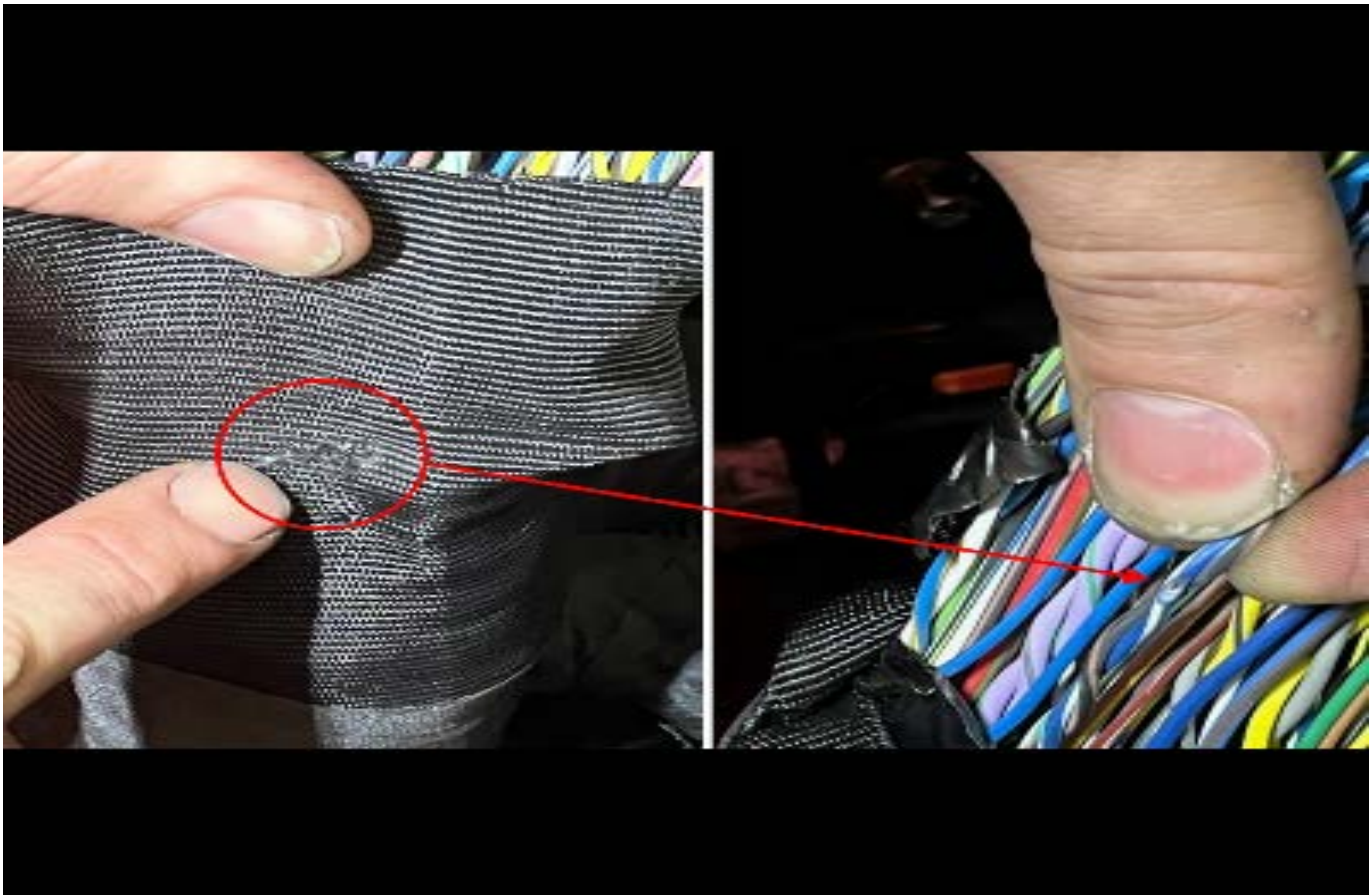
6357529

LM2 – Wiring Harness Contact at Alternator Bracket.

- The engine wire harness was chafed by a bracket next to the back of the alternator.

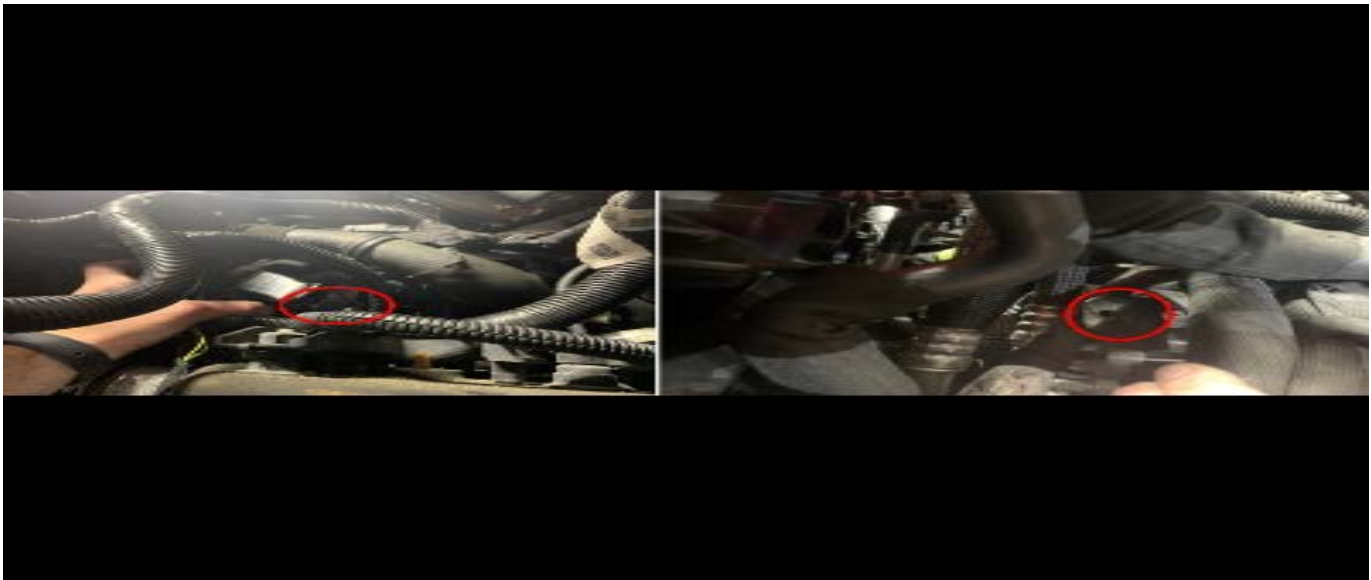
6357546

U0073 CAN BUS 2 off or U0074 CAN BUS 3 off

LM2 – TCCM Wiring Harness Contact at A/C Line and Bracket near Alternator.

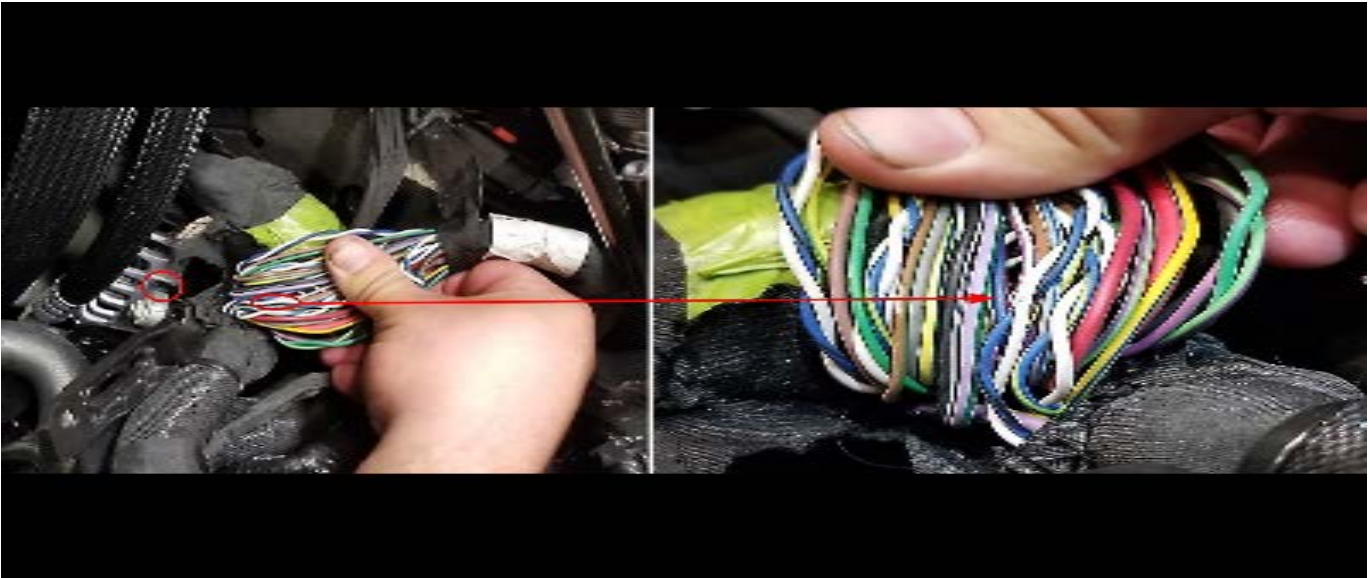
6357562

LZ0 – The Wiring Harness Contacted the Alternator Bracket do to Routing of the Harness.

Note: During the repair. It was noted that a 5/8 ths diameter hose was used to prevent a reoccurring chafe condition.

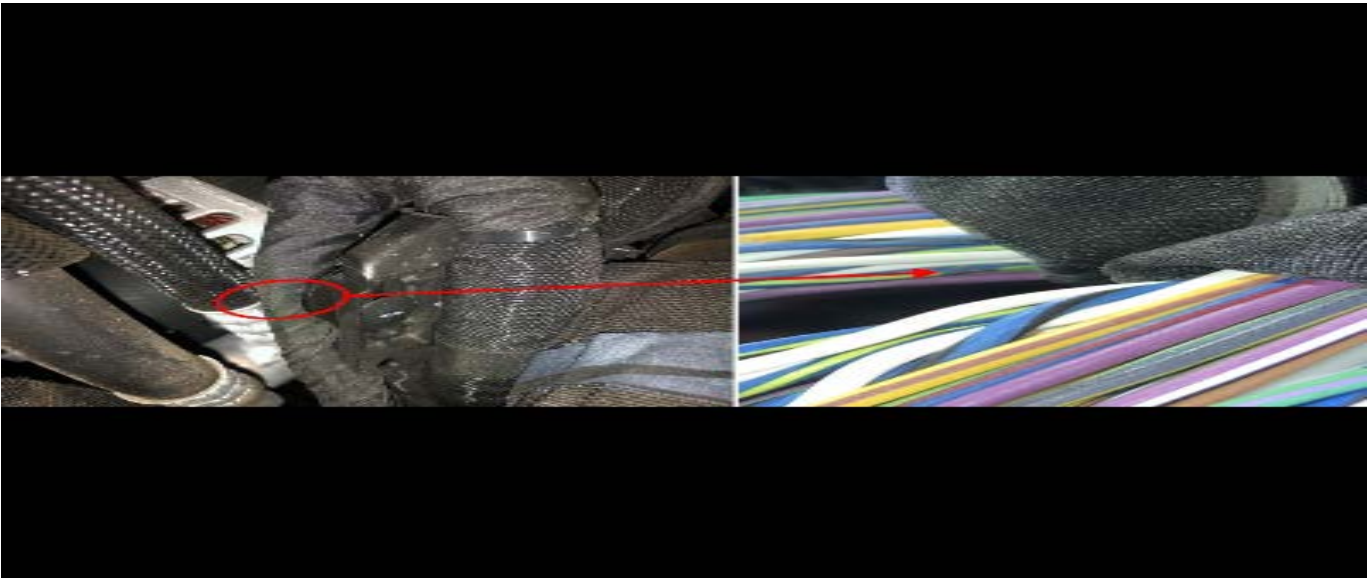
6357567

This is CAN 3 wire harness. Can 4 is also in this bundle only blue and yellow twisted with white.

LZ0 – Wiring Harness Contacting the A/C Line and Alternator Bracket.
