GROUP	MODEL
Voluntary Emissions Service Campaign	2023MY Sportage (NQ5a)
NUMBER	DATE
SC268	July 2023

VOLUNTARY EMISSIONS SERVICE CAMPAIGN

FUEL FILLER NECK VENT COLLAR

INSPECTION & REPLACEMENT (SC268)

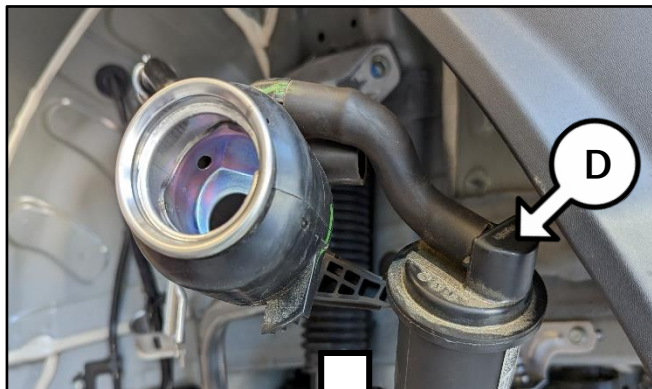
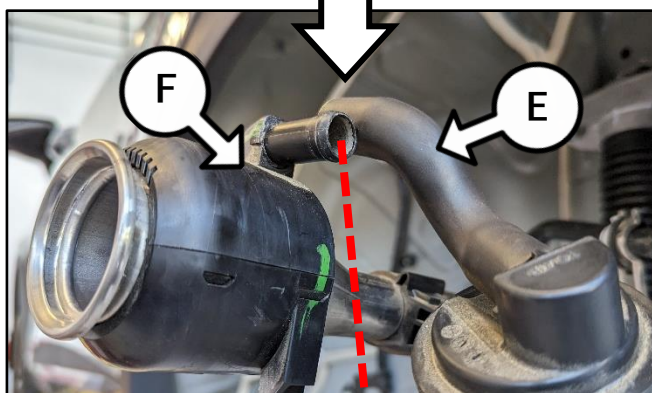
6. Detach the fuel tank filter (D) vent hose (E) from the vent collar (F).

Do **NOT** twist or rotate the vent collar when removing vent hose (E). Doing so may damage the vent collar.

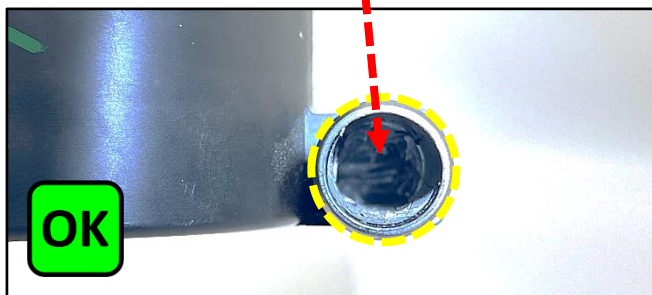
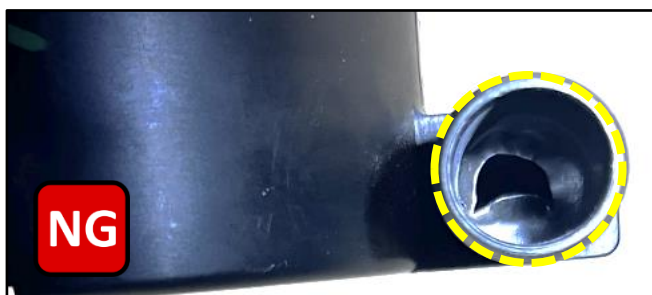
7. Using a flashlight, inspect the vent collar (F) vent port and confirm the following conditions:

- Vent collar port is **not blocked (OK)**, then reinstall all removed parts in the reverse order of removal to complete this service action.
- Vent collar port is **partially blocked (NG)**, then proceed the 'Repair Procedure' on page 4 to replace the vent collar.

Repair Procedure:

1. Remove the vent collar (A) from the filler neck assembly (B).
