# TECHNICAL SERVICE BULLETIN

Technical Service Bulletin: 64-1656

# TECHNICAL SERVICE BULLETIN 64-1656 REMEDY INSTRUCTIONS

Make(s): CHEROKEE & CASCADE Model(s): MANY, SEE BELOW Model Year(s): 2023	Repair Code: SB-431-22-00-004376 Allotted Time: .30 HRS. Inspection Code: SB-431-05-00-004375 Allotted Time: .10 HRS.
	Concern: THE FREEZE SENSON WIRE MAY BE INCORRECTLY WIRED INTO THE GROUND SIDE OF THE AIR CONDITIONER.	Photo(s) Required: YES, POST REMEDY Prior Authorization Required: YES Part(s) Number: F100431666 Part(s) Return: NO

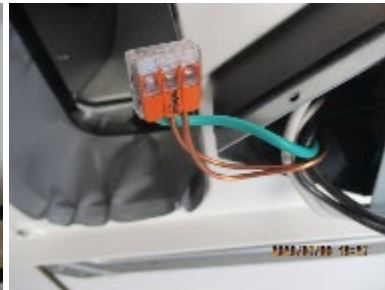
FIG. 2

- STEP 1: REMOVE AC PLENUM ASSEMBLY COVER (FIG. 1);
- STEP 2: REMOVE NON DUCTED ASSEMBLY FROM BOTTOM OF ROOF AC UNIT;
- STEP 3: CHECK TO SEE IF FREEZE SENSOR IS CONNECTED TO 110 VOLT GROUND SENSOR (FIG 2 & 3);
- IF NOT CONNECTED TO GROUND CONNECTOR, THEN NO FURTHER REPAIR IS NEEDED, CLAIM INSPECTION;
  - IF THE FREEZE SENSOR IS CONNECTED TO THE GROUND CONNECTION, MOVE ON TO REMEDY AND NOTE THE THERMOSTAT WILL HAVE TO BE REPLACED AND NEW FREEZE SENSOR WIRE WILL NEED TO BE ROUTED;
