GROUP	MODEL
Service Campaign	2022-2023MY EV6 (CV)
NUMBER	DATE
SC271	July 2023

VOLUNTARY SERVICE CAMPAIGN

ICCU SOFTWARE UPGRADE OR ICCU ASSEMBLY AND FUSE REPLACEMENT (SC271)

This bulletin provides information to inspect the Integrated Charging Control Unit ("ICCU") in certain 2022-2023MY EV6 (CV) vehicles manufactured from November 17, 2021 through May 30, 2023. Depending on the results of the inspection, dealers are to either install an improved ICCU software logic or replace the ICCU and ICCU Fuse. The ICCU in the subject vehicle may get damaged due to an over-current condition in the high-voltage system. This condition may cause the illumination of the "Service Warning Light," "Check electric vehicle system", and/or "Stop vehicle and check power supply" warning messages, along with audible beeps, instructing the driver to stop the vehicle at a safe location. Following these warnings, gradual reductions in power may occur. If the vehicle continues to be driven, it will gradually come to a halt. Kia is conducting this Voluntary Service Campaign to improve the ICCU software logic to prevent high-voltage circuit damage. Follow the procedure outlined in this publication. Before con

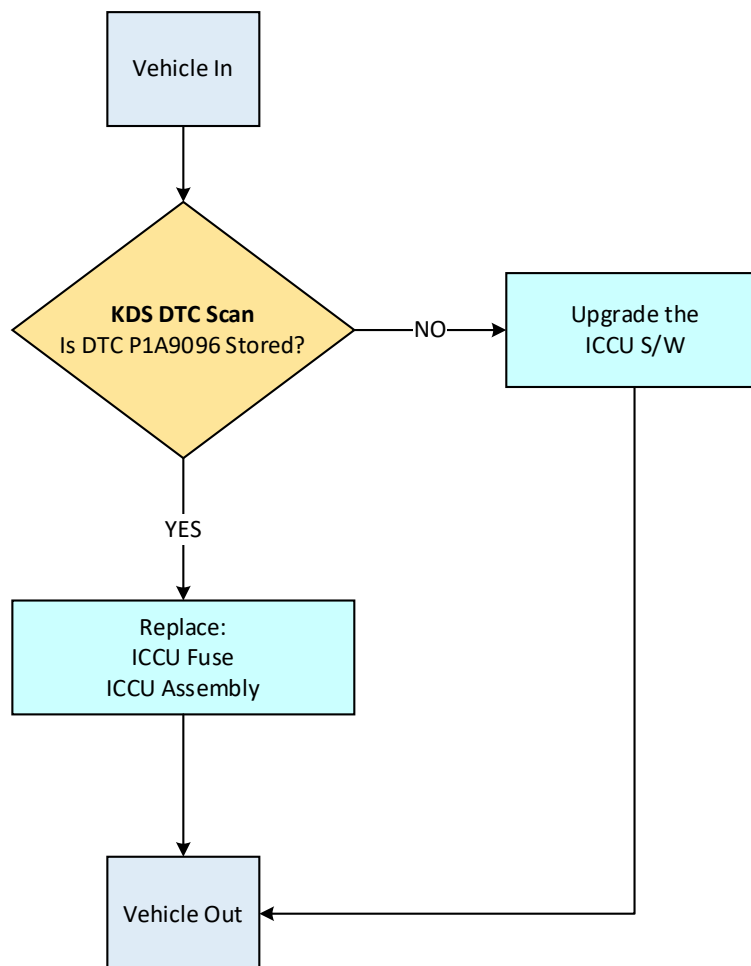
Follow the flowchart below to inspect the vehicle you are working on and confirm if DTC P1A9096 is stored.

- DTC P1A9096 (Not Stored) → Upgrade the ICCU Software (Event #685)
- DTC P1A9096 (Stored) → Replace the ICCU Fuse and ICCU Assembly
(DO NOT perform ICCU software upgrade if ICCU Assy/Fuse are replaced)

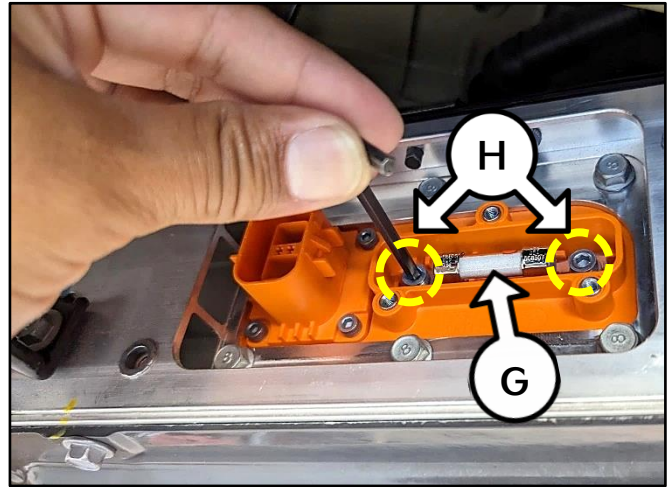
DO NOT use a power tool to remove these bolts. There are two (2) securing nuts inside the battery. If the nuts fall inside the battery, additional time will be required to extract them.

9. Carefully and gently remove the two (2) ICCU fuse (H) retaining allen head bolts (H) using a hand tool and replace the ICCU fuse (I) with a new part.

Tightening torque for T5 hex bolts (H):
39.1 -47.7 lb.in (3.3 - 4.0 N.m)
