**Diagnostic Sheet**

# Grecale: Checks for TPMS and/or Keyfob Recognition Issues

DATE: JUNE 1 2023

**MODEL:** Grecale (All MY)**CHECKLIST:**

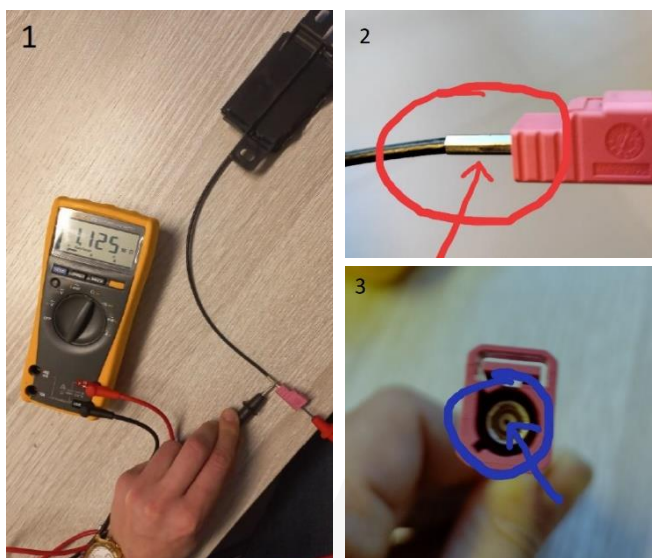
- 8) Measure the resistance of the antenna (see picture 1) by positioning the tester probes as follows:
  - negative probe >> outer metal band (see picture 2)

- positive probe >> center of the connector (see picture 3)

**NOTES:** It is important to connect the probes as described above. Do not invert the position of the probes. The resistance value shown in picture 1 is just an example.

9) If the measure is on the order of milliohm ( $m\Omega$ ), check the correct positioning of the probes. The expected resistance value is in the order of Megaohm ( $M\Omega$ );

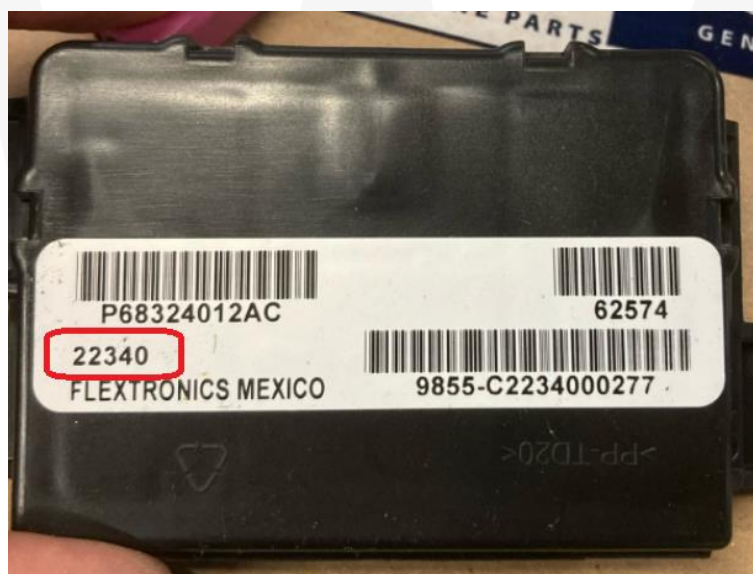
10) Check the production date of the antenna (see example highlighted in the figure below). The date is in YYDDD format. Replace the antenna if the number reported is lower than **23031** (refer to the spare parts catalogue, section 08.53 – 1, item n.4).
