MAS003623 RU 23-22

RAPID UPDATE

Rapid Update 631 Granturismo – Eyelet terminal check

DATE: JUNE 7 2023

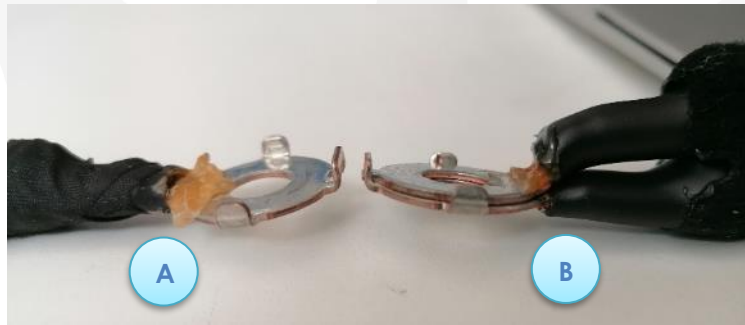
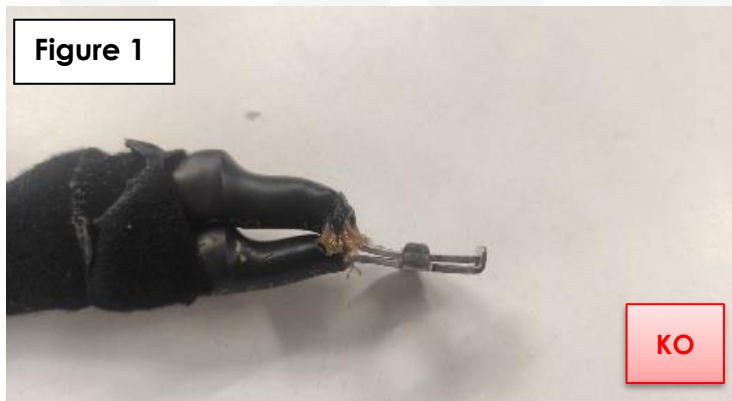
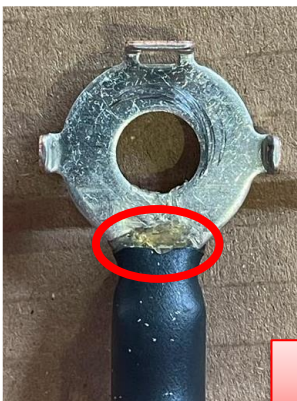
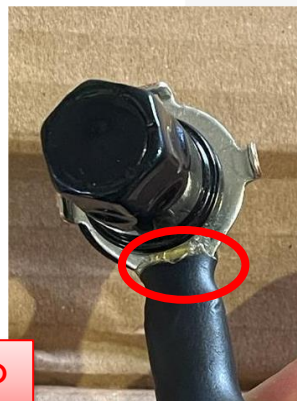
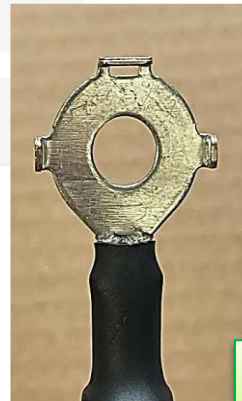
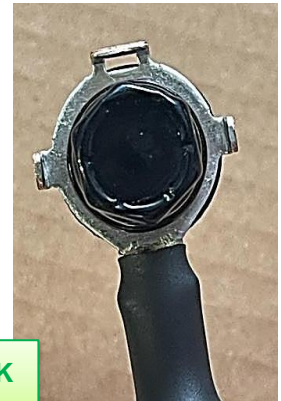
IMPORTANT: On traditional metal terminals, the excess glue used to waterproof the wiring to the terminals is usually eliminated automatically through the applied torque. However, this cannot be achieved with aluminum terminals as they have a lower tightening torque specification (8Nm - Class C). Consequently, it is necessary to manually remove and clean any excess glue on the eyelet terminal. This step is crucial as the excess glue can impede the clamping of the nut and hinder proper contact between the eyelet terminal and the body ground stud surface.

A: Single eyelet terminal: check for the presence of glue covering the eyelet and proceed with the removal according to the cleaning procedure indicated on **page 6** of this bulletin.

B: Double eyelet terminal: in addition to the above check, if excess glue appears between the two eyelets as shown in **Figure 1**, please open a BOL as "SUPPORT REQUEST" attach pictures and await further instructions

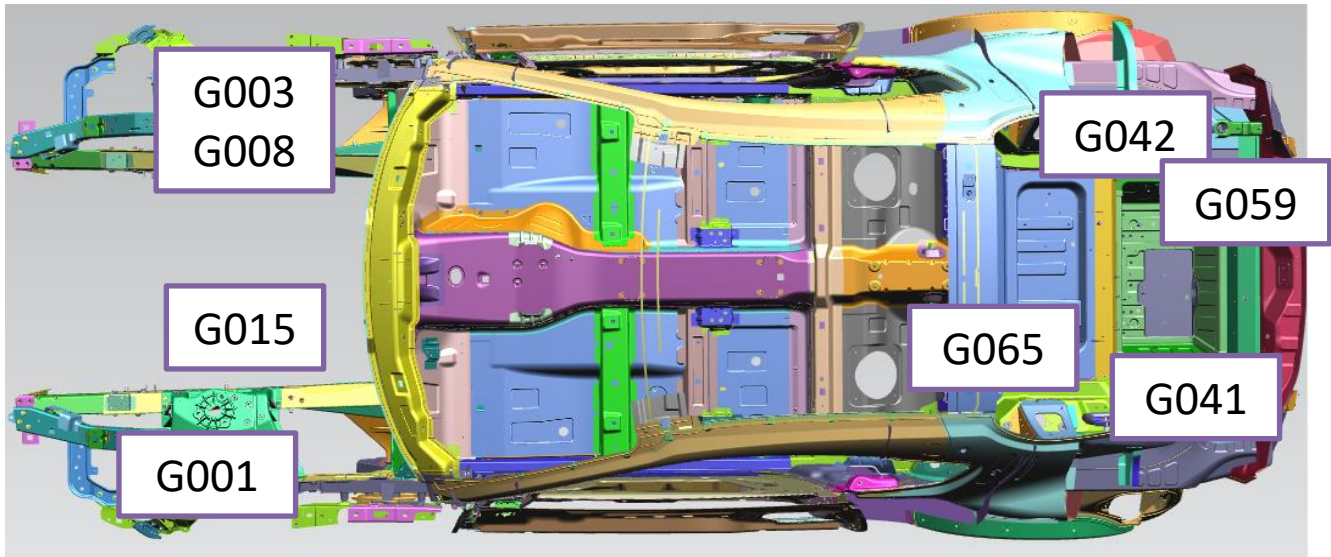
IMPORTANT: The ground points that need to be checked are situated in various areas of the vehicle. The image below provides an overview of all the points affected by the rework. Each individual point will be accompanied by the appropriate procedure to access it effectively.
