MAS003628 RU 23-20

Rapid Update 633 Granturismo – Top Strut Mount check

DATE: JUNE 7 2023

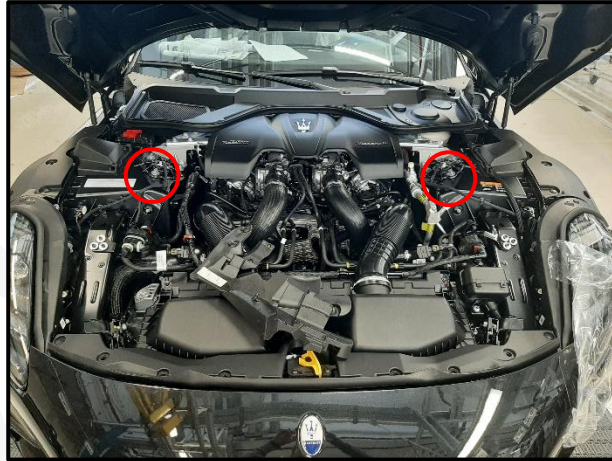
1. Always check ModisCS+ to see if the vehicle is involved in this action and if it has not been previously performed.
2. Disconnect the battery, following the procedure in the workshop manual.
 - a. **08.20.001 - BATTERY - Connection/disconnection of the electric power supply**
3. Open the front hood and locate the top of both the right and left shock absorber areas. Remove both front wheels to access the shock absorber attachment area via the wheel well area.
 - a. **06.00.001 - RH FRONT WHEEL RIM - Removal and refitting**

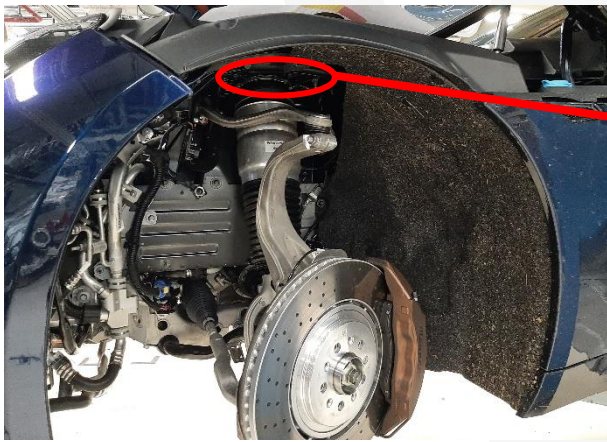
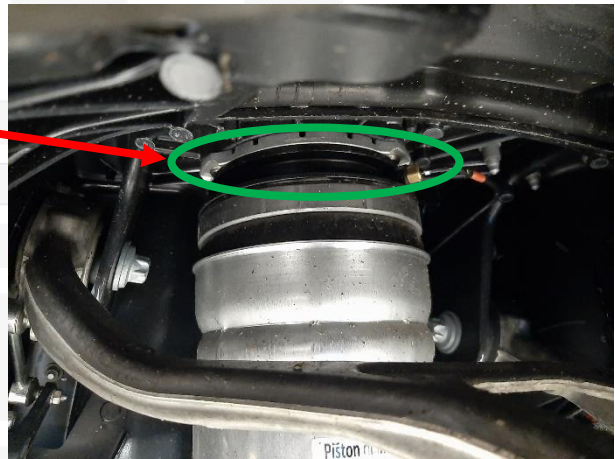
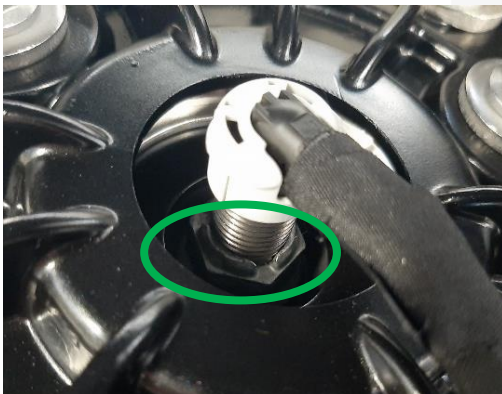
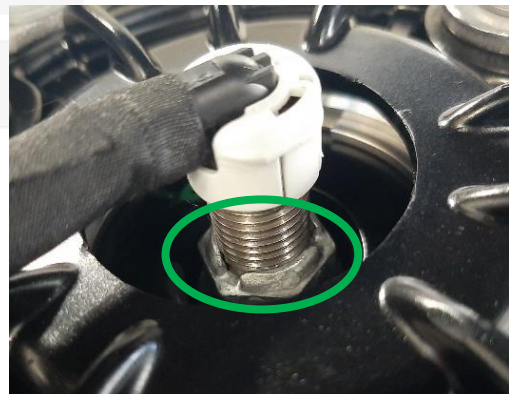
This action is necessary because, on a limited number of vehicles, a component has been installed with a material that has excessively high porosity. This can result in air leaks from the suspension circuit. To address this issue, it is advisable to utilize a leak detector to determine whether the front shock absorbers are leaking. If leaks are detected, they should be replaced accordingly.

4. Using leak detection liquid (e.g., Snoop Leak Detector) or an equivalent, check for air leaks in the areas circled in **GREEN** (both the Driver and Passenger side engine compartment and in the wheel well compartment areas) Make sure to spray the entire circumference of the areas shown.

- **OK** ▶ No leak has occurred; the procedure is finished. No further action needed.
- **NOT OK** ▶ Air leak found (formation of bubbles). Replace the complete shock absorber assembly that is leaking following the procedure in the workshop manual.

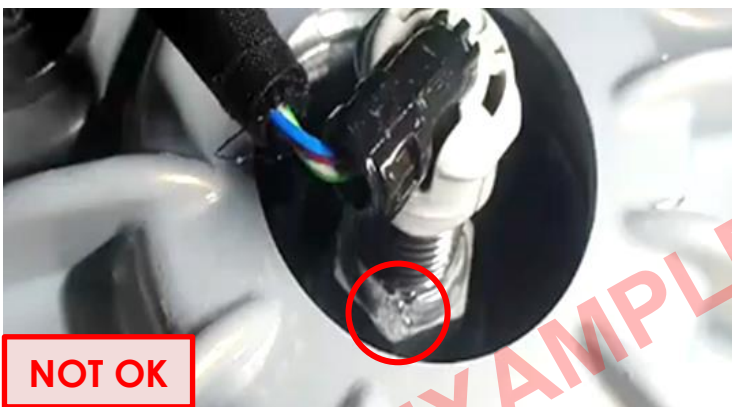
Example of air leakage shown
