MAS003627 RU 23-23

Rapid Update 632 Grecale – Top Strut Mount Check

DATE: JUNE 8 2023

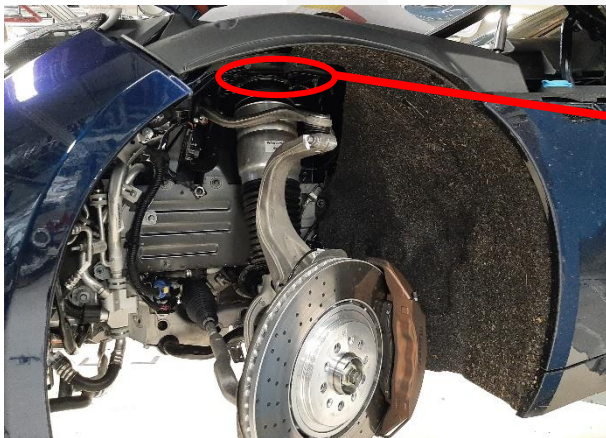
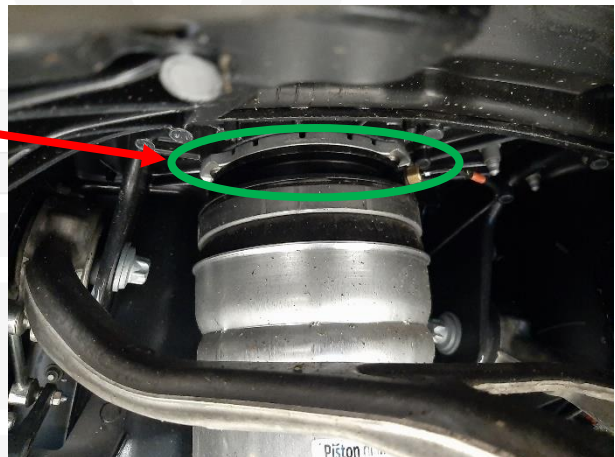
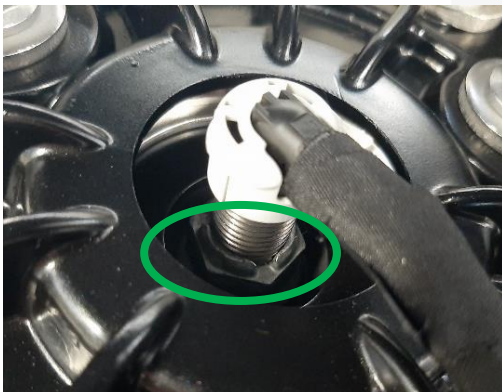
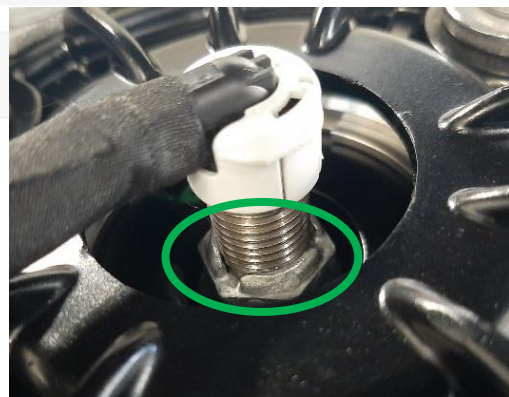
This action is necessary because, on a limited number of vehicles, a component has been installed with a material that has excessively high porosity. This can result in air leaks from the suspension circuit. To address this issue, it is advisable to utilize a leak detector to determine whether the front shock absorbers are leaking. If leaks are detected, they should be replaced accordingly.

4. Using leak detection liquid (e.g., Snoop Leak Detector) or an equivalent, check for air leaks in the areas circled in **GREEN** (both the Driver and Passenger side engine compartment and in the wheel well compartment areas) Make sure to spray the entire circumference of the areas shown.

- **OK** ▶ No leak has occurred; the procedure is finished. No further action needed.
- **NOT OK** ▶ Air leak found (formation of bubbles). Replace the complete shock absorber assembly that is leaking following the procedure in the workshop manual.
 - a. **6.11.001 RH FRONT SHOCK ABSORBER** **Removal-Refitting or Replacement**
 - b. **6.11.002 LH FRONT SHOCK ABSORBER** **Removal-Refitting or Replacement**

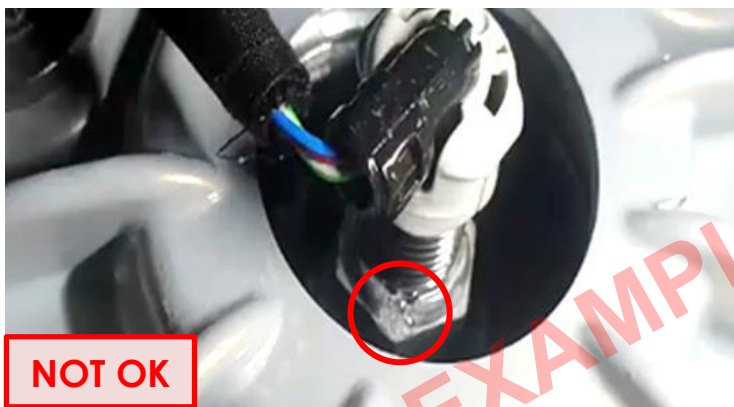
Example of air leakage shown
