REFERENCE:	TSB: 07-004-23 GROUP 07 - Cooling	Date:	May 2, 2023	REVISION:	-
VEHICLES AFFECTED:	2022 - 2023 (JL) Jeep Wrangler This bulletin applies to vehicles built on or after August 01, 2022 (MDH 0801XX) and on and before November 07, 2022 (MDH 1107XX) equipped with a 6.4L V8 SRT Hemi MDS Engine (Sales Code ESG).	MARKET APPLICABILITY:			
		<input checked="" type="checkbox"/> NA		<input checked="" type="checkbox"/> MEA	
		<input type="checkbox"/> SA		<input type="checkbox"/> IAP	
		<input type="checkbox"/> EE		<input type="checkbox"/> CH	
CUSTOMER SYMPTOM:	Coolant Leak.				
CAUSE:	Weak seam in the overflow coolant bottle.

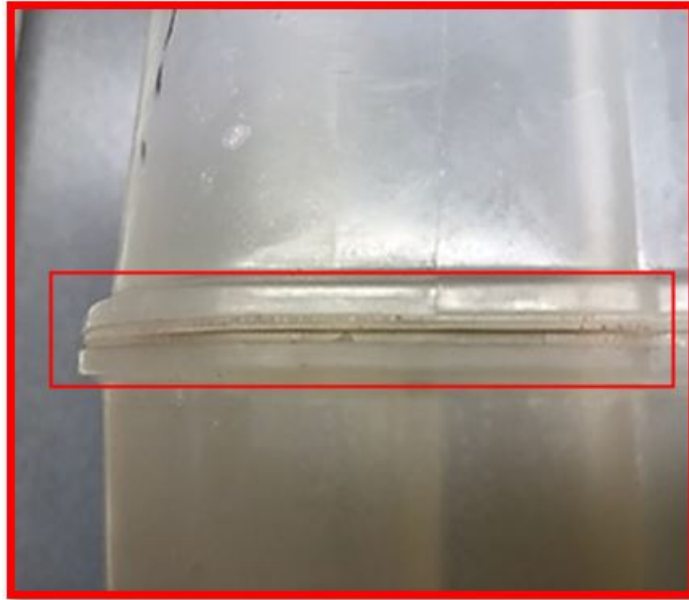
1. **For Unsold vehicles:** Proceed to [Step 1](#) of the Repair Procedure..
2. **For Sold vehicles:** Pressure test the cooling system and check for leaks around the seam of the overflow bottle. Refer to the detailed service procedures available in DealerCONNECT> Service Library under: 09 - Engine, 6.4L / Cooling System / Engine Cooling / Diagnosis and Testing, ([Fig. 1](#)) and ([Fig. 2](#)) .

Fig. 1
Coolant Leak Area

1. Drain only the coolant overflow tank and reuse as much coolant as possible.

2. Replace the coolant bottle ([Fig. 3](#)) . Refer to the detailed service procedures available in DealerCONNECT> Service Library under: 09 - Engine, 6.4L / Cooling System / Engine Cooling / Bottle, Pressurized Coolant / Removal and Installation. **For reference only.**

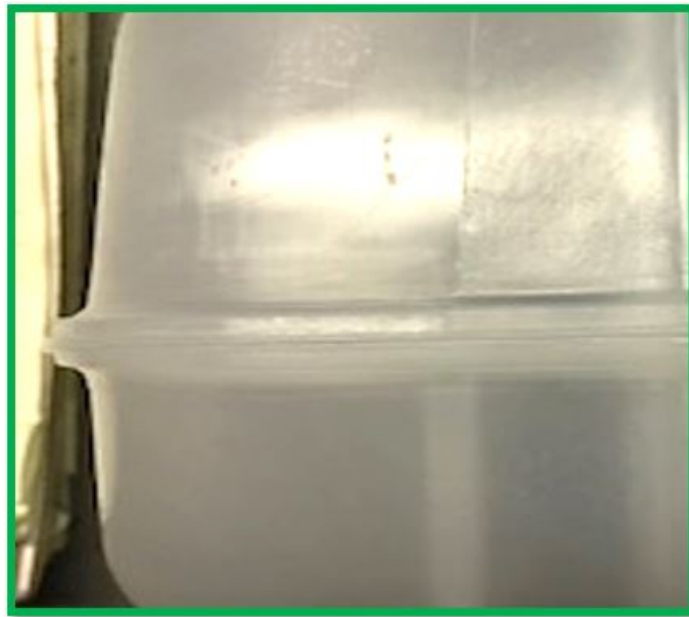
Fig. 2
Tight Seam, No Leaks
