Technical Service Bulletin (TSB)
Water Leak - Liftgate Glass to Swing Gate

REFERENCE:	TSB: 23-049-23 GROUP 23 - Body	Date:	May 2, 2023	REVISION:	—
VEHICLES AFFECTED:	2022 - 2023 (JL) Jeep Wrangler This bulletin applies to vehicles built on and after August 1, 2022 (MDH 0801XX) and on and before October 8, 2022 (MDH 1008XX) equipped with Black Three Piece Hard top (Sales Code HT1) or Body Color Three Piece Hard top (Sales Code HT3).	MARKET APPLICABILITY:			
		<input checked="" type="checkbox"/> NA	<input checked="" type="checkbox"/> CH	<input checked="" type="checkbox"/> EE	<input checked="" type="checkbox"/> IAP
		<input checked="" type="checkbox"/> SA	<input checked="" type="checkbox"/> MEA		
CUSTOMER SYMPTOM:	Water leak into rear cargo area at the bottom of lift glass seal and top of swing gate.				
CAUSE:	Body fit and dimensional variation.

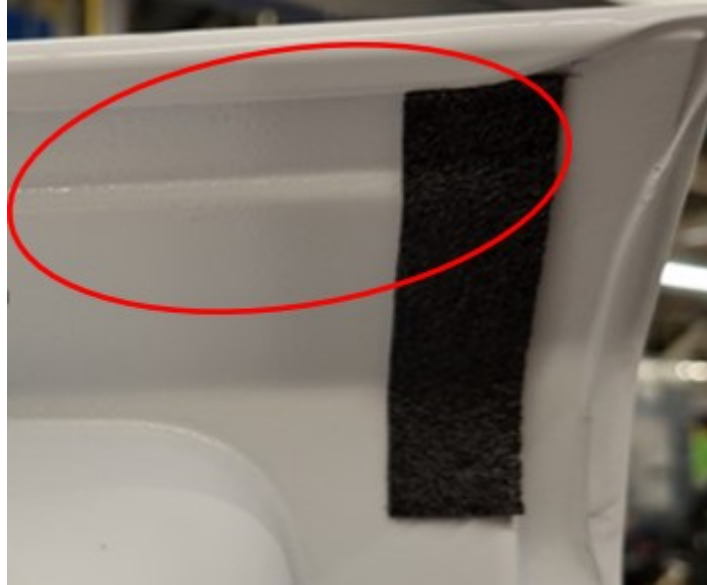
Fig. 1
Foam Pad Area

1. Clean the surface area that the foam is being applied to with an alcohol wipe (Fig. 1) .
2. Install foam pads on rear swing gate (Fig. 2) , (Fig. 3) .

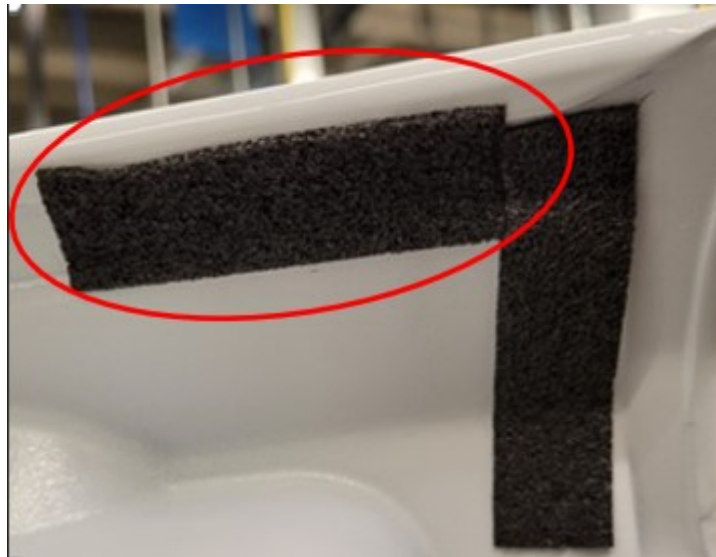
Fig. 2
Foam Pad Installed

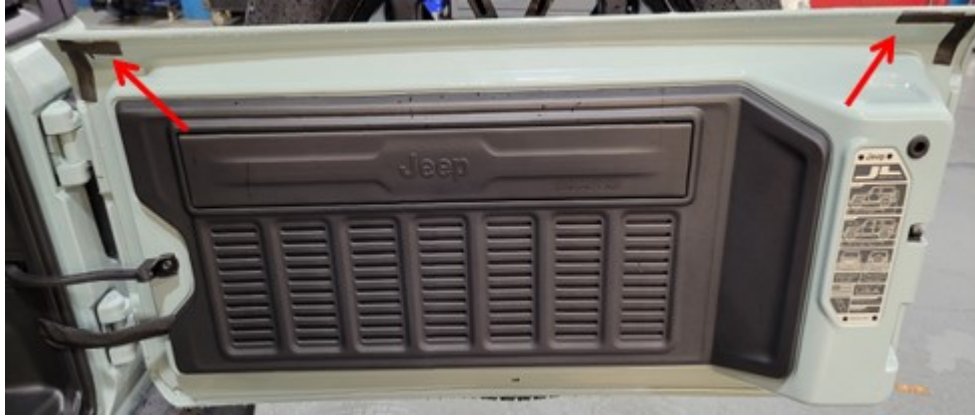
Fig. 3
Foam Pad Installation Complete
