| REFERENCE: | TSB: 08-116-23 GROUP 08 - Electrical | Date: | May 3, 2023 | REVISION: | – |
| VEHICLES AFFECTED: | 2023 (WL) Jeep Grand Cherokee This bulletin applies to vehicles built on or after February 06, 2023 (MDH 0206XX) and on or before March 30, 2023 (MDH 0330XX) equipped with a Telematics Box Module (Sales Code RDG) and Remote Monitoring System-China (Sales Code RTZ). | MARKET APPLICABILITY: <input type="checkbox"/> NA <input type="checkbox"/> MEA <input type="checkbox"/> SA <input type="checkbox"/> IAP <input type="checkbox"/> EE <input checked="" type="checkbox"/> CH | | | |
| CUSTOMER SYMPTOM: | Remote Monitoring System (RMS) feature is inoperative, or disabled. | | | | |
| CAUSE: | TBM Software | | | | |

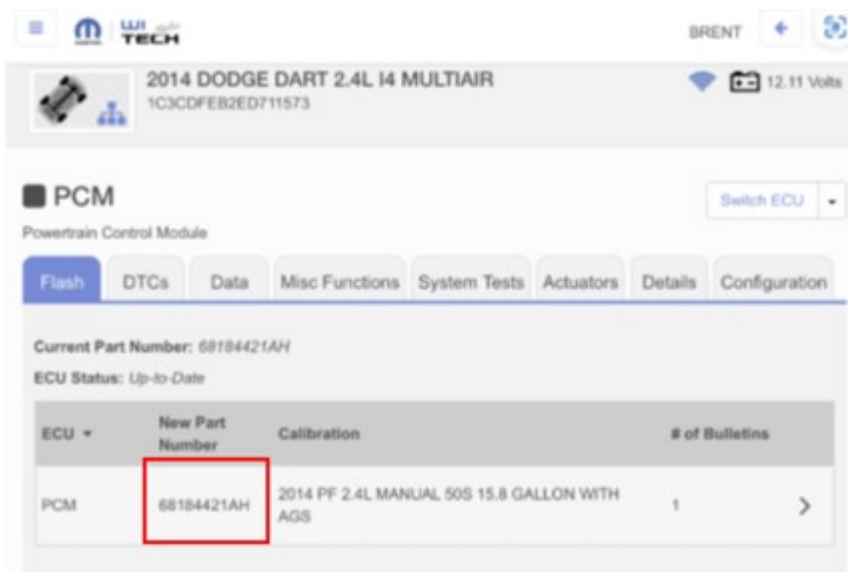
Fig. 5
New Part Number 68569548AD Screen

NOTE: The TBM “New Part Number” should be 68569548AD.

9. From the “Flash” tab, compare the “Current Electronic Control Unit (ECU) Part Number” with the “New ECU Part Number” listed (Fig. 5) .

- YES>>> The “Current ECU part number” is the same as the “New Part Number”? Proceed to [Step 17](#).
- NO>>> The “Current ECU part number” is **NOT** the same as the “New Part Number”? Proceed to [Step 10](#).
