**Technical Service Bulletin (TSB)**  
**Radio UNP T25.49 USB Software Update**

<b>REFERENCE:</b>	<b>TSB:</b> 08-117-23 <b>GROUP</b> 08 - Electrical	<b>Date:</b>	May 3, 2023	<b>REVISION:</b>	-
<b>VEHICLES AFFECTED:</b>	<b>2023 (W7) Jeep Grand Cherokee (India)</b> This bulletin applies to vehicles built on or after October 20, 2022 (MDH 1020XX) and built on or before January 27, 2023 (MDH 0127XX) equipped with Uconnect 5 NAV W 10.1" Display (Sales Codes UPN).			<b>MARKET APPLICABILITY:</b>	
				<input type="checkbox"/> NA	<input type="checkbox"/> MEA
				<input type="checkbox"/> SA	<input checked="" type="checkbox"/> IAP
				<input type="checkbox"/> EE	<input type="checkbox"/> CH
<b>CUSTOMER SYMPTOM:</b>	The customer may describe one or more of the following: <ul style="list-style-type: none"> <li>• Half camera display on screen.</li> <li>• Only left side camera is visible on screen.</li> <li>• Camera view on screen not changing upon selection.</li> </ul>				
<b>CAUSE:</b>	Radio software

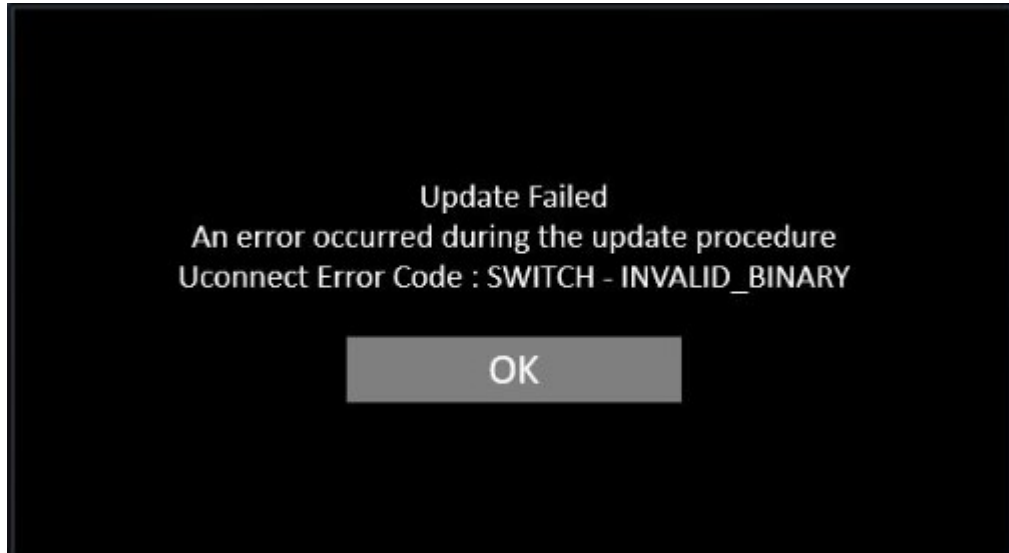
Fig. 8  
Error Message

22. Sometimes the radio will display an error pop up “ SWITCH - INVALID\_BINARY“ after successful radio update. Please ignore this error message and press “OK” to continue (Fig. 8) .

23. Press “OK” to continue (Fig. 9) .
