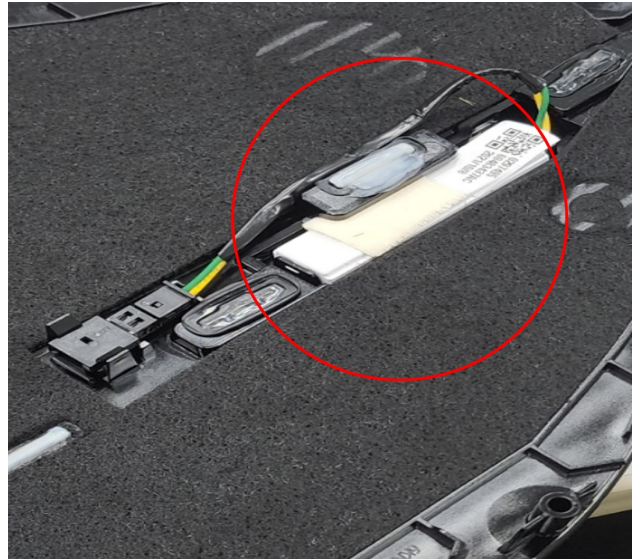
Fig. 2
Tape Properly Installed

5. Light should now be secured to the tape and speaker grille (Fig. 2) .
