Technical Service Bulletin (TSB)

Heated Windshield Inoperative

REFERENCE:	TSB: 23-050-23 GROUP 23 - Body	Date:	May 10, 2023	REVISION:	-
VEHICLES	2023 (JL) Jeep Wrangler This bulletin applies to vehicles built on or after February 23, 2023 (MDH 0223XX) and on or before March 24, 2023 (MDH 0324XX).			MARKET APPLICABILITY:	
AFFECTED:				⊠NA	□СН
				⊠EE	□IAP
				⊠SA	⊠MEA
CUSTOMER SYMPTOM:	Customers may comment on the followThe heated windshield is inoperation	•			
CAUSE:	Electrical connection button is not fully engaged onto the windshield.

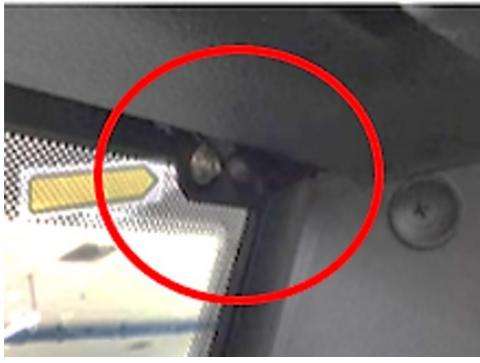
- If a customer's VIN is listed in VIP or your RSU VIN list, perform the inspection.
- 1. Visually look at the windshield heated button being disconnected (Fig. 1) .

Fig. 1 Heated Windshield Button Is Disconnected

- 2. Is the heated windshield button disconnected?
 - YES>>> Proceed to Step 1 of the Repair Procedure.
 - NO>>> This bulletin has been completed. Use inspect LOP (23-30-50-9P) to close the active RSU. Normal diagnosis should be performed.

1. Connect the heated windshield button to the windshield.
