Technical Service Bulletin (TSB)  
Engine Coolant Leak

<b>REFERENCE:</b>	<b>TSB:</b> 07-005-23 <b>GROUP</b> 07 - Cooling	<b>Date:</b>	May 10, 2023	<b>REVISION:</b>	
<b>VEHICLES AFFECTED:</b>	<b>2023 (WL) Grand Cherokee</b> This bulletin applies to vehicle built on or after November 25, 2022 (MDH 1125XX) and on and before December 08, 2022 (MDH 1208XX) equipped with 3.6L V6 VVT Engine Upgrade 1 (Sales Code ERC).	<b>MARKET APPLICABILITY:</b>			
<b>CUSTOMER SYMPTOM:</b>	Coolant leak under vehicle and/or low coolant warning on dash.				
<b>CAUSE:</b>	Broken lock ring on Engine Coolant Temperature (ECT) sensor.

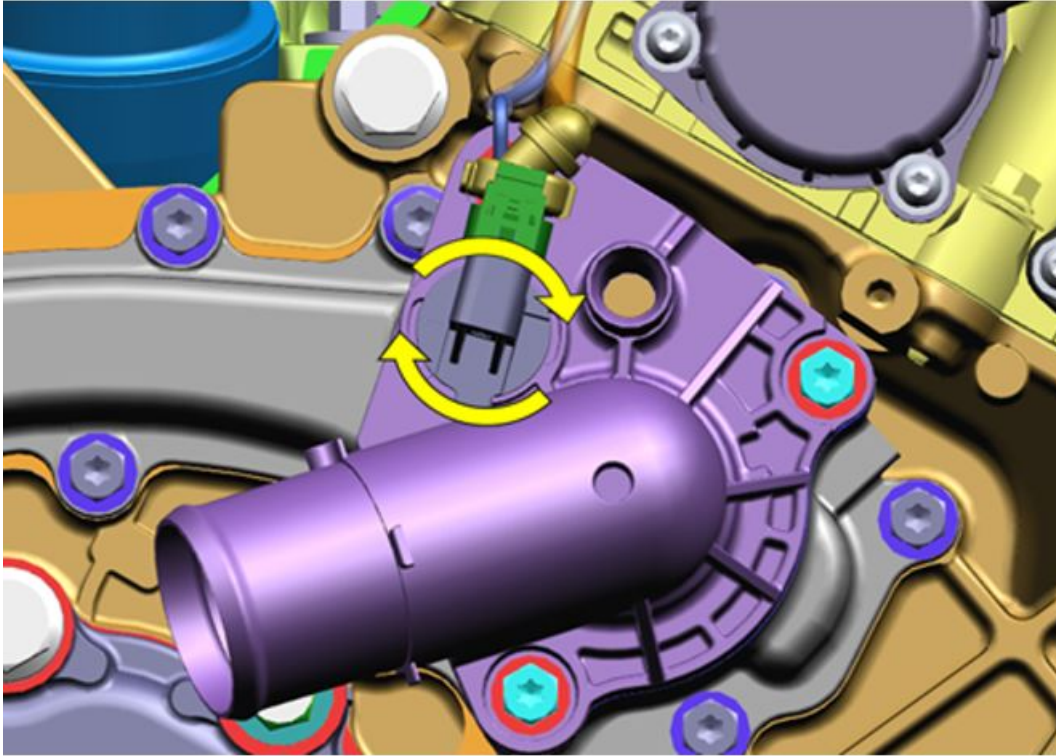
**Fig. 1**  
**ECT Sensor Location**

2. Hold the ECT sensor and **gently** attempt to rotate it clockwise and then counterclockwise. If the sensor rotates, then it has failed ([Fig. 1](#)).

5. Replace the ECT sensor. Refer to the detailed service procedures available in DealerCONNECT/Service Library under: Service Info> 09 - Engine, 3.6L / Engine Sensors / Removal and Installation - Engine Coolant Temperature Sensor.
6. Connect the battery. Refer to the detailed service procedures available in DealerCONNECT/Service Library under: Service Info> 08 - Electrical / 8F - Engine Systems / Battery System / Standard Procedure
