REFERENCE:	TSB: 23-051-23 GROUP 23 - Body	Date:	May 11, 2023	REVISION:	-
VEHICLES AFFECTED:	2022 - 2023 (LA) Dodge Challenger 2022 - 2023 (LD) Dodge Charger This bulletin applies to vehicles built on or after December 01, 2022 (MDH 1201XX) and on or before January 03, 2023 (MDH 0103XX) equipped with Bright "345" Fender Badge (L/R) (Sales Code MGS) or Dark "345" Fender Badge (L/R) (Sales Code MGU).	MARKET APPLICABILITY:			
CUSTOMER SYMPTOM:	Both 345 fender badges (Fig. 1) are missing.				
CAUSE:	Demand issue.

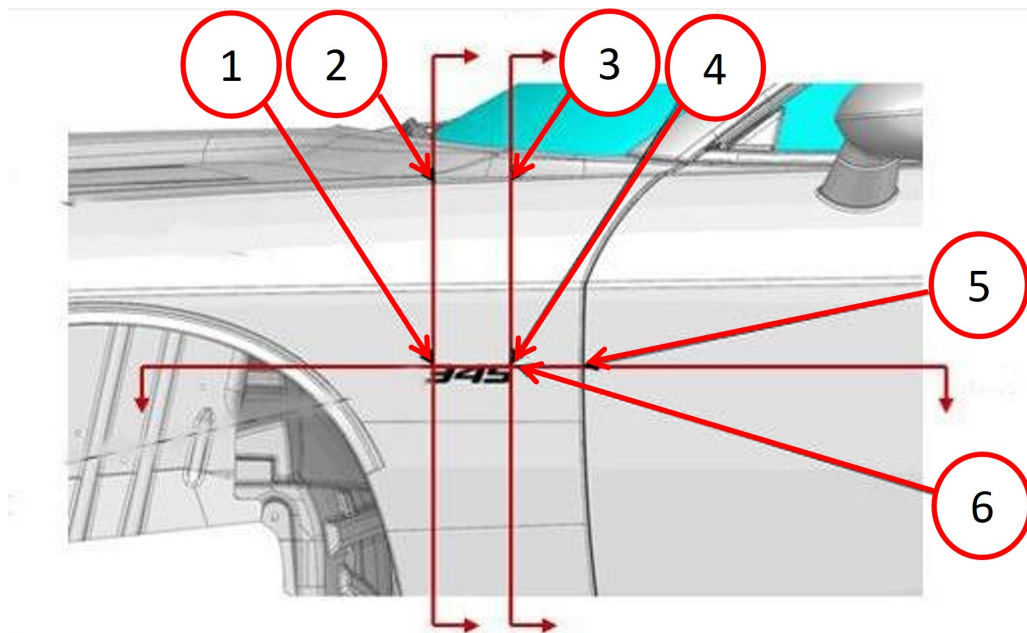
Fig. 2

Challenger Driver Side Badge Location

1. Wipe the fender badge attachment area (Fig. 2) or (Fig. 3) with a clean, lint-free cloth, moistened with a 50% solution of water and alcohol, to thoroughly clean all residue from the fender badge attachment surface area. Wipe dry the areas immediately with a dry, lint-free cloth.

2. Using the measurements provided (Fig. 4) , remove the protective covering from the back of the badge and position the badge onto the fender (Fig. 2) or (Fig. 3) .

3. Visually inspect that there is 100% adhesion all around the perimeter of the badge to the fender (Fig. 2) or (Fig. 3) .
