Technical Service Bulletin (TSB)
Lower Day Light Opening or B-Pillar Moldings Have a Poor Fit or are Loose

| REFERENCE: | TSB: 23-053-23 GROUP 23 - Body | Date: | May 13, 2023 | REVISION: | - |
| VEHICLES AFFECTED: | 2022 - 2023 (WS) Grand Wagoneer/Wagoneer This bulletin applies to vehicles built: <ul style="list-style-type: none"> On or before November 07, 2022 (MDH 1107XX) covering lower day light opening moldings have a poor fit to door glass, On or after March 03, 2023 (MDH 0303XX) and on or before March 06, 2023 (MDH 0306XX) covering loose door trim at the B-pillar, equipped with Window Mldg-Polished Stainless Steel (Sales Code MDR) or UPR And LWR DLO Mldg - Gloss Black (Sales Code MMR). | | | MARKET APPLICABILITY: <input checked="" type="checkbox"/> NA <input type="checkbox"/> CH <input type="checkbox"/> EE <input type="checkbox"/> IAP <input type="checkbox"/> SA <input checked="" type="checkbox"/> MEA | |

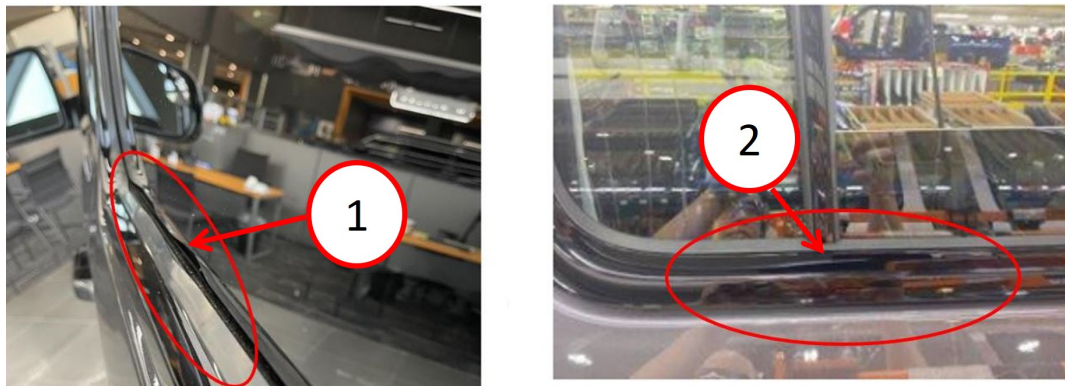
Fig. 1

1. Was the vehicle built on or before November 07, 2022?
 - YES>>> Proceed to [Step 2](#).
 - NO>>> Proceed to [Step 4](#).
2. Using a 4 mm (0.157 in.) gap gauge, measure between the lower day light opening molding top edge and the glass surface ([Fig. 1](#)), on all four doors.

Lower Day Light Opening Molding Top Edge To Glass Gaps

- 1 - Area To Measure - Front Door Example Gap Shown
- 2 - Area To Measure - Rear Door Example Gap Shown

3. Did one or more, lower day light opening moldings top edge to glass surface, exceed 4 mm (0.157 in.) ([Fig. 1](#)) on any of the four doors?
 - YES>>> Proceed to [Step 1](#) of the Repair Procedure.
 - NO>>> This bulletin has been completed. Use inspect LOP (23-51-16-9E) to close the active RSU.
4. Was the vehicle built on or after March 03, 2023 and on or before March 06, 2023?
 - YES>>> Proceed to [Step 5](#).
 - NO>>> This bulletin does not apply.
5. Lower both front door windows all the way down.

1. Replace the lower day light opening molding(s), as required. Refer to the detailed service procedures available in DealerCONNECT> Service Library under: Service Info>23 - Body / Doors - Front / Molding / Removal and Installation **OR** Refer to the detailed service procedures available in DealerCONNECT> Service Library under: Service Info>23 - Body / Doors - Rear / Molding / Removal and Installation.

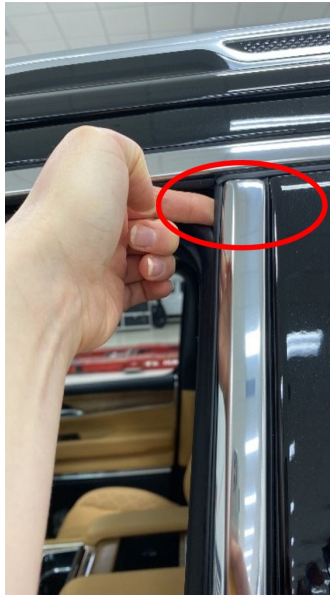
Fig. 2

6. Using a 5 mm (0.19 in.) gap gauge, inspect both the left and right front lower day light opening molding at the B-pillar and verify if properly seated to the door frame (Fig. 2) . Moldings should not move away from the door frame at the B-pillar (Fig. 2) more than 5 mm (0.19 in.).

Molding Area To Measure At B-Pillar

7. Did either the left and right front lower day light opening moldings move away from the door frame (Fig. 2) more than 5 mm (0.19 in.) at the B-pillar?
- YES>>> Push the molding into the door frame to try to re-seat the molding clip. If it will not re-seat, proceed to [Step 1](#) of the Repair Procedure.
 - NO>>> This bulletin has been completed. Use inspect LOP (23-51-16-9E) to close the active RSU.
