Technical Service Bulletin (TSB)

Mis-Installed 3-way Coolant Valve

REFERENCE:	TSB : 07-006-23 GROUP 07 - Cooling	Date:	May 13, 2023	REVISION:	_
VEHICLES AFFECTED:	022 (JL) Jeep Wrangler PHEV his bulletin applies to vehicles built on June 4, 2022 (MDH 0604XX) quipped with the 2.0L I4 DOHC DI TURBO PHEV Engine (Sales Code CX).		MARKET AF	PPLICABILITY: □MEA □IAP □CH	
CUSTOMER SYMPTOM: The customer may experience a Malfunction Indicator Lamp (MIL) illumination. Upon further investigation the technician may find the following Diagnostic Trouble Code (DTC): P0E80-00 - Coolant Bypass Valve "B" Control Stuck Closed. Customer may also experience the following: Intermittent no heat. 					
CAUSE:	Mis-routed three way coolant valve hos	es.

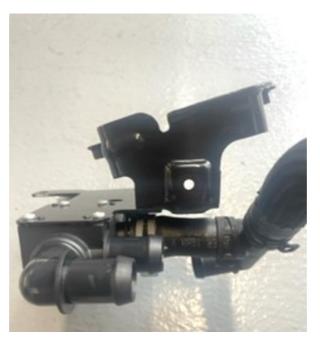
2. Inspect the hose routing. Hose number one should be at the top of the valve: (Fig. 1) , (Fig. 2) , (Fig. 3) .

Fig. 1 Correct Hose #1 Location

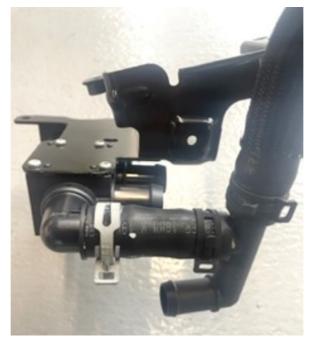
Fig. 2 Incorrect Hose #1 Location

- 1. Drain the high temperature cooling system. Refer to the detailed service procedures listed in DealerCONNECT>Service Library under: 07 Cooling / Standard Procedure (Draining).
- 2. Using hose clamp pliers, Remove the incorrect hoses from the Three Way Coolant Valve.
- 3. Install the hoses to the correct coolant valve ports. Use the hose alignment marks on the backside of the three way valve to confirm each hose is orientated correctly (Fig. 4).

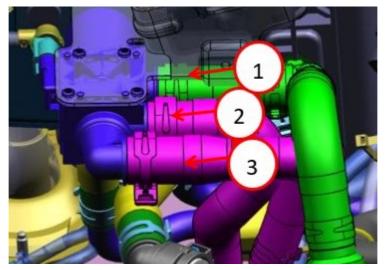
Fig. 3 Correct Hose Locations

1 - Number 1 Hose

2 - Number 2 Hose (Runs to Dash Area)

3 - Number 3 Hose (Runs to Dash Area)

NOTE: The bottom two hoses should route coolant back to the dash and continue to run parallel and not cross each other.

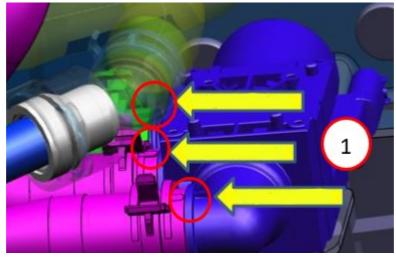
Fig. 4 Hose Alignment Marks

1 - Hose Alignment Marks
