Technical Service Bulletin (TSB)
Front Door Panel Noise When Closing

| REFERENCE: | TSB: 23-056-23 GROUP 23 - Body | Date: | May 17, 2023 | REVISION: | — |
| VEHICLES AFFECTED: | 2022 - 2023 (MV) Jeep Compass This bulletin applies to vehicles built on and after March 24, 2023 (MDH 0324XX) and on and before April 5, 2023 (MDH 0405XX). | | | MARKET APPLICABILITY: <input type="checkbox"/> NA <input type="checkbox"/> CH <input checked="" type="checkbox"/> EE <input type="checkbox"/> IAP <input type="checkbox"/> SA <input checked="" type="checkbox"/> MEA | |

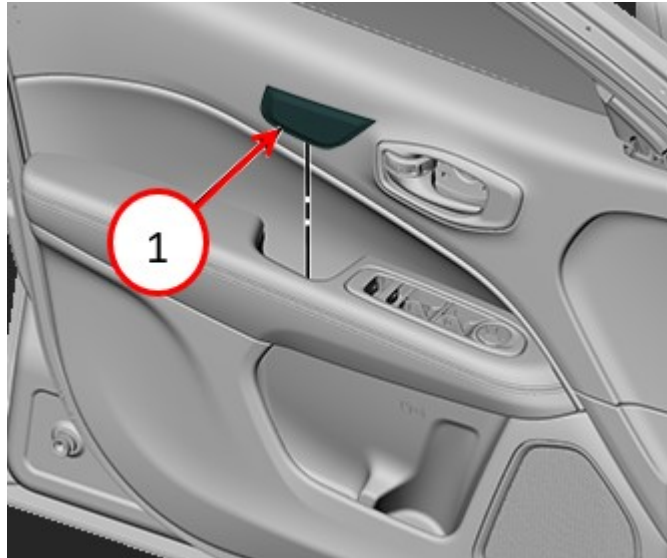
Fig. 1
Pull Cup Trim Mat

1 - Pull Cup Trim Mat

1. Remove the pull cup trim mat ([Fig. 1](#)) .

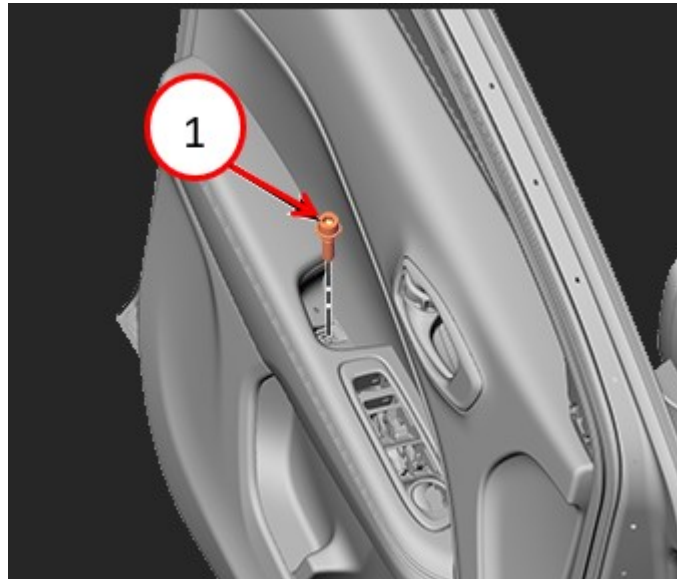
Fig. 2
Door Panel Mounting Screw

| CAUSE: | Front door panel mounting screw not tightened properly. | | | | |

1 - Door Panel Mounting Screw

2. Ensure screw is tightened to the proper torque of 3.5 N·m. (31 In - lbs.) ([Fig. 2](#)) .
