NUMBER: 23-058-23

Door Trim/Audio Related Noise

This bulletin involves replacing the door trim panel retainer clips and securing the door panel.

RAM 1500 Pickup

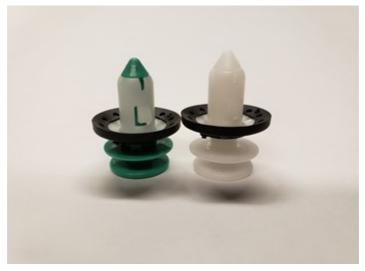
Possible source of issue could be door trim panel upper retainer clips are faulty or door trim panel is not fully seated. Listen to music and adjust sound output to one door at a time to identify point of issue.

Fig. 1
Green And White Retaining Clips

- 1. Remove door trim panel. Refer to the detailed service procedures found in DealerCONNECT/ Service Library under: 23 - Body/Doors - Rear / Panel, Rear Door Trim / Removal and Installation or 23 - Body / Doors - Front / Panel, Door Trim / Removal.
- 2. Ensure that the door trim panel does not have the upper panel green retaining clips. If it does, replace them with new white retaining clips P/N 06509673AA. (Fig. 1)

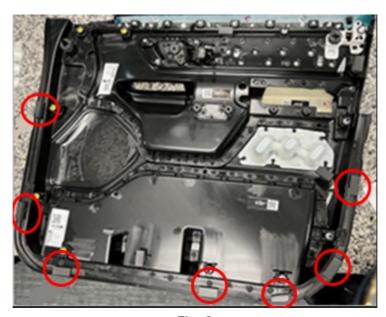
Fig. 2
Front Door Foam Tape Locations

3. Foam tape kit has seven pieces. Apply in between door trim edge and the door sheet metal to dampen the noise. (Fig. 2), (Fig. 3)

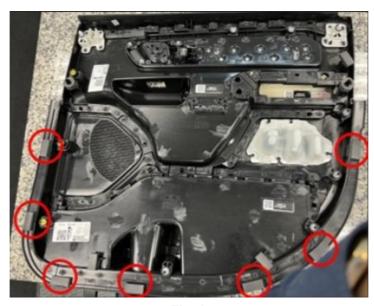
Fig. 3
Rear Door Foam Locations

NOTE: This kit should be used only for the specific door which has the buzzing noise issue.
