<b>REFERENCE:</b>	<b>TSB:</b> 23-048-23 REV. A <b>GROUP</b> 23 - Body	<b>Date:</b>	May 23, 2023	<b>REVISION:</b>	23-048-23
<b>VEHICLES AFFECTED:</b>	<b>2022 - 2023 (WS) Grand Wagoneer/Wagoneer</b> **This bulletin applies to vehicles built on or before October 28, 2022 (MDH 1028XX) equipped with Second Row Console (Sales Code X8K) and First Row Console without Optional Cooler (Sales Code XGP)**.	<b>MARKET APPLICABILITY:</b>			
<b>CUSTOMER SYMPTOM:</b>	Front And/Or Rear Console/Armrest Lid Not Closing. Lower cover is separating from the lid at the rear.				
<b>CAUSE:</b>	Center console incorrectly assembled.

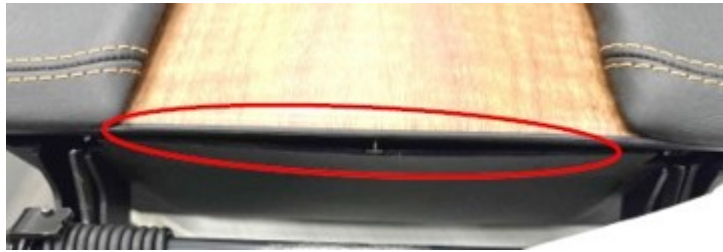
- Operate both the front and rear seat center console/armrest lid covers.
- Do either or both of the console/armrest lid covers not close completely as a result of the lower cover(s) separating (Fig. 1) ?
  - YES>>> Proceed to [Step 1](#) of the Repair Procedure.
  - NO>>> This bulletin is complete. Use Inspect LOP (23-14-08-90) to close this active RSU.

**Fig. 1**  
**Console Lower Cover Separating**

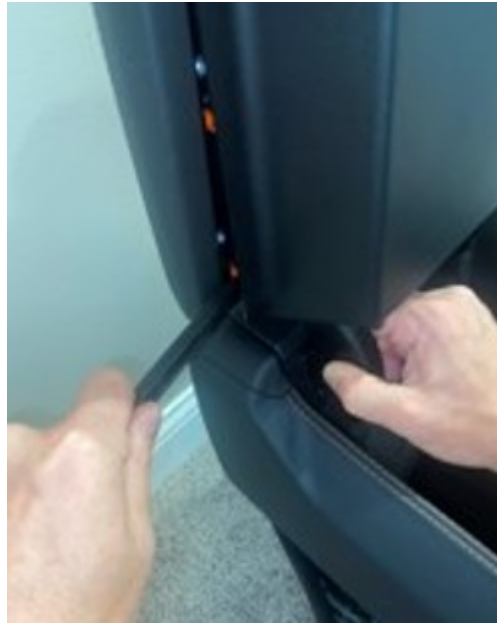
**Fig. 2**  
**Lower Cover Removal**

1. Open armrest and begin to remove lower cover. Use trim stick at bottom corners first (Fig. 2) .

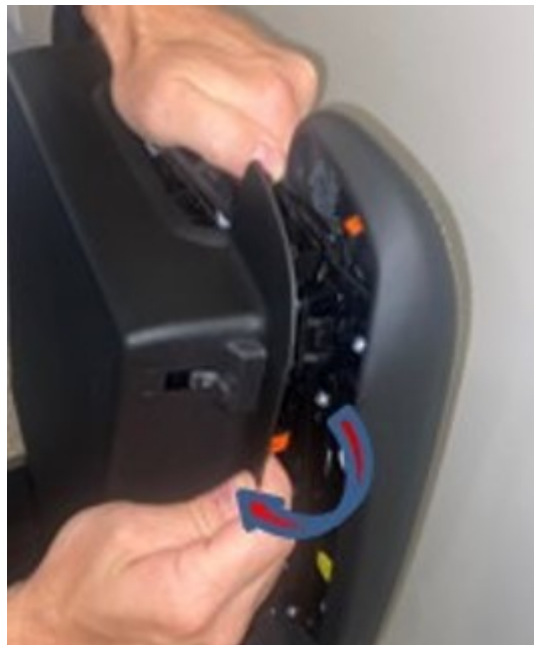
**Fig. 3**  
**Lower Cover From Pawls**

2. Completely remove armrest lower cover. Push armrest button with left hand to retract latch pawls while using right hand to pull lower cover out and away from latch pawls (Fig. 3) .

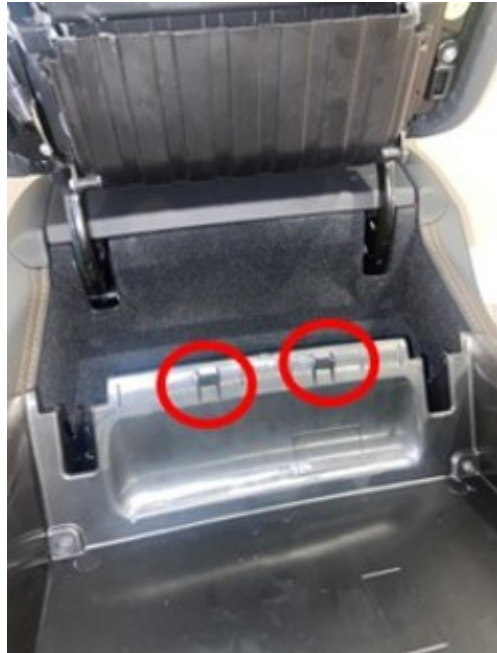
**Fig. 4**  
**Molded Hooks**

3. Re-attach armrest lower cover. Start at bottom to ensure molded hooks are engaged before clipping in top clips (Fig. 4) , (Fig. 5) .

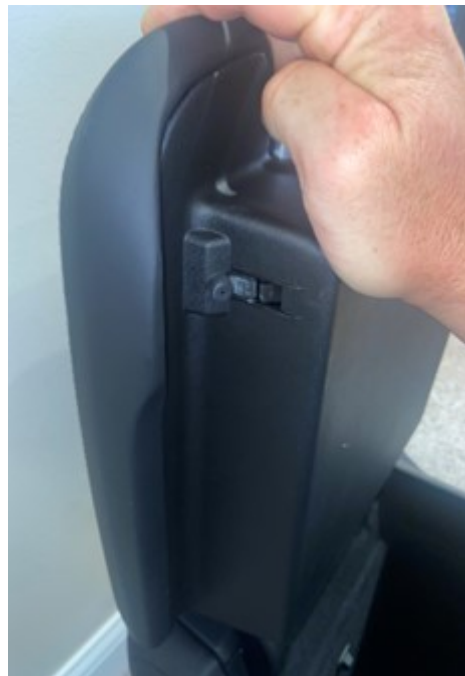
**Fig. 5**  
**Top Clips**
