REFERENCE:	TSB: 19-004-23 REV. A GROUP 19 - Steering	Date:	May 23, 2023	REVISION:	19-004-23
VEHICLES AFFECTED:	2021 - 2023 (WL) Jeep Grand Cherokee This bulletin applies to vehicles built on or after December 03, 2020 (MDH 1203XX) **and on or before April 27, 2023 (MDH 0427XX)** .	MARKET APPLICABILITY:			
		<input checked="" type="checkbox"/> NA		<input type="checkbox"/> MEA	
		<input type="checkbox"/> SA		<input type="checkbox"/> IAP	
		<input type="checkbox"/> EE		<input type="checkbox"/> CH	
CUSTOMER SYMPTOM:	<p>The customer may experience one or more of the following:</p> <ul style="list-style-type: none"> • A popping noise can be heard when turning, while in the driver seat. • One or both of the tie rod boots are extended, or compressed (Fig. 1) . 				
CAUSE:	Pressure differential inside the tie rod boot.

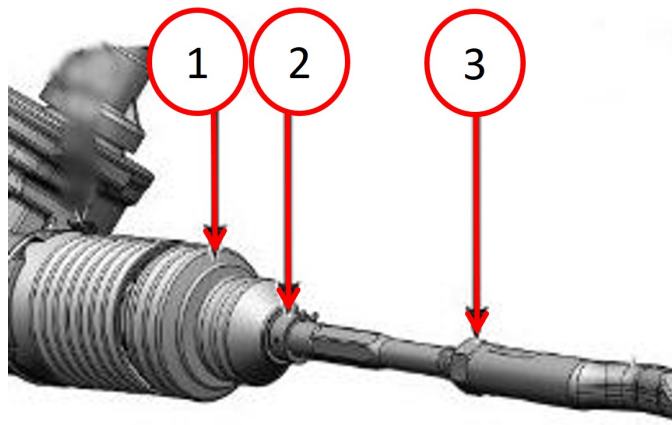
Fig. 2
Tie Rod Assembly

- 1 - Inner Tie Rod Boot
- 2 - Small Clamp
- 3 - Tie Rod Jam Nut

2. Remove the small tie rod boot clamp from the inner tie rod (Fig. 2) .

3. Pull the tie rod boot outwards towards the jam nut (Fig. 2) , so the end of the boot passes the hex portion of the tie rod. **This will break the seal and allow the tie rod boots to breath and equalize. A hiss of air escaping may be heard.**
4. Install the tie rod boot back into the groove on the inner tie rod (Fig. 2) . Verify the boot is in the groove.
5. Install the small tie rod boot clamp on the tie rod (Fig. 2) .
6. Lower the vehicle.
