REFERENCE:	TSB: 18-067-23 GROUP 18 - Vehicle Performance	Date:	May 24, 2023	REVISION:	18-102-22 REV. A
VEHICLES AFFECTED:	2020 (DJ) RAM 2500 Pickup 2020 (D2) RAM 3500 Pickup This bulletin applies to vehicles equipped with a 6.7L I6 Cummins Turbo Diesel Engine (Sales Code ETL) or a 6.7L I6 Cummins HO Turbo Diesel Engine (Sales Code ETM).			MARKET APPLICABILITY: <input checked="" type="checkbox"/> NA <input type="checkbox"/> MEA <input type="checkbox"/> SA <input type="checkbox"/> IAP <input type="checkbox"/> EE <input type="checkbox"/> CH	
CUSTOMER SYMPTOM:	<p>Customers may experience a Malfunction Indicator Lamp (MIL) illumination. Upon further investigation the technician may find that one or more of the following Diagnostic Trouble Codes (DTC)s have been set:</p> <ul style="list-style-type: none"> • **P0299-00 - Turbocharger Underboost. • P061B-00 - Internal Control Module Torque Calculation Performance. • P0461-00 - Fuel Level Sensor 1 Performance.** • P0506 - Idle Control System RPM Lower Than Expected. • P20EE-00 - NOx Catalyst Efficiency Below Threshold. • P242F-00 - Diesel Particulate Filter Restriction - Ash Accumulation. • P1451-00 - Diesel Particulate Filter System Perfor

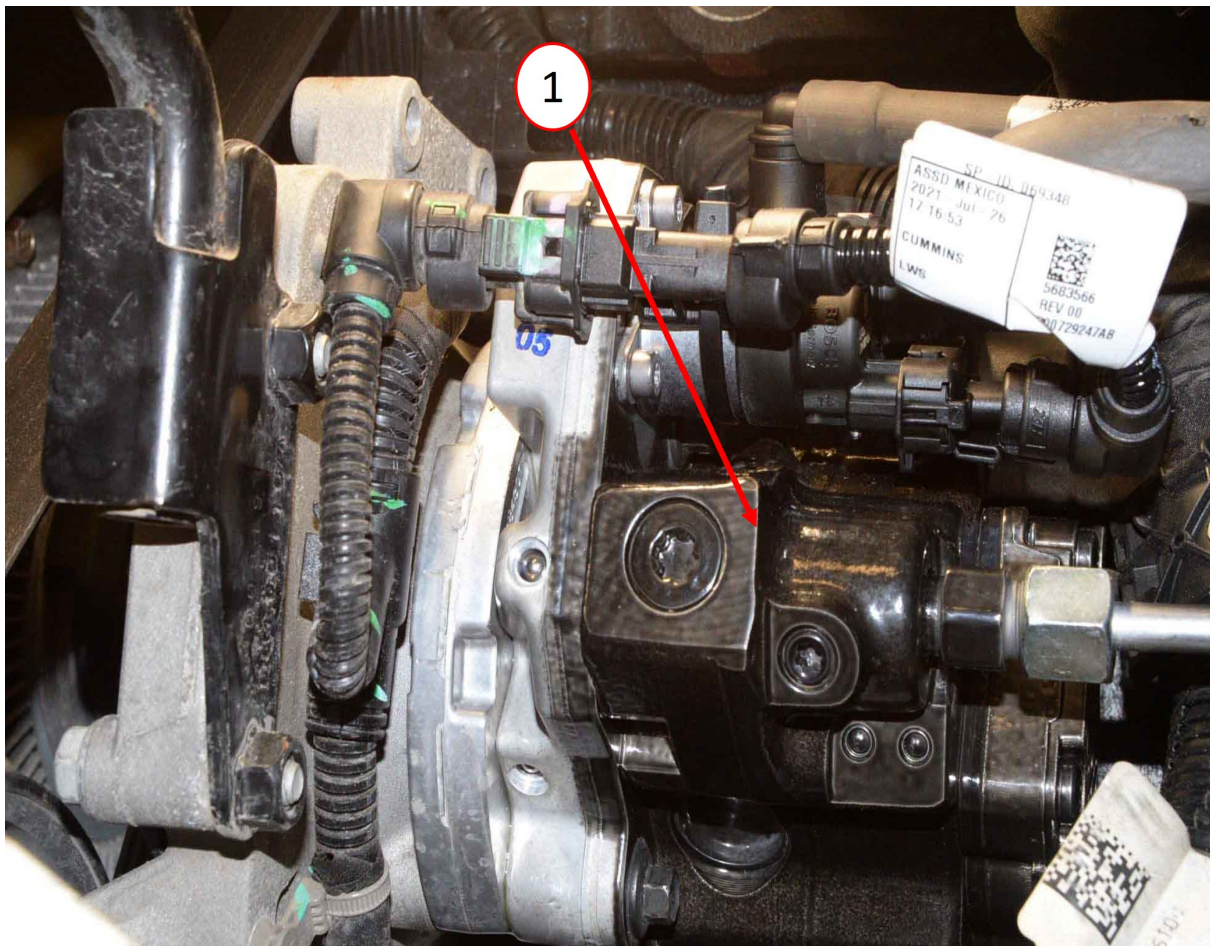
Fig. 1
CP3.3 Design Pump

NOTE: The only calibration available will be for the updated CP3.3 design High-Pressure Fuel Injection Pump (Fig. 1) . Please ensure that recall Y78 has been completed first before proceeding with this update.

1. Inspect the High-Pressure Fuel Injection Pump to see which pump is currently installed on the vehicle (Fig. 1) . Also review the vehicle VIP report to see if campaign Y78 has been performed.

1 - CP3.3 Design Pump From Top View.

2. Does the VIP report indicate that Y78 has been performed, and is the vehicle equipped with the new design fuel injection pump released under the campaign?
 - YES>>> Proceed to [Step 1](#).
 - NO>>> Perform the Y78 campaign first. Once the campaign is performed, new pump installed and PCM updated, the PCM will have all of the updates listed in this document. This Bulletin does not apply.
