<b>REFERENCE:</b>	<b>TSB:</b> 18-066-23 <b>GROUP</b> 18 - Vehicle Performance	<b>Date:</b>	May 24, 2023	<b>REVISION:</b>	18-101-22 REV. A
<b>VEHICLES AFFECTED:</b>	<b>2019 (DJ) RAM 2500 Pickup</b> <b>2019 (D2) RAM 3500 Pickup</b> <b>This bulletin applies to vehicles equipped with a 6.7L I6 Cummins Turbo Diesel Engine (Sales Code ETL) or a 6.7L I6 Cummins HO Turbo Diesel Engine (Sales Code ETM).</b>			<b>MARKET APPLICABILITY:</b> <input checked="" type="checkbox"/> NA <input type="checkbox"/> MEA <input type="checkbox"/> SA <input type="checkbox"/> IAP <input type="checkbox"/> EE <input type="checkbox"/> CH	
<b>CUSTOMER SYMPTOM:</b>	<p>Customers may experience a Malfunction Indicator Lamp (MIL) illumination. Upon further investigation the technician may find that one or more of the following Diagnostic Trouble Codes (DTC)s have been set:</p> <ul style="list-style-type: none"> <li>• **P061B-00 - Internal Control Module Torque Calculation Performance.</li> <li>• P0299-00 - Turbocharger Underboost.**</li> <li>• P0461-00 - Fuel Level Sensor 1 Performance.</li> <li>• P0506 - Idle Control System RPM - Lower Than Expected.</li> <li>• P20EE - NOx Catalyst Efficiency Below Threshold.</li> <l

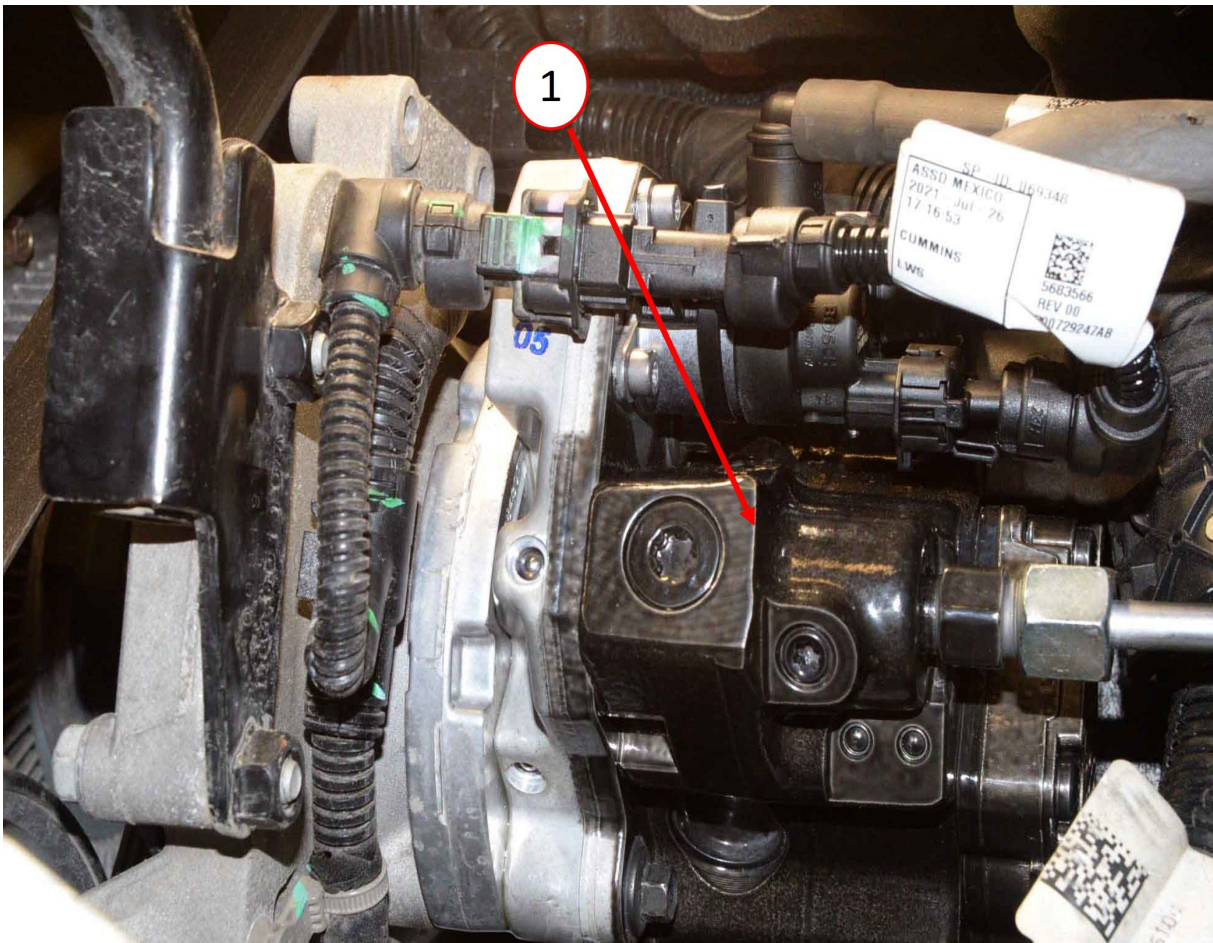
**Fig. 1**  
**CP3.3 Design Pump**

**NOTE: The only calibration available will be for the updated CP3.3 design High-Pressure Fuel Injection Pump (Fig. 1) . Please ensure that recall Y78 has been completed first before proceeding with this update.**

1. Inspect the High-Pressure Fuel Injection Pump to see which pump is currently installed on the vehicle (Fig. 1) . Also review the vehicle VIP report to see if campaign Y78 has been performed.

1 - CP3.3 Design Pump From Top View.

2. Does the VIP report indicate that Y78 has been performed, and is the vehicle equipped with the new design fuel injection pump released under the campaign?
  - YES>>> Proceed to [Step 1](#).
  - NO>>> Perform the Y78 campaign first. Once the campaign is performed, new pump installed and PCM updated, the PCM will have all of the updates listed in this document. This Bulletin does not apply.
