REFERENCE:	TSB: 08-130-23 GROUP 08 - Electrical	Date:	May 26, 2023	REVISION:	—
VEHICLES AFFECTED:	2022 (DS) RAM 1500 Pickup 2022 (DJ) RAM 2500 Pickup 2022 (D2) RAM 3500 Pickup 2022 (DD) RAM 3500 Cab Chassis 2022 (DF) RAM 3500 10K LB. Cab Chassis 2022 (DP) RAM 4500/5500 Cab Chassis This bulletin applies to vehicles equipped with Global Telematics Box Module (Sales Code RDG).			MARKET APPLICABILITY:	
				<input checked="" type="checkbox"/> NA	<input type="checkbox"/> MEA
				<input type="checkbox"/> SA	<input type="checkbox"/> IAP
				<input type="checkbox"/> EE	<input type="checkbox"/> CH
CUSTOMER SYMPTOM:	Customers may experience one or more of the following: <ul style="list-style-type: none"> • Uconnect Box Message at Startup. • Uconnect Box Error Or Requires Service Message. • Connectivity: Uconnect Mobile App trunk status showing as closed when trunk is open. • Connectivity: Diagnostic Trouble Codes (DTCs) for Electronic Control Modules (ECUs) won't be shown to customer through the Vehicle Health alert (Mobile app or email).

CAUSE:	TBM Software

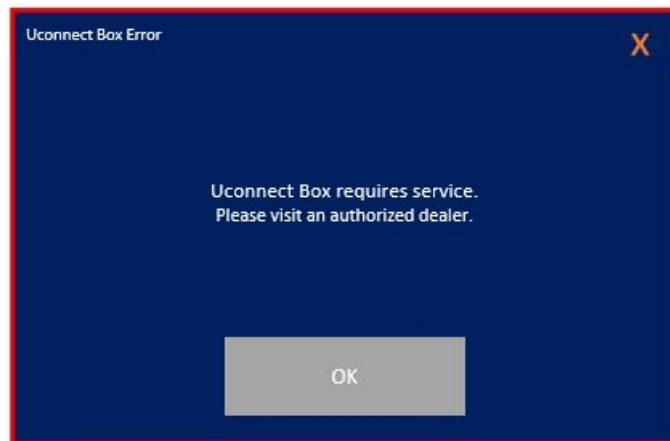
Fig. 1
Uconnect Box Error Message

Message display on the radio screen, “Uconnect Box requires service. Please visit an authorized dealer.” (Fig. 1) , with no active or stored DTCs set by the TBM.

This bulletin provides information regarding the latest Firmware Over The Air (FOTA) update and provides the service technician an overview of the steps a customer will need to take to complete the update. The TBM software will be updated from 5.13 to 5.25 to 5.39.1 (DS) and 5.25 to 5.39.1 (DJ, DD, D2, DP, DF).

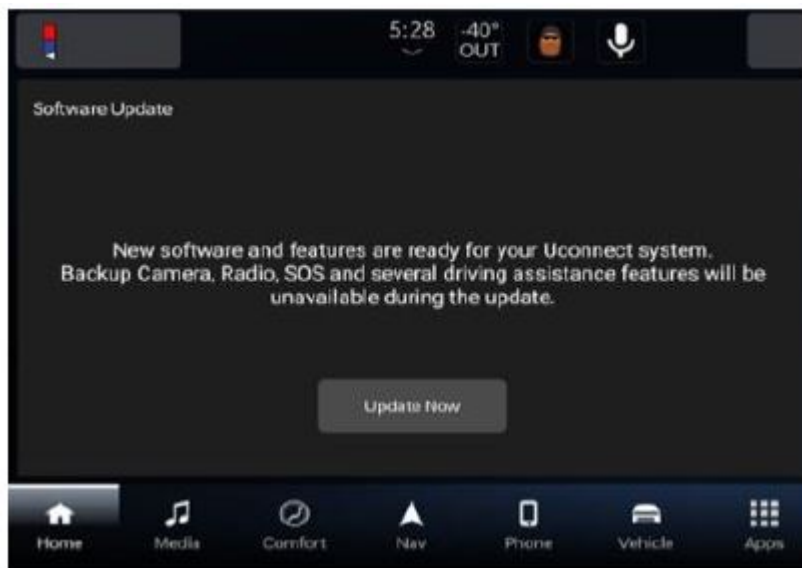
Fig. 2
Software Acceptance Screen

1. The vehicle needs to be in 'Park'. The ignition needs to be in the off position.
2. If the customer selects “Update Now” (Fig. 2) they can shut off the vehicle and leave. The update will be completed automatically.

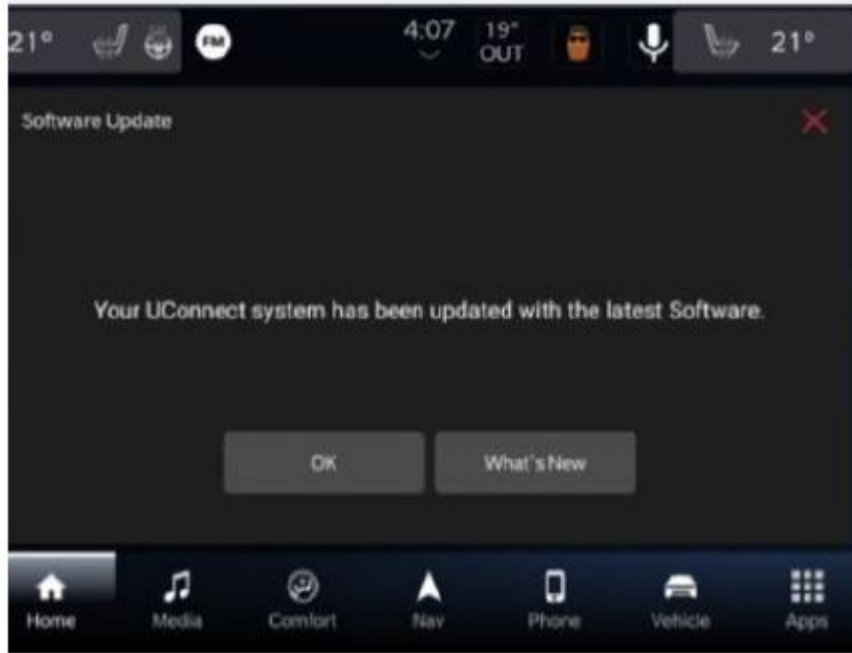
Fig. 3
Software Update Confirmation Screen

3. Upon completion of update, the radio will display a confirmation message (Fig. 3) .
