REFERENCE:	TSB: 08-135-23 GROUP 08 - Electrical	Date:	May 31, 2023	REVISION:	08-232-22
VEHICLES AFFECTED:	2017 (LA) Dodge Challenger 2017 (LD) Dodge Charger 2017 (LX) Chrysler 300 This bulletin applies to vehicles equipped with an Uconnect 8.4 navigation radio (Sales Codes UAQ or UCQ) or an Uconnect 8.4 radio (Sales Code UAS).			MARKET APPLICABILITY:	
				<input checked="" type="checkbox"/> NA	<input type="checkbox"/> MEA
				<input type="checkbox"/> SA	<input type="checkbox"/> IAP
				<input type="checkbox"/> EE	<input type="checkbox"/> CH
CUSTOMER SYMPTOM:	Customers may experience one or more of the following: <ul style="list-style-type: none"> • Vehicle has lost connectivity after radio swap or battery disconnect. 				
CAUSE:	Radio software

This bulletin supersedes Technical Service Bulletin (TSB) 08-232-22, date of issue December 15, 2022, which should be removed from your files. All revisions are highlighted with ****asterisks**** and include new LOP, steps and note.

This bulletin involves inspecting and if required, updating the radio to software: 16.12.

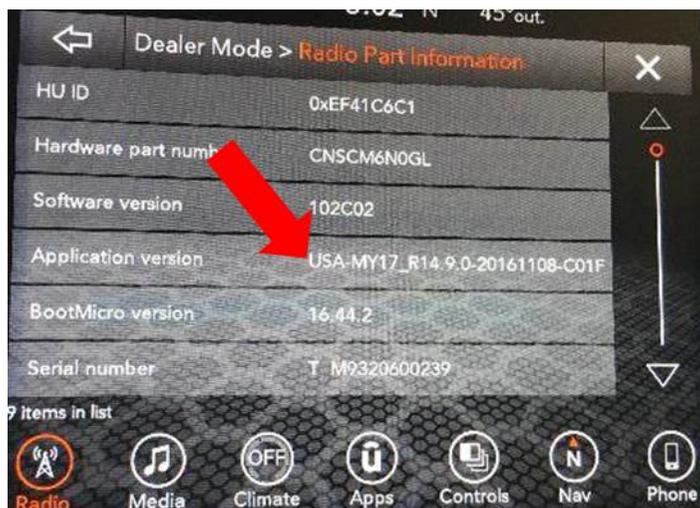
Fig. 1
Radio Software Level Screen

1. Verify the radio software version. Radio must be in Dealer Mode to verify by following these steps:
 - Push and hold the Front Defrost, Driver Temperature Up and Temperature Down buttons simultaneously until the Dealer Mode screen appears (approximately seven seconds). Release buttons.
 - Select "Radio Part Information". The software version will be listed next to "Application Version".
2. Is the radio currently at software level 16.12 or higher (Fig. 1) ?
 - YES >>> The radio software is already up to date. This bulletin does not apply.
 - NO >>> The radio software needs to be updated. Back out of Dealer Mode and proceed to [Step 1](#) of the Repair Procedure.

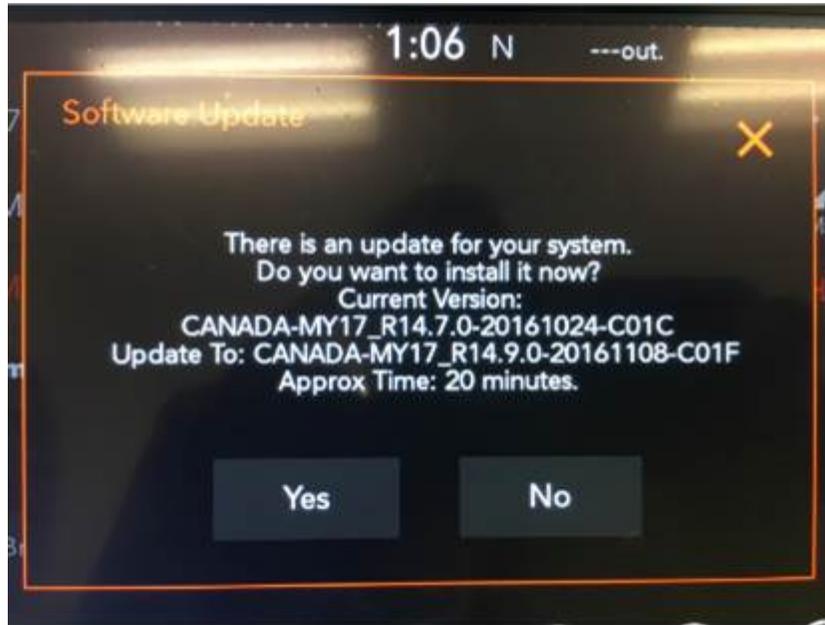
Fig. 7

Software Levels (Figure is for reference only, actual software level will be 16.12)

11. The next screen display will have the old and new software levels (Fig. 7) . The radio will be updated to 16.12.

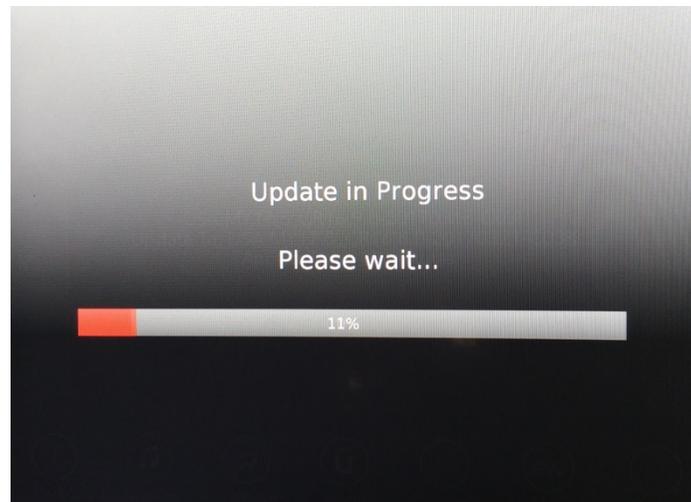
Fig. 8

Update In Progress Screen

12. Press the touchscreen “YES” to start the update. The update may take up to 20 minutes to load for non-navigation radios and up to 40 minutes for navigation radios. No other actions are needed to initiate the update (Fig. 8) .

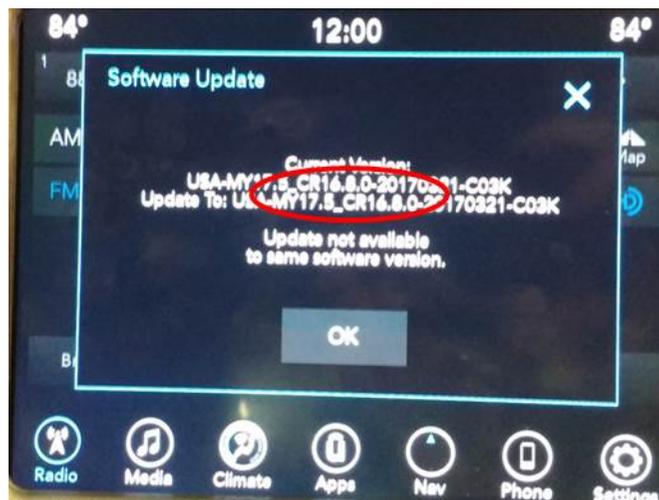
Fig. 10

Software Levels After Radio Restart Screen (Figure is for reference only, actual software level will be 16.12)

14. After the update is done the screen will display the software levels again and the message that an update is not available to the same software version (Fig. 10) .
