REFERENCE:	TSB: 08-134-23 GROUP 08 - Electrical	Date:	May 31, 2023	REVISION:	08-235-22
VEHICLES AFFECTED:	<p>2017 - 2018 (MP) Jeep Compass This bulletin applies to vehicles built on or before January 12, 2018 (MDH 0112XX) equipped with a Uconnect 4C Nav With 8.4" Display radio (Sales Codes UDQ or UGQ). This bulletin applies to vehicles built on or before **July 18 2018 (MDH 0718XX)** equipped with a Uconnect 4C Nav With 8.4" Display radio (Sales Code UAQ or UCQ).</p>			MARKET APPLICABILITY:	
				<input checked="" type="checkbox"/> NA	<input checked="" type="checkbox"/> MEA
				<input checked="" type="checkbox"/> SA	<input type="checkbox"/> IAP
				<input type="checkbox"/> EE	<input type="checkbox"/> CH
CUSTOMER SYMPTOM:	<p>Customers may experience one or more of the following:</p> <ul style="list-style-type: none"> • WiFi hotspot connection failure (UAQ and UCA). • Mobile Station Integrated Services Digital Network (MSISDN) missing from radio, no connected services working (UAQ and UCA). • Navigation voice prompts are in a different language than what is set. • Radio may reset or go blank (Rear View Camera (RVC) not affected). • Unable to enter non-alphanumeric (Emoji) characters i

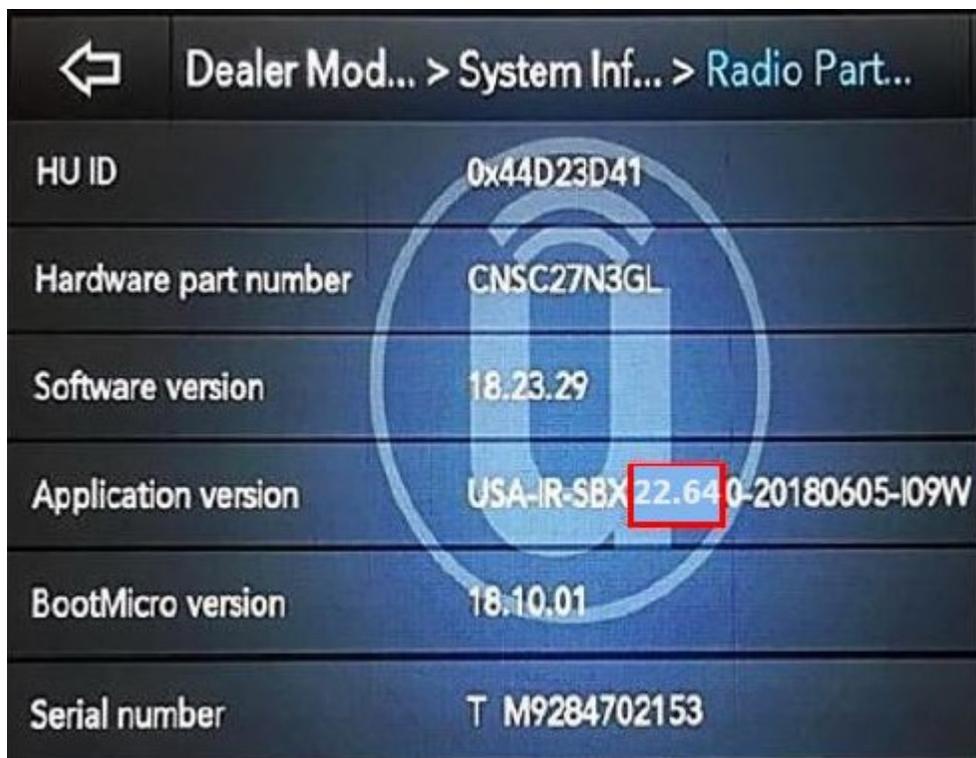
Fig. 1

1. Verify the radio software version. Radio must be in Dealer Mode to verify by following these steps:
 - Press and hold both lower corners of the display screen, until the Dealer Mode screen appears (approximately seven seconds). Release screen.
 - Select "Radio Part Information". The software version will be listed next to "Application Version" (Fig. 1) .

Radio Software Level Screen

2. Is the radio software level 18.7 (UGQ or UDQ) 18.8 (UAQ or UCQ) or higher?
 - YES >>> The radio software is already up to date. Normal diagnostics should be performed.
 - NO >>> The radio software needs to be updated. Proceed to [Step 3](#) of the Inspection Procedure.
3. Does the vehicle have a UGQ radio?
 - YES>>> Proceed to [Step 4](#).
 - NO>>> Proceed to [Step 1](#) of the Repair Procedure.
4. While in Dealer Mode, go to "Navigation" and check the 'Map Database' version.

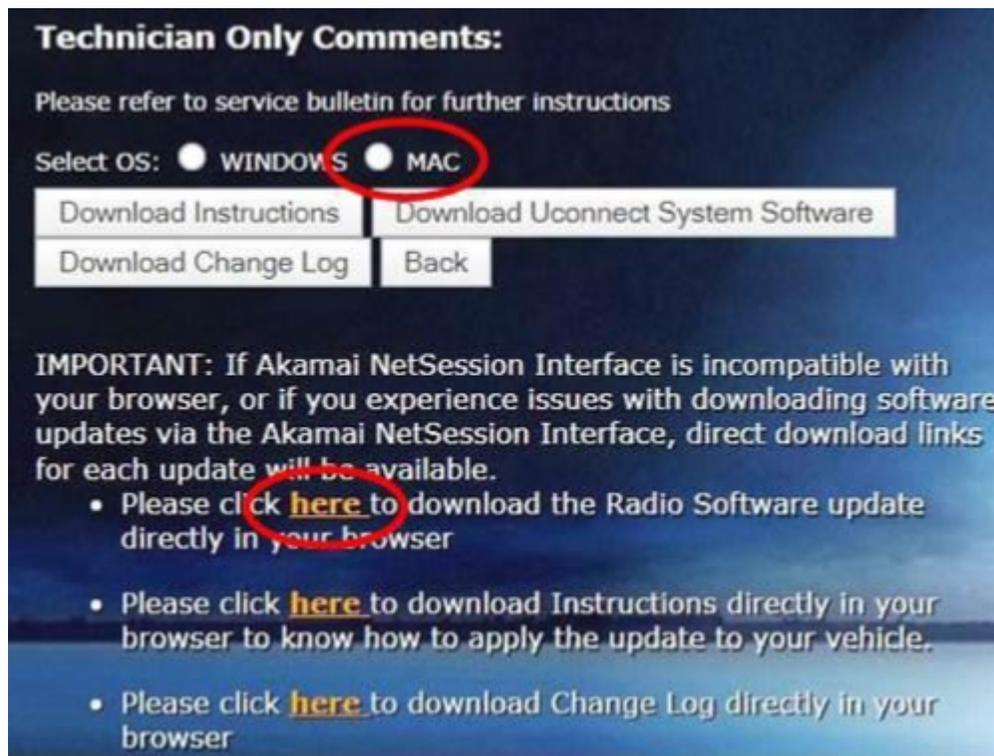
Fig. 2
MAC Download Steps

4. Use a blank USB flash drive with at least 16GB of space for each software update. Follow the on-screen instructions to download the software files.
5. Download the software update file to your local PC's desktop. Make sure to select the "MAC" radial button for all downloads ([Fig. 2](#)) .

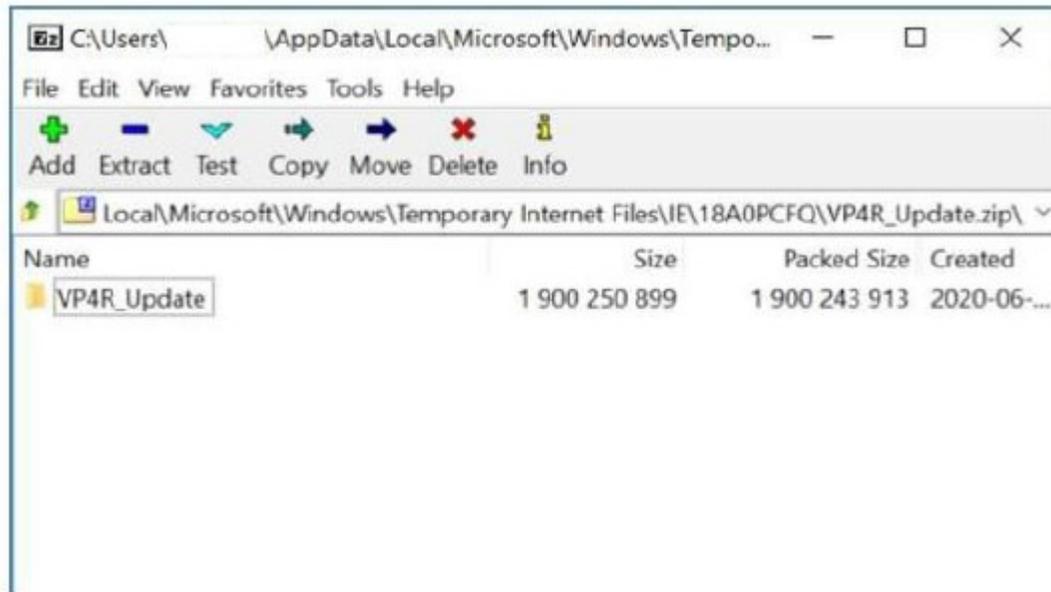
Fig. 3
Files/Folders In The USB Flash Drive

7. Unzip the file to the root folder of USB flash drive. File should not be within a zip folder. Your USB file should look like (Fig. 3) when you open it.

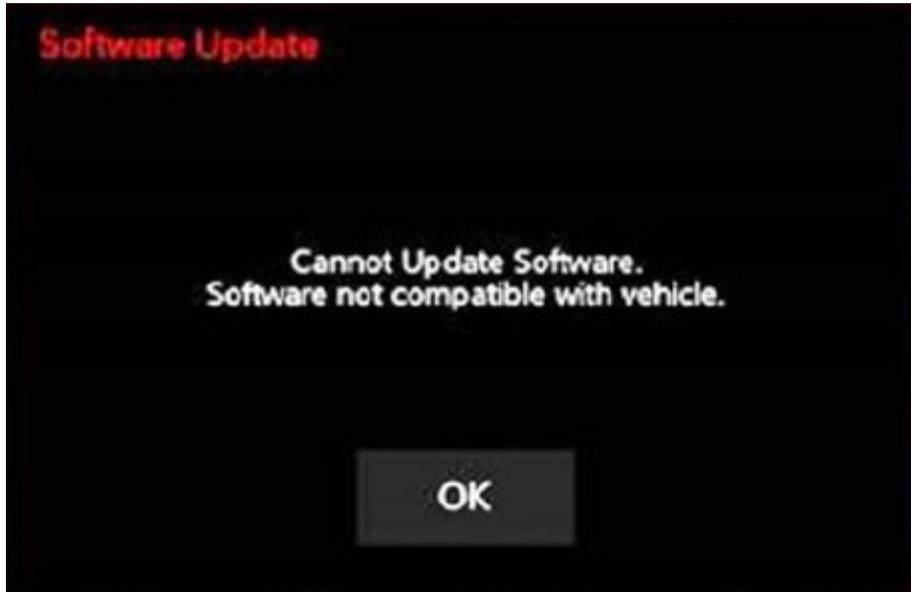
Fig. 4
Software Not Compatible Screen

10. If the screen in (Fig. 4) is displayed, the USB flash drive was not set up correctly. Use a top name brand USB flash drive, like Kingston, create a new USB flash drive and start the update again.

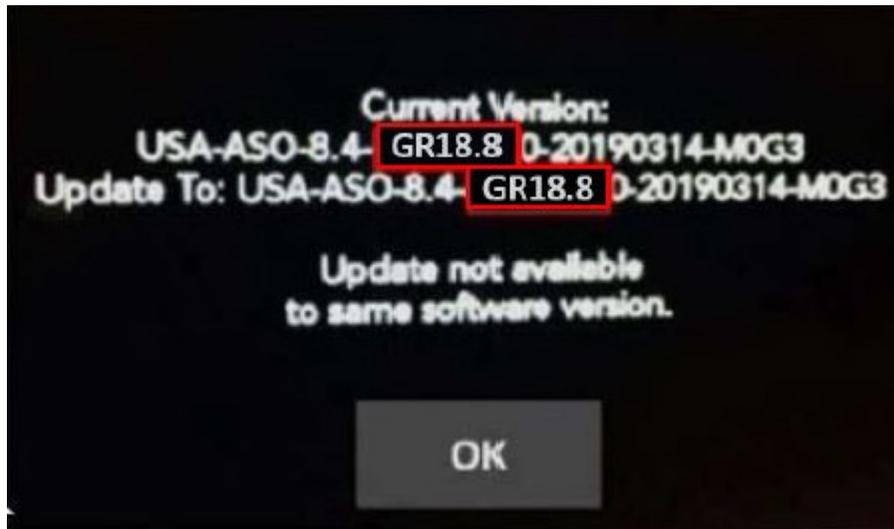
Fig. 5
Screen Displayed When Radio Software Level Is Up To Date

11. If the radio software is already up to date, the screen in (Fig. 5) will be displayed. Press "OK" and remove the USB flash drive.

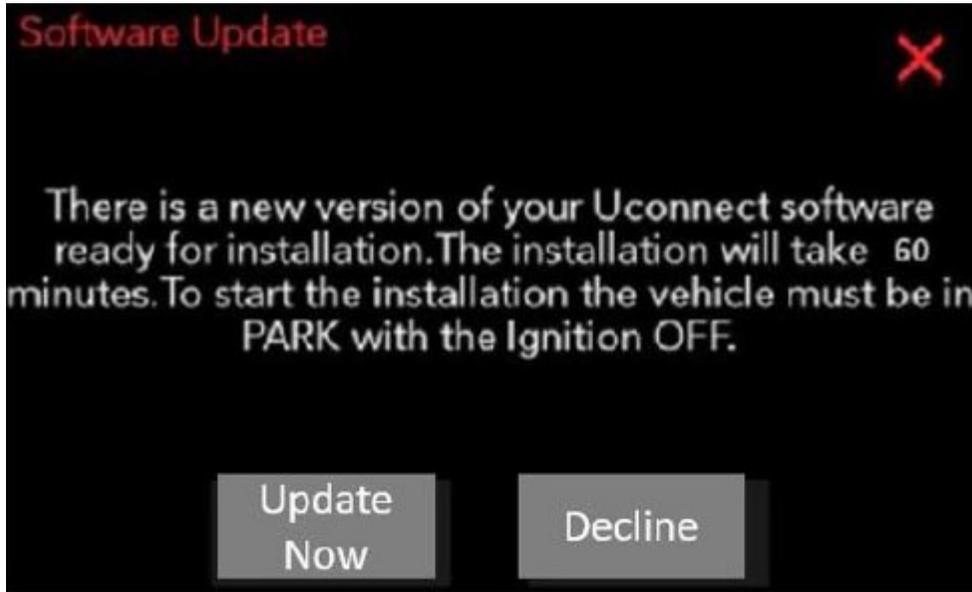
Fig. 6
Software Update Is Available

12. Once the system has verified there is an available update, press the "Update Now" button. Make sure the vehicle is in park, **DO NOT turn off the ignition (Fig. 6)** .

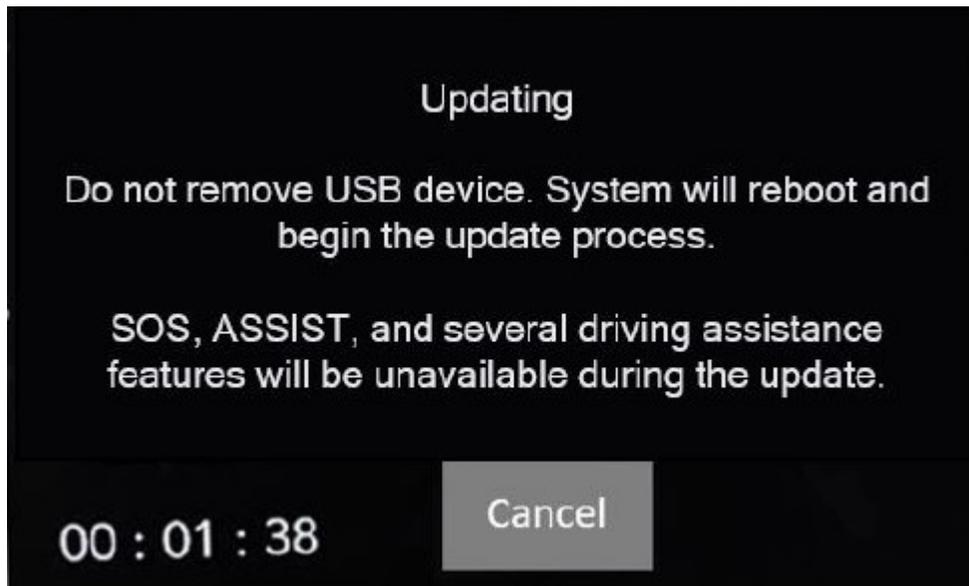
Fig. 7
Updating Screen

13. When the radio starts updating, the screen in (Fig. 7) will be displayed.

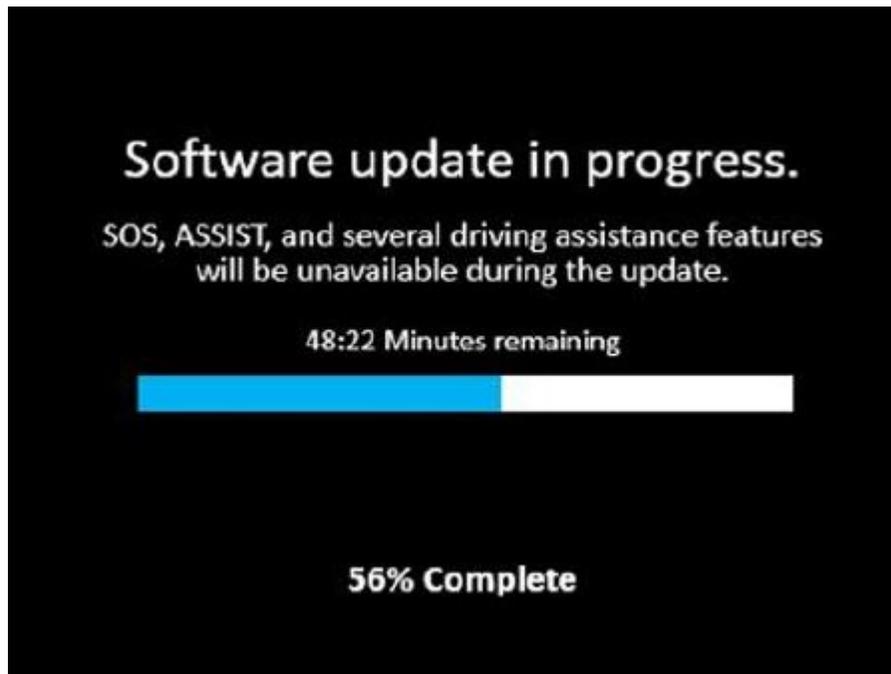
Fig. 8
Software Update In Progress

14. The radio will reboot and the update will begin. The update should only take 25 minutes, the timer on the screen may display the incorrect time remaining, (Fig. 8) .

NOTE: The completion indicator may not reach 100%, even though the software update has been completed. Once the software update has finished, the radio and display screen will turn off.

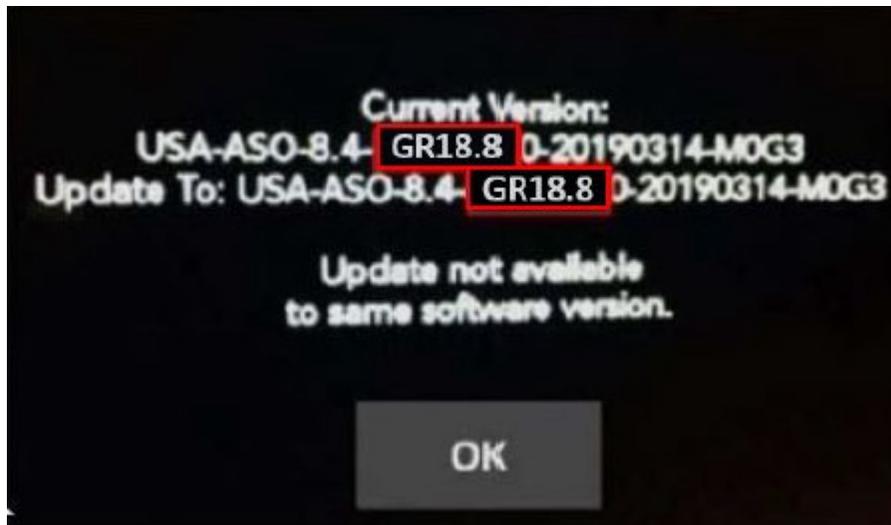
Fig. 9
Radio Software Has Been Updated

15. After the update has completed, the radio will shut down. With the USB flash drive still inserted in the USB port, cycle the ignition back (if it was turn off) to the run position. If the radio software was updated correctly the "Current Version:" and the "Update To:" software levels in (Fig. 9) will display the identical software level. Press "OK" and remove the USB flash drive.
