STAR ONLINE PUBLICATION

Case Number: S2323000036

Symptom/Vehicle Issue: Rattle Noise From Instrument Panel To Door Area.

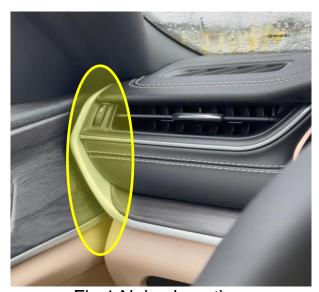
Fig 1 Noise Location.

Discussion: Inspect the dash end caps for fitment. If the cap is not flush it could vibrate causing a buzz, squeak, rattle (BSR). See Figures 1 and 2.

Drivers Side Shown Passenger Side Similar.
