STAR ONLINE PUBLICATION

Case Number: S2308000063

Symptom/Vehicle Issue: Loss Of Driver's Power Seat Position Functions

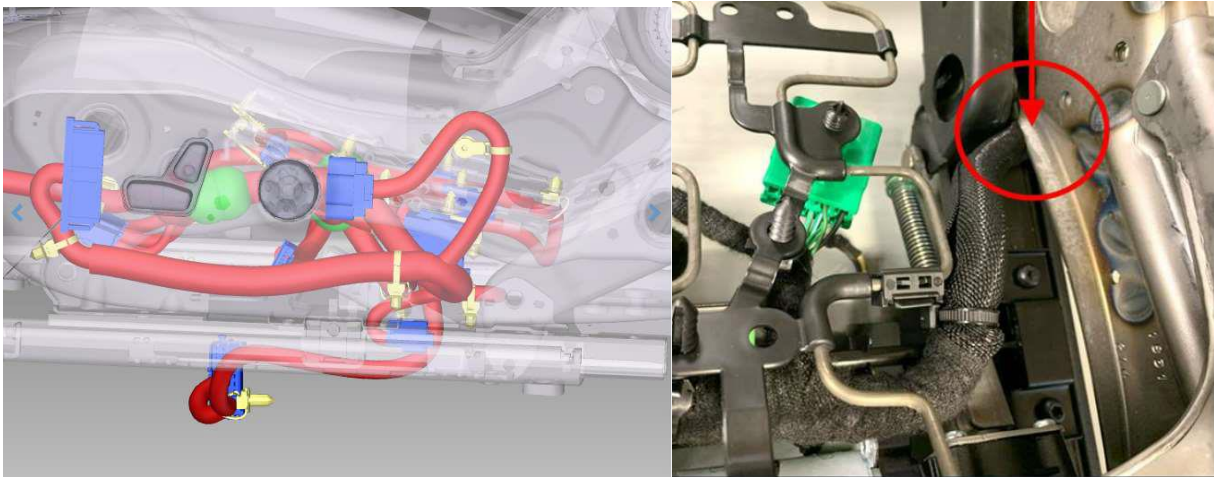
Diagnosis: Under the driver's seat. Inspect the seat cushion harness approximately 12" from the driver's seat switch position for possible chaffing/pinching damage.

Location of Chaffing/Pinching Damage

Repair: If damage to the harness is found, replace the seat cushion harness. Route the harness away from the seat frame so it will not be damaged in the future like the original harness.

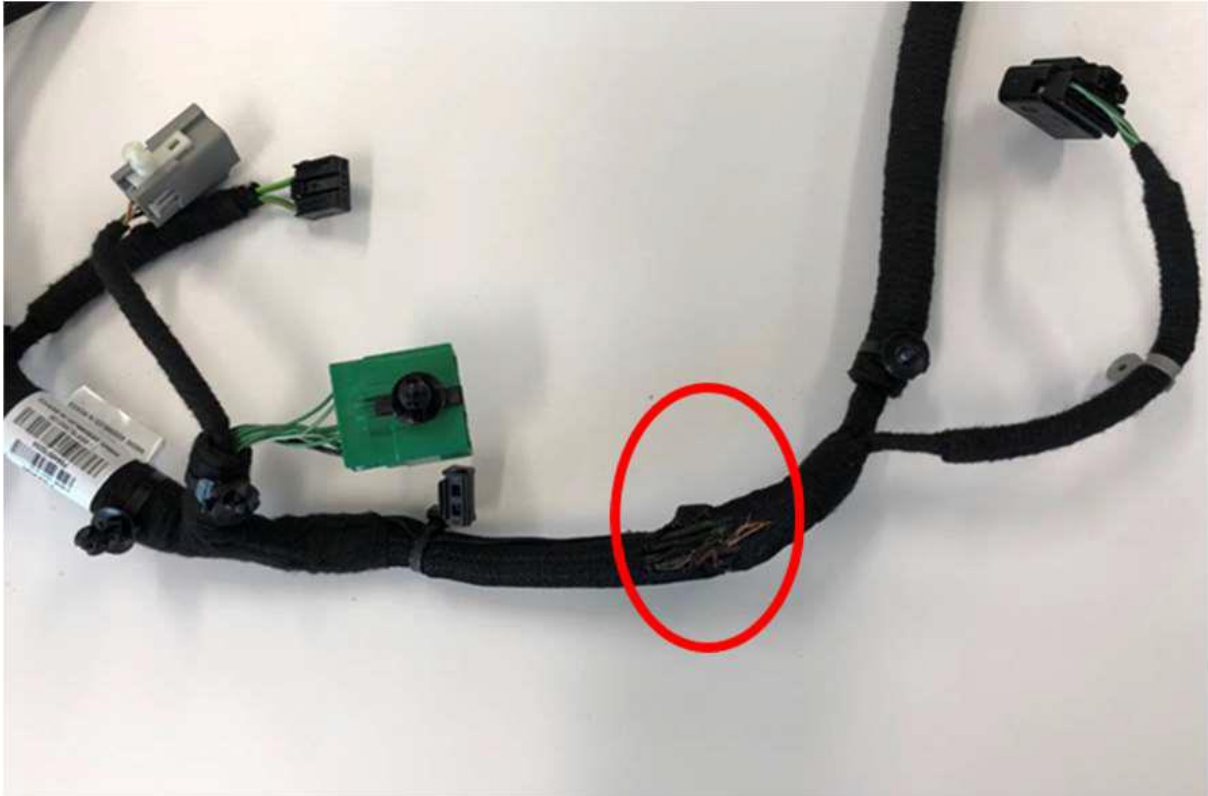
Damaged Drivers Seat Cushion Harness

Verification: After replacement of the harness. Test the power seat and ensure all movement function normally.
