STAR ONLINE PUBLICATION

Case Number: S2323000021 Rev. A

Symptom/Vehicle Issue: Clunk Noise From Front End Driving Between 15 And 35 MPH And When Decelerating. C0604- Active Air Dam Control Performance

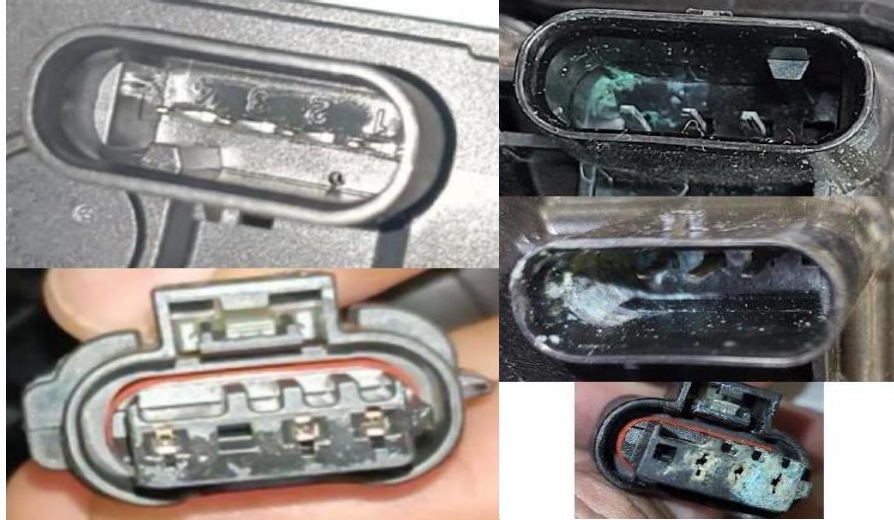
Dielectric grease or a wetness that could be described as an oily appearance in the active air dam connector is normal and should not cause a C0604 diagnostic trouble code (DTC). To verify whether the connector is contaminated with water from a damaged or rolled connector seal, use an UV black light to illuminate inside the connector. Dielectric grease will glow in appearance under a UV light (Fig 2). Water will not. Corrosion such as green or white oxidation material on the pins or inside the connectors will require connector and component replacement before continuing diagnosis (Fig 1).

Fig 1.
Normal condition left. Corrosion on right.

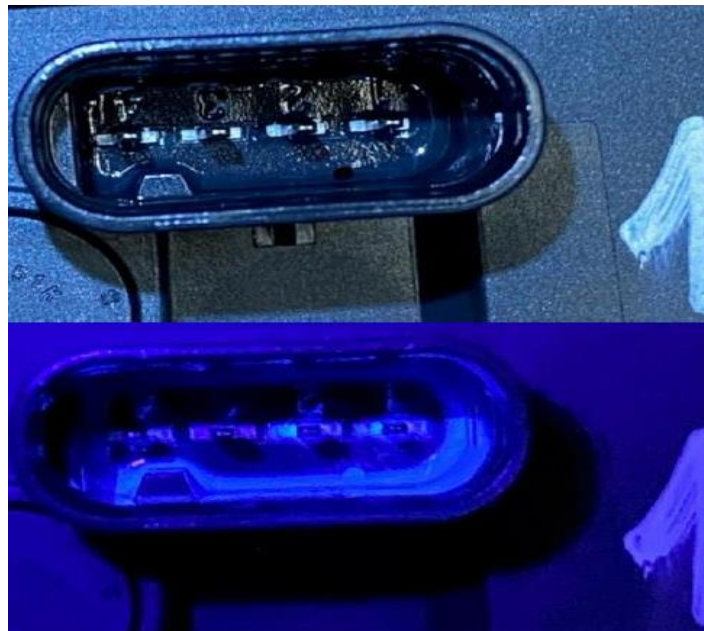
Fig 2.
Glow of dielectric grease under a UV black light.

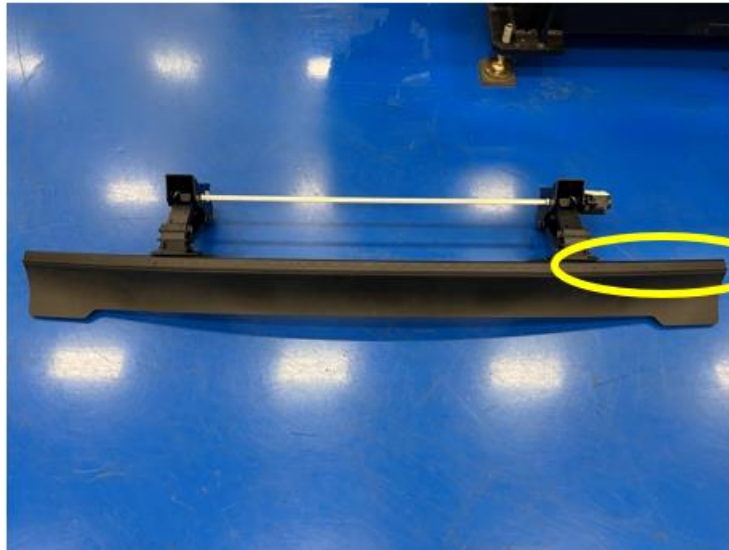
2. Clunk noise diagnosis. Check the active air dam blade front seal lip for witness marks (Fig 3) at the driver side fascia clip locations noted (Fig 4).

Fig 3
Area to inspect for contact marks.

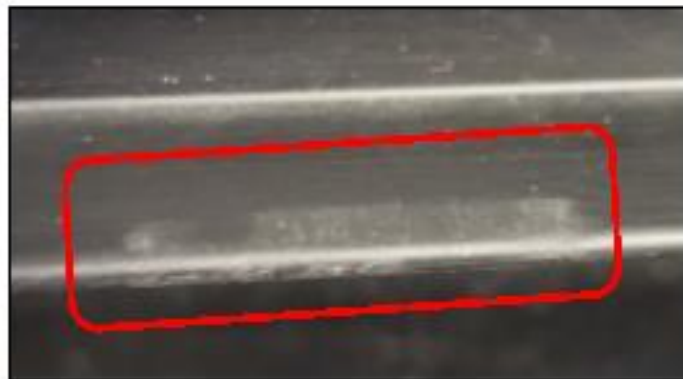
Fig 4
Example of contact witness mark on the active air dam.

If the witness marks exist on the active air dam follow the below steps to trim the lip.
