Case Number: S2323000038

Release Date: May 2023

Symptom/Vehicle Issue: Buzz, Squeak, Rattle (BSR) From Door Panel With Loud Music And Or Bass.

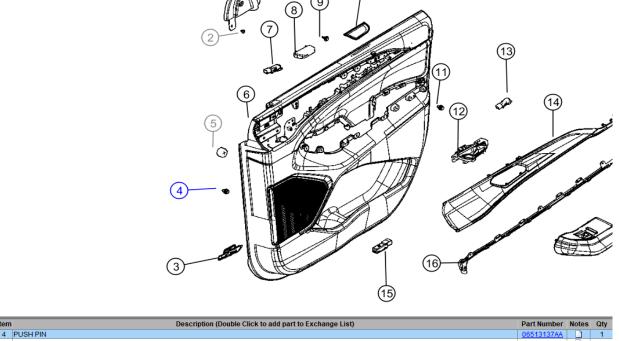
Discussion: Inspect the door panel mounting for any unseated or damaged pushpins. A door panel that is not fully retained could sound like a failed speaker and mislead diagnosis. While duplicating the condition place hand pressure on the door panel in various areas to isolate a damaged or missing pushpin. Push pins are available as a service part.
