## STAR ONLINE PUBLICATION

**Case Number:** S2319000003

**Symptom/Vehicle Issue:** Oil Wetness On Electric Power Steering (EPS).

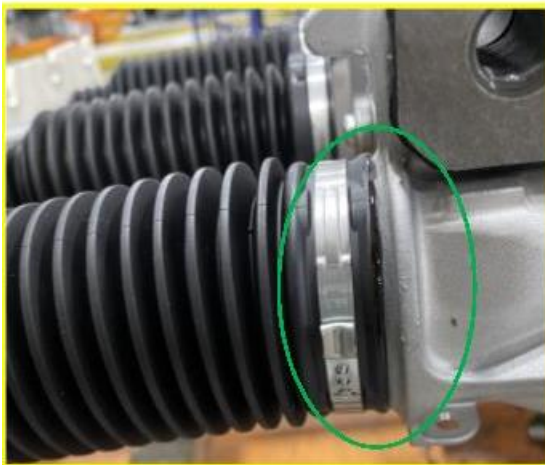
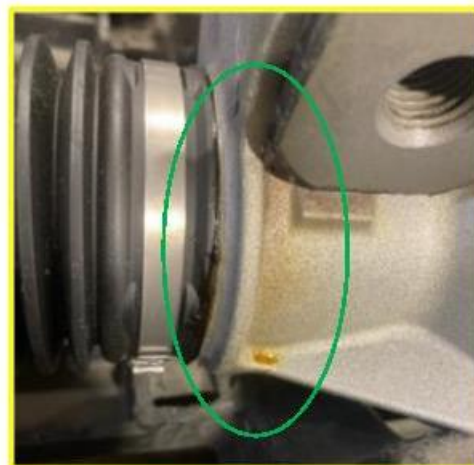
**Customer Complaint/Technician Observation:** Wetness Near the EPS tie rod bellows boots observed.

**Discussion:** Minor wetness shown in the above image is normal and part of the manufacturing process of installing the tie rod boots. The wetness near the tie rod boots is normal and would not indicate an EPS repair/replacement is needed. The EPS unit does not contain any oil or grease that can leak out.
