STAR ONLINE PUBLICATION

Case Number: S2308000068

Symptom/Vehicle Issue: Front Inverter Outlet and Rear Center Console Power Outlets Inoperative

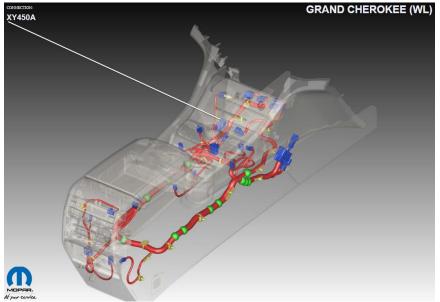
Discussion: The customer may find that the front power inverter and rear center console power outlets are inoperative. This may be caused by a loose XY450A connector.

Diagnosis: Inspect the XY450A connector located under the center console.

Repair: Resecure the XY450A connector confirming it is fully seated and locked.
