STAR ONLINE PUBLICATION

Case Number: S2323000043

Symptom/Vehicle Issue: Swing Gate Bumper Falls Off Of The Gate.

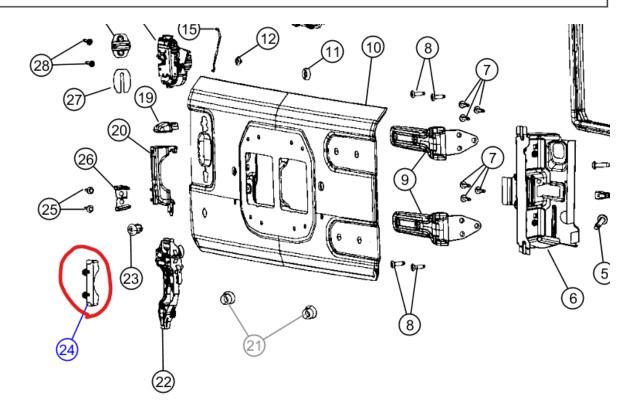
Iten	Description (Double Click to add part to Exchange List)	Part Number
24	BUMPER, Tailgate	
		68281894AA
		68281894AA

Discussion: The swing gate over slam bumper installs with 2 push retainers. If the gate inner panel has flashing material around the holes the tabs will not snap in place as designed and could allow the bumper to fall off when the gate is opened. Inspect the bumper holes of the gate for flashing and remove with a file or deburring tool as needed. Flashing around the hole that exceeds 4.8mm (.188 inch) will need to be removed. Protect the painted surface of the gate with masking tape as necessary to prevent scratching while filing in this area.
