TO: Freightliner Principals, General Managers, Sales Managers, Service Managers, Parts Managers	FROM: Anthony Washington, Department Manager, Regulations and Certifications
<b>Re: Recall Campaign Launch Notification Model - Sprinter Model Years 2019-2020 Modify Interior Blower Motor Fuse Layout NHTSA ID - 23V100</b>	DATE: June, 2023

<b>Campaign No. :</b>	<b>Campaign Desc. :</b>	Modify Interior Blower Motor Fuse Layout
<b>2023040008</b>	<b>VS30SIGEBL</b>	
<p>This is to notify you of a <b>Recall Campaign Launch</b> to modify the interior blower motor fuse layout on approximately <b>3,539</b> MY19-20 Freightliner Sprinter vans. The recall campaign will be visible on the <a href="http://www.safercar.gov">www.safercar.gov</a> website and may generate questions from customers. All affected VINs will be flagged “<b>OPEN</b>” in VMI and <b>cannot be sold</b> until remedied.</p>		
<b>Background</b>		
<b>Issue</b>	<p>Mercedes-Benz AG (“MBAG”), the manufacturer of Freightliner vehicles, has determined that on certain Sprinter (907 platform) vehicles, the fuse layout of the interior blower motor might not meet the requirements for prolonged operation at the highest blower setting. Ambient and

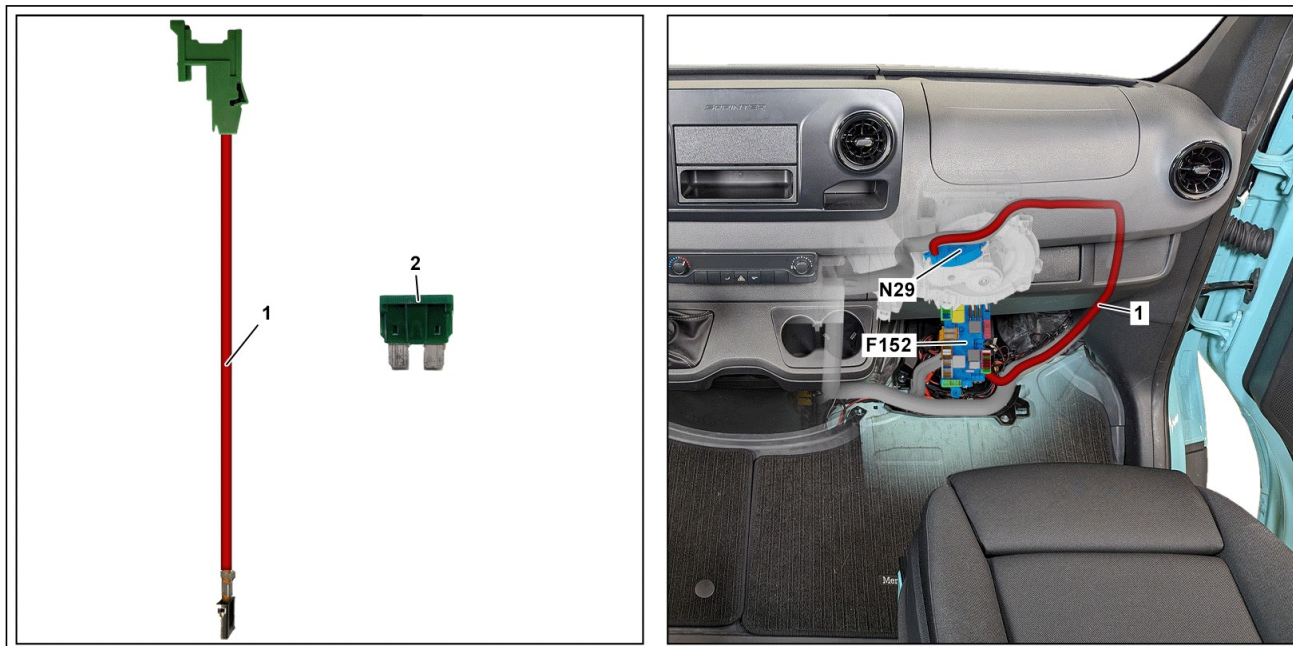
D83.10-A024-79

| 1 | Electrical line | F152 | Front-passenger-side fuse and relay module | N29 | Blower regulator of inner blower |
| 2 | Fuse link | | | | |

Remove bottom trim for instrument panel on front passenger side.	Model 907  except code FJ4 (Stowage compartment under cockpit)	AR68.10-D-1502TSF
	<b>Retrofit electric lines (1)</b>		
5	Retrofit electric line (1) for power supply of blower regulator of inner blower (N29).
