Door Scuff Plate Carpet Untucked and/or Torn Carpet Loops

Service Category Vehicle Interior

YEAR(S)	MODEL(S)	ADDITIONAL INFORMATION
2019 - 2022	Avalon, Avalon HV	
2018 - 2023	Camry, Camry HV

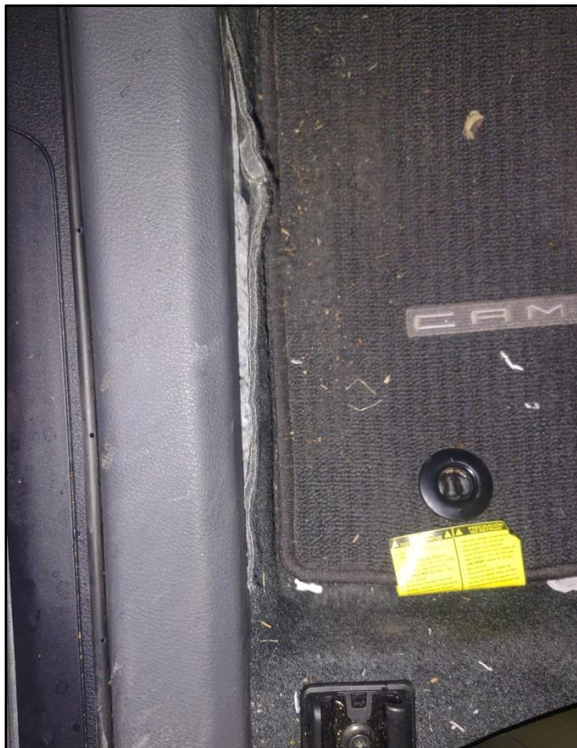
Some 2019 – 2022 model year Avalon and Avalon Hybrid and 2018 – 2023 model year Camry and Camry Hybrid vehicles may exhibit a condition in which the carpet underneath the door scuff plate becomes untucked (Figure 1) or a carpet loop is torn (Figure 2). The condition(s) can occur on both the front driver and front passenger sides of the vehicles.

Figure 1. Untucked Carpet

To address this concern, an updated floor mat no. 2 has been developed to reduce the likelihood of this condition from occurring. Follow the Repair Procedure in this bulletin to address this condition.

2. Remove the door scuff plate.
3. If applicable, disengage the undamaged carpet loop(s) from the tab(s).
4. Are there ANY torn carpet loops?
 - **YES** — Continue to the step 5.
 - **NO** — Go to step 6.
5. Remove and replace the damaged carpet from the vehicle.
6. Apply the hot melt adhesive to the carpet mating side (back side) of the NEW floor mat No. 2 per Figure 3 and Figure 4.

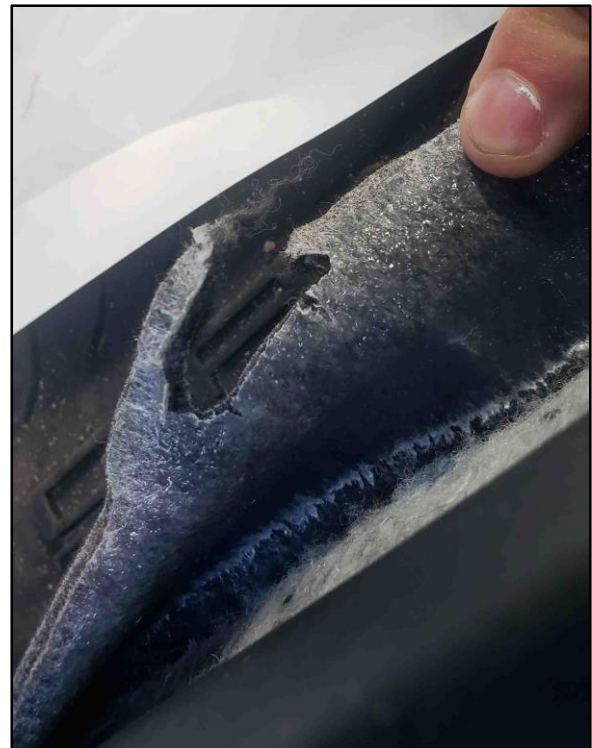
Figure 2. Torn Carpet Loop
