| HYUNDAI Technical Service Bulletin | GROUP AUTOMATIC TRANSMISSION | NUMBER 23-AT-008H |
| SUBJECT: AUTOMATIC TRANSAXLE (8-SPEED FWD) POSITION SENSOR DTC P070500, P070512, P070514, P07051C, P070600, P070661 & P070696 DIAGNOSIS | | |

This TSB supersedes TSB 21-AT-007H to revise Parts Information, add HMMA built Santa Fe Hybrid (TMA HEV) and add information for Santa Fe (TMA), Step 8.

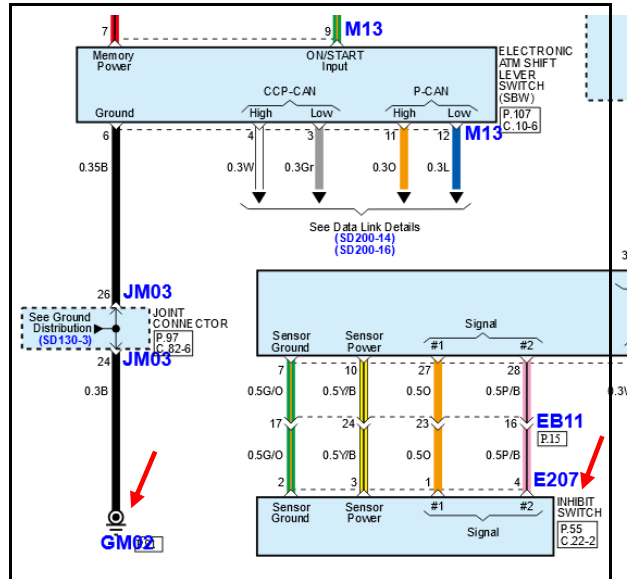
6. Check the grounds for the electronic shift lever. (Refer to ETM, SD450-1).
Turn the ignition and headlights on. Use a DVOM to check the voltage drop between the wiring terminal and ground.

Specification: Less than 0.2 V.

- If more than 0.2V, clean the terminal and bolt threads and tighten the bolt.
- If less than 0.2V, go to Step 7.

Torque: 7~9 lb-ft, 1.0~1.2kgf.m, 10~12 N.m

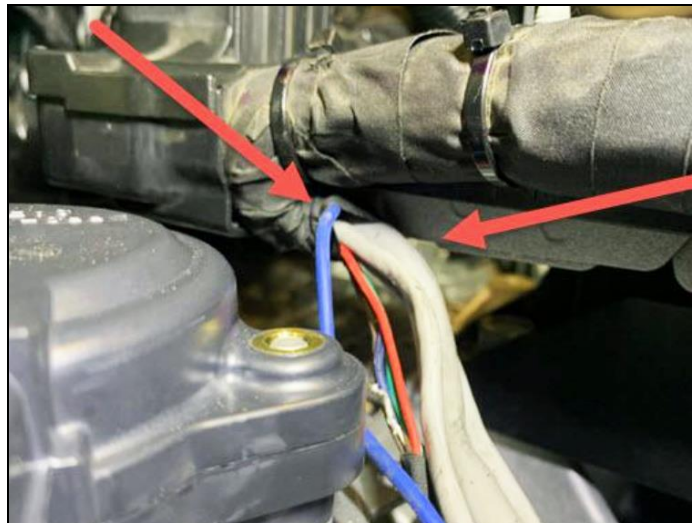
Check the harness in the area under the battery tray from the main harness to the position sensor. Check if the harness wires are in contact with the battery tray or transmission case. Go to Step 9.

9. Carefully unwrap the harness protector in the area shown.

Check if the insulation on the wires has been damaged by contact with the battery tray or transmission case.

If so, repair or replace the control harness.
