GROUP	NUMBER
CAMPAIGN	23-01-052H-1
DATE	MODEL(S)
JULY, 2023	TUCSON HYBRID (NX4 HEV) & SANTA FE HYBRID (TM HEV)

Technical Service Bulletin

COOLING SYSTEM CIRCUIT DEBRIS DISCHARGE AND COOLANT SUBJECT: CHANGE (SERVICE CAMPAIGN T9L)

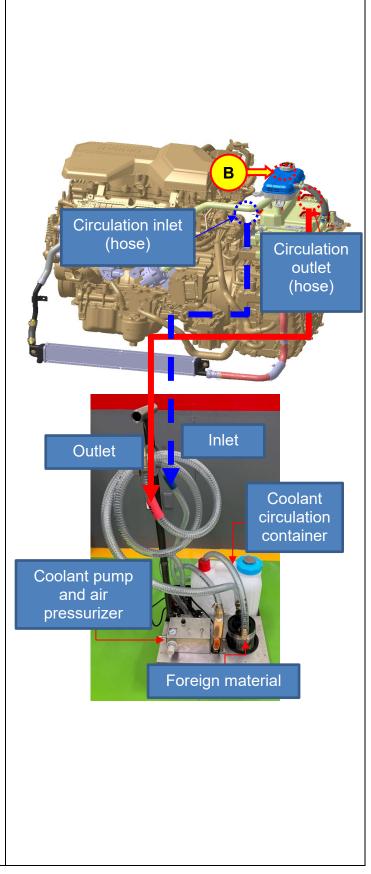
- If there is a large amount of low-conductivity coolant (blue) remaining inside the vehicle, the color of the newly injected pink coolant may change to murky. In this case, drain all coolant inside the vehicle and re-inject normal (pink) coolant.

12. Confirm that all coolant hoses are properly installed and inject coolant (LLC-10) into vehicle.

- Reconnect the Service Interlock Connector (A) -Use the GDS under Actuation Test to manually turn on EWP to aid in air bleeding during coolant injection.

- Coolant concentration (coolant: diluted water): 6:4

- Coolant injection: 1.9 liters (coolant + diluted water)

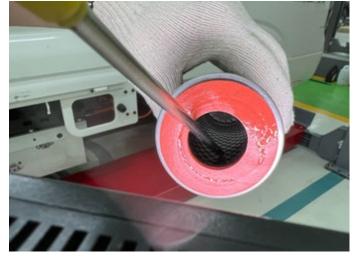
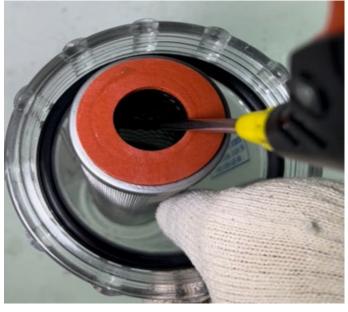
- Ensure to remove as much of the foreign substances as possible.
- A poorly cleaned filter can result in decreased flow rate and degrade the cleaning effect of the cleaning machine.
- Sludge can get stuck to the inner wall of the filter gaps, be sure to clean the filter evenly.

15. Clean the filter & filter case of the equipment with the air gun to remove foreign substances.
