## Technical Service Bulletin

| BODY<br>ELECTRICAL | 23-BE-008H |
| JULY 2023 | Accent (HC) |

**SUBJECT:** HORN ASSEMBLY WARRANTY EXTENSION (TXXR)  
AND REPLACEMENT

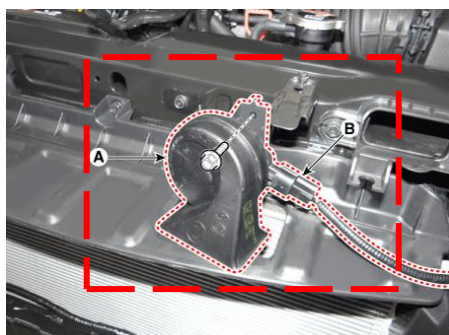
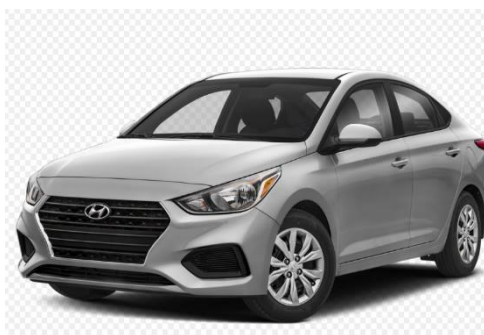
**Description:** Certain 2018~19MY Accent (HC) vehicles may experience an inoperable horn that may be caused by internal contact alignment and corrosion.

Hyundai is extending the warranty coverage for the horn replacement to 10 years or 120,000 miles from the date of original retail delivery or date of first use (whichever occurs first) and is valid for original and subsequent owners.

This bulletin provides information on how to fix the inoperative horn.
