SERVICE PROGRAM BULLETIN

APPLICABILITY: 2022MY Forester
 2022MY WRX
 2022-23MY BRZ

SUBJECT: Telematics Data Communications Module Reprogramming

NUMBER: WRB-23R
DATE: 02/14/23
REVISED: 07/05/23

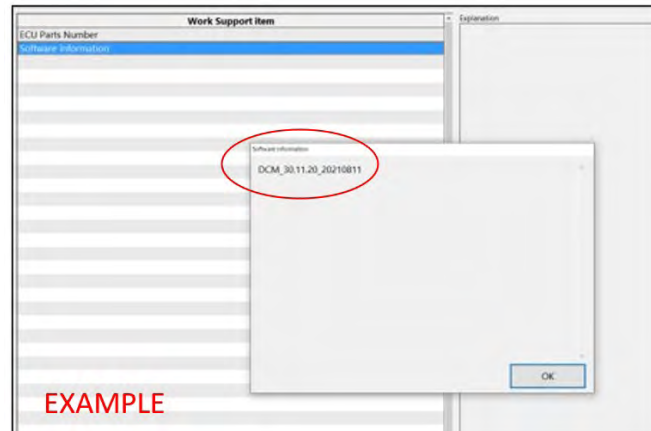
STEP 1: Connect the applicable Subaru Select Monitor (SSM) to the vehicle. Read the Software Information of the DCM. Record this information for confirmation after reprogramming is performed.

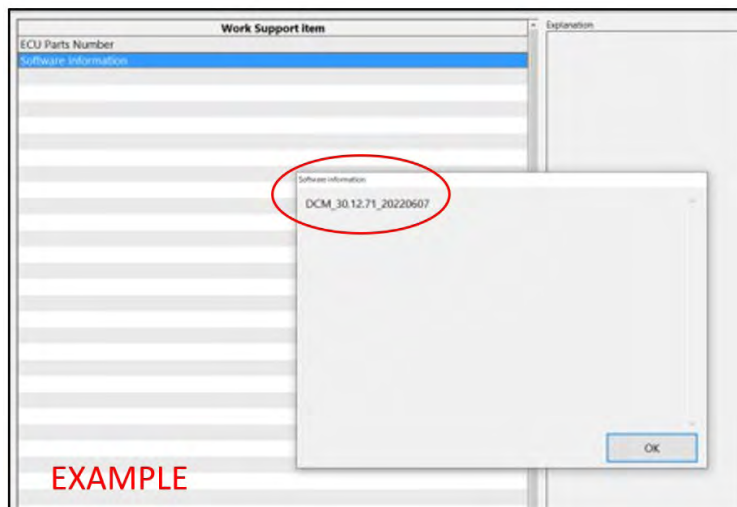
STEP 9: Using the applicable SSM, read the Software Information of the DCM.
