## SERVICE BULLETIN

**APPLICABILITY:** 2015MY Legacy & Outback

**NUMBER:** 09-103-23

**SUBJECT:** DTC P2404 / Reprogramming Files

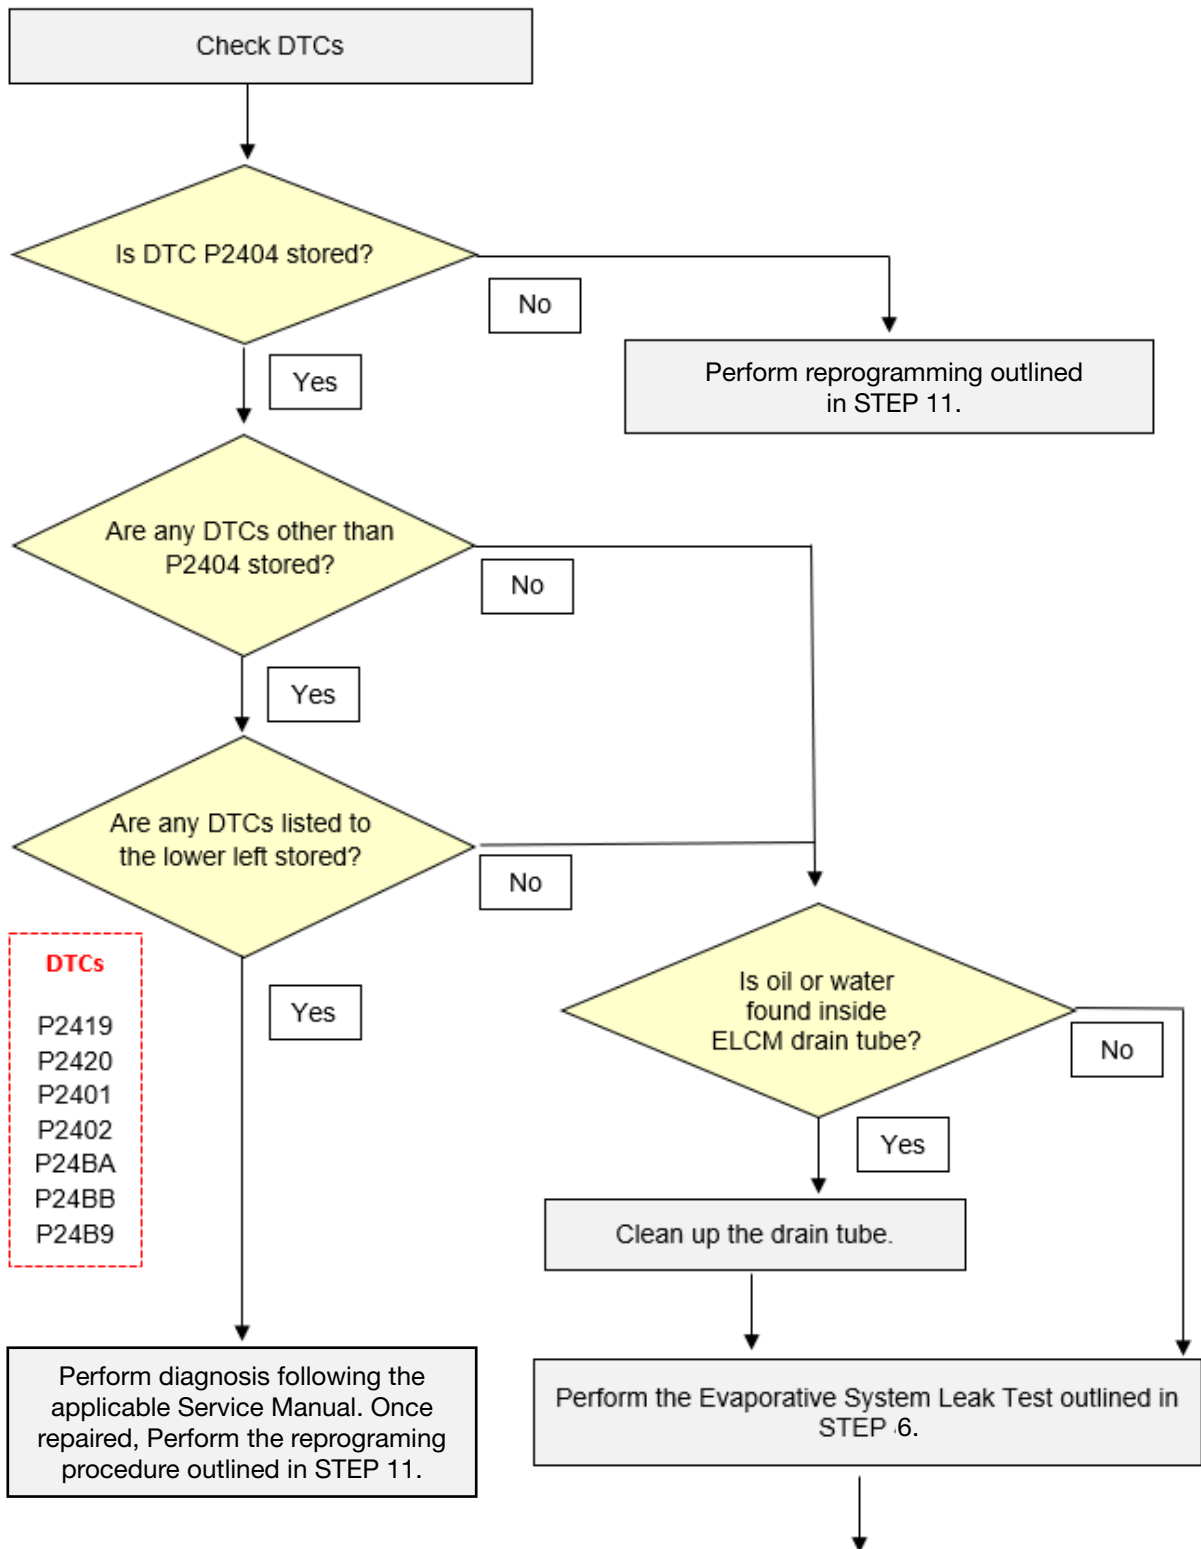
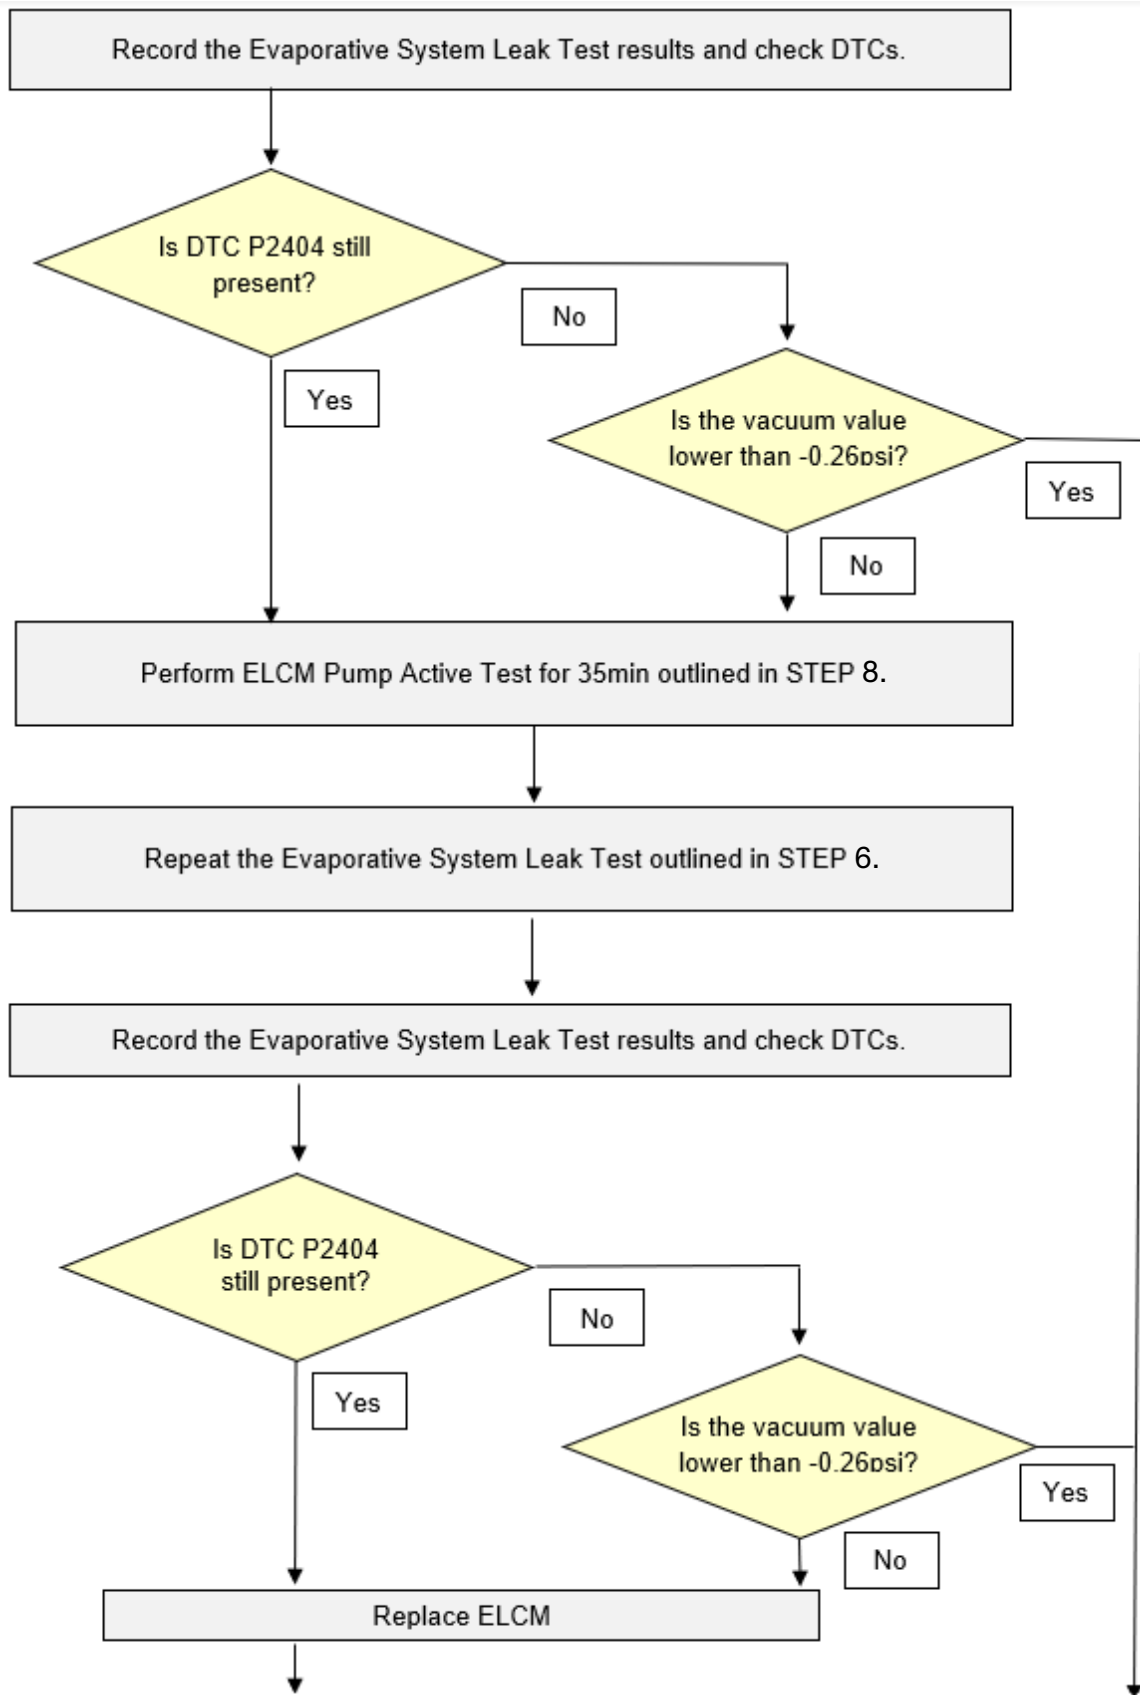
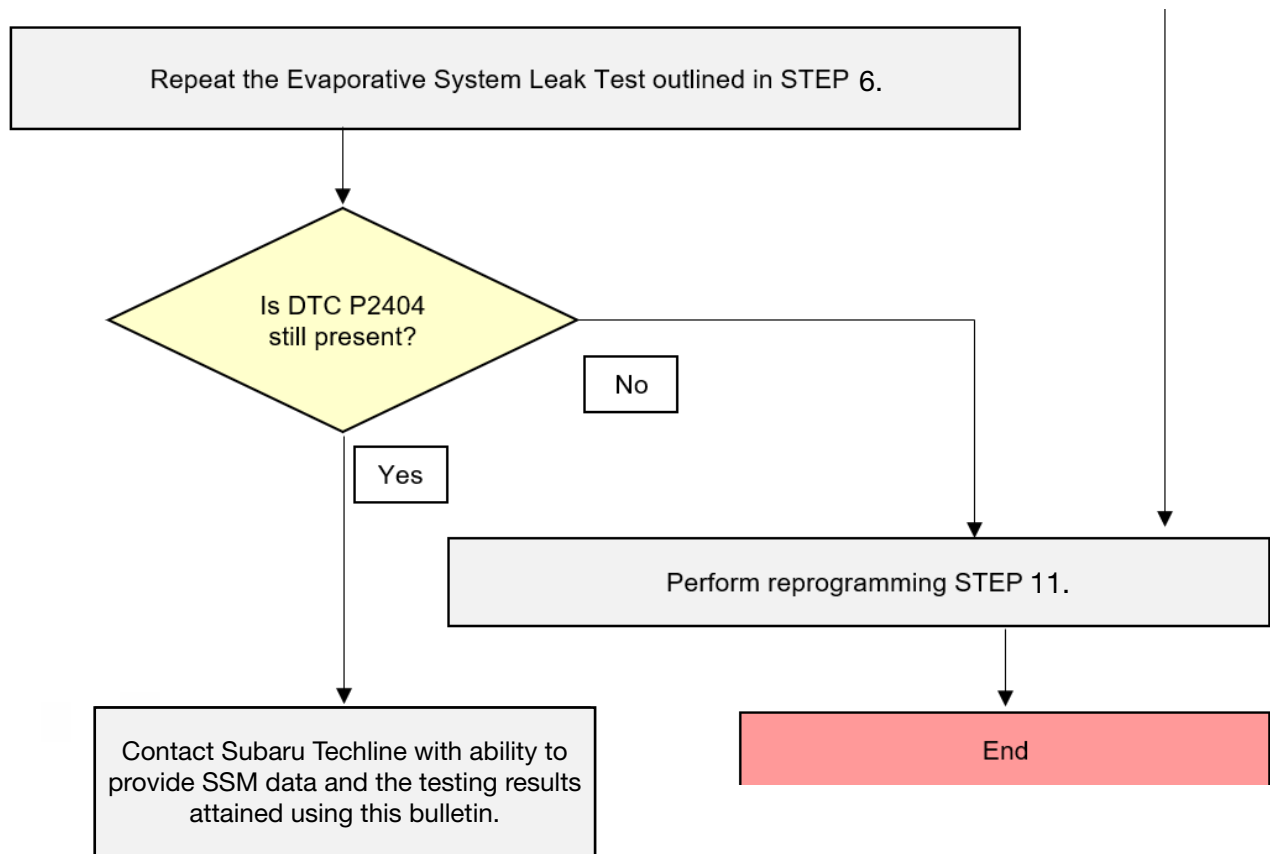
**SERVICE PROCEDURE FLOWCHART:**

This bulletin announces diagnostic procedures and availability of new Engine Control Module (ECM) reprogramming files to address DTC P2404 (Evap System Leak Detection Pump Sensor Circuit Range/Performance) detection. In rare cases, the internal pump for the Evaporative Leak Check Module (ELCM) system can seize temporarily. The new files contain enhanced logic to prevent the ELCM pump from seizing temporarily. If P2404 is found stored in the fault memory, follow the procedures outlined below.

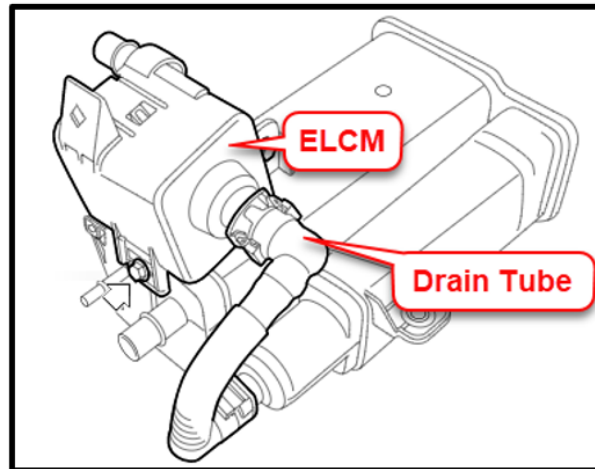
**STEP 5:** **CAREFULLY** disconnect the ELCM drain tube. Inspect for signs of water or oil.

Have signs of water or oil been detected withing the ELCM drain tube?

**YES** – Clean and dry the drain tube using a non-alcohol base cleaner. Proceed to STEP 6.

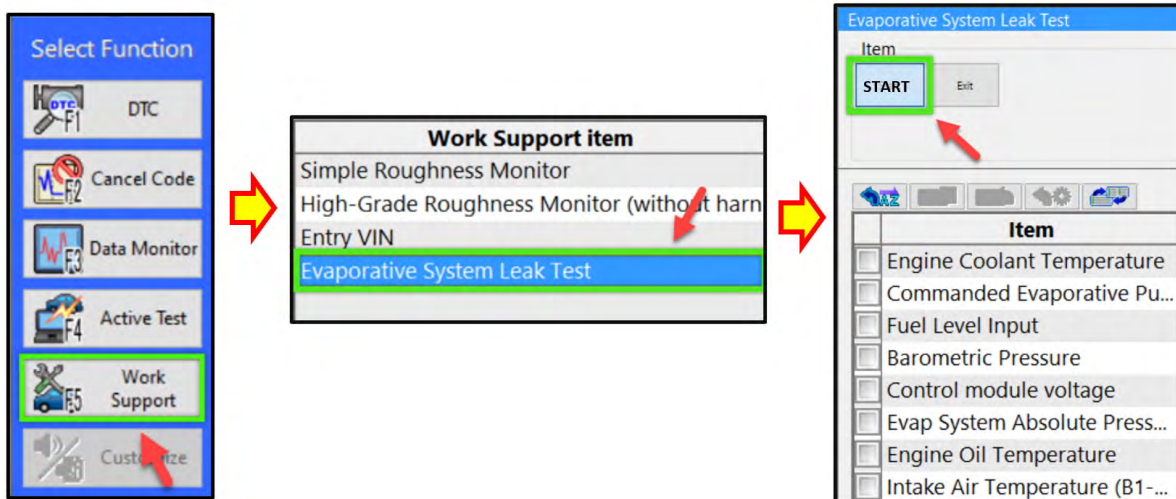
**STEP 6:** Connect the vehicle to a recommended power supply. See **APPENDIX A** for addition information regarding power supply. Using SSM, perform the Evaporative System Leak Test. Collect and save all data.

Once the evaporative system leak test is complete, check the DTCs and examine the vacuum value results. Record the value shown in the row labeled MID: \$3C, TID: \$C4, and Scaling ID: \$FE. This value should be lower than -0.26 PSI.

Value Must Be Lower Than -0.26 PSI

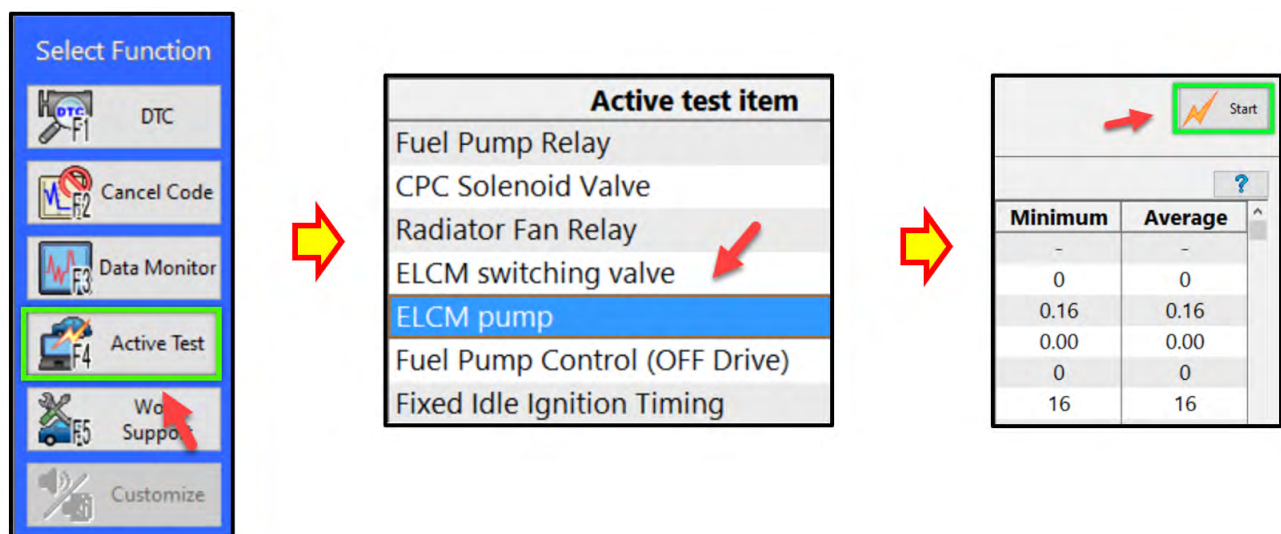
**STEP 8:** Using SSM, perform the ELCM Pump Active Test for a period of 35 minutes or more. See **APPENDIX A** for addition information regarding power supply.

Once the ELCM Pump Active Test has been performed for a period of 35 minutes or more, repeat the Evaporative System Leak Test outlined in STEP 6. Check the DTCs and the vacuum value results.

**STEP 10:** Replace the Evaporate Leak Check Module and repeat the Evaporative System Leak Test outlined in STEP 6. Check the DTCs and the vacuum value results.
