Articles Contained in this Issue

Techline has been receiving calls related to diagnosing and replacing Thermo Control Valve DTC's. There is a TSB related to Thermo valve replacement for some of our model lineup. It can be found here ([TSB 09-80-21](#)).

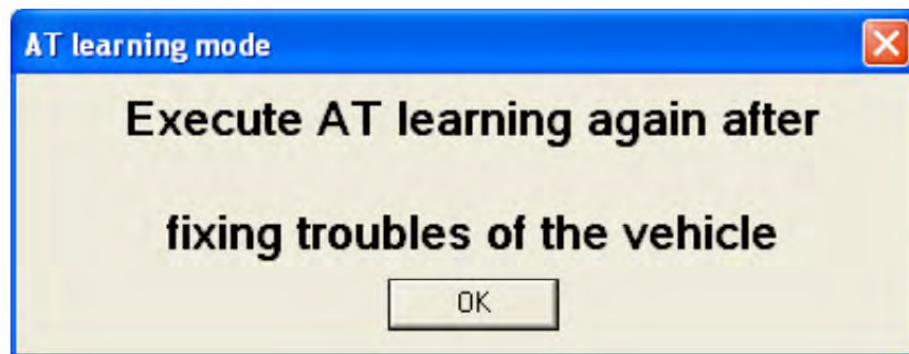
The pictures below show the two different error messages you can receive during the AT Learning Control process. Each has a different diagnostic approach. It is important to note where in the learning procedure, the process ends.

The image above can be a result of detection of DTCs. Correct the DTCs and perform the AT learning procedure again. The image below can be a result of a wide variety of different causes. See below for a detailed list of things to check.

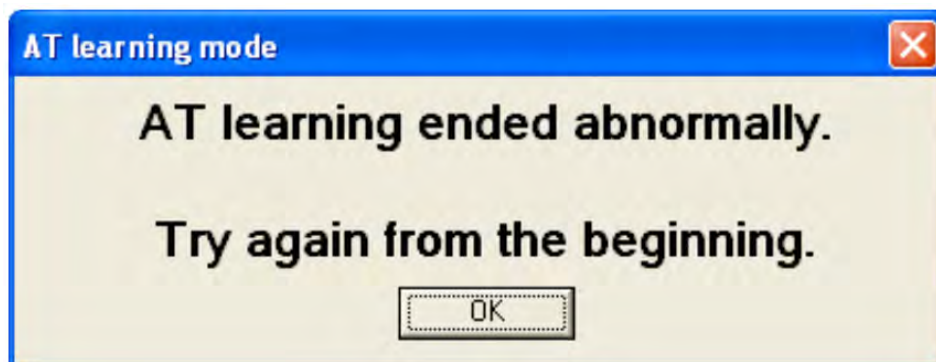
Message	Primary cause of abnormal end
AT learning ended abnormally.	<ul style="list-style-type: none"> • Fault is detected during AT learning. • The accelerator pedal is depressed during AT learning. • Operation which is not directed is performed during AT learning. • ATF temperature becomes out of specification during AT learning. • Battery voltage is low. • Malfunction indicator light illuminates. • Electronic parking brake not applied strongly enough • Brake pedal not stepped on firmly enough. • Abnormal idle speed increase, etc.

If “AT learning ended abnormally” message is received, be aware of items such as:

- Firm pressure applied to the pedal is required. If insufficient pressure is applied to the brake pedal, the process will abort.
- When commanded to release the brake pedal, do so immediately and let the pedal return on its own.
- Faulted brake light circuit, such as open brake light bulbs.
- Aftermarket brake lights, such as LED bulbs
- Open brake light bulbs or LED bulbs can result in erratic brake light switch (BLS) operation or control module interpretation even when the pedal is released. This can cause erratic operation due to incorrect circuit resistance and voltage consumption.

- Verify there are no diagnostic trouble codes present in all modules including the OBD section.

- No accelerator input should be used at any point during the Learning Control procedure.
- Any RPM deviation or idle increase not created by the Learning Control process will abort the procedure, so verify there are no outside influences that could affect this.

- Application of the parking brake requires enough force to keep both rear wheels stationary. Any movement of the rear wheels will abort the process.
- Verify the parking brake operates appropriately (no adjustments needed, calibration performed, etc.) according to the applicable Service Manual.

- Please refer to the applicable Service Manual for the appropriate Learning Control procedures, including the required fluid temperature range.
- The process cannot be performed at the incorrect fluid temperature.
- Verify the fluid level is correct, as this will affect fluid temperature in some cases.

- Perform a battery and system charging test using the Subaru Midtronics tester.
- Verify the battery terminals are not corroded.

- Verify the TCM has the latest software logic installed.

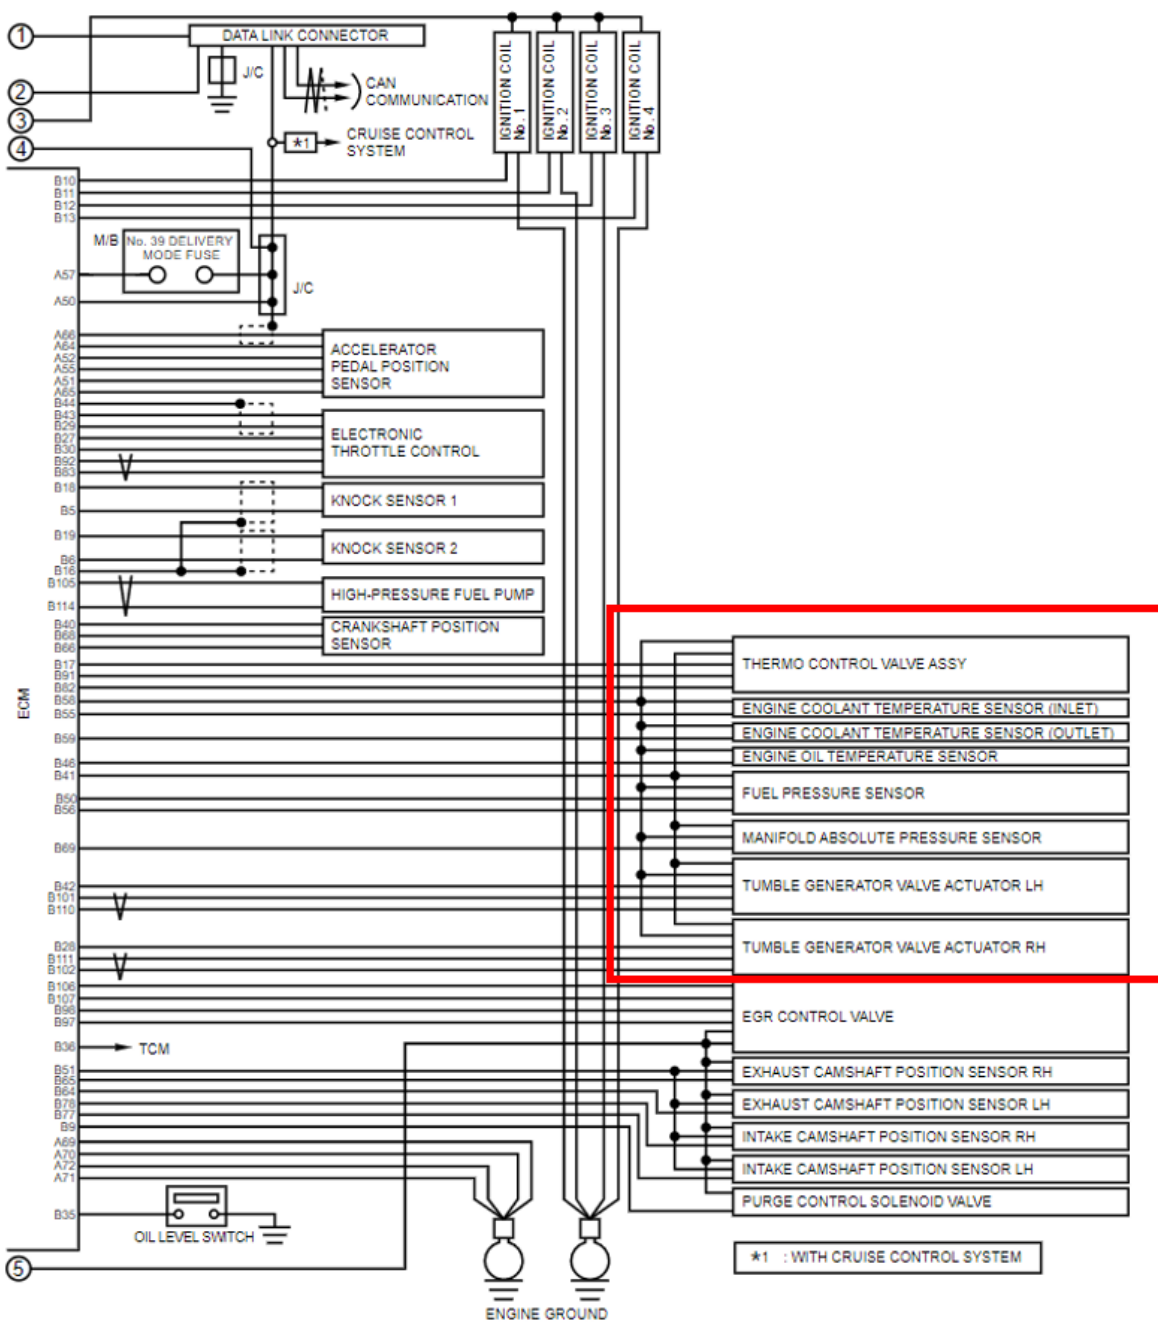
There are a few different scenarios that have been reported. When scanning for DTC's a Thermo valve code (P26A3-7) will be found as well as numerous other codes. Some of the other codes found could be P2004, P2005, P0087, P0088, P0191 as well as others. Some technicians have reported the vehicle running poorly, no Crank/no Start intermittently along with a long list of DTC's. When presented with this many codes it can be intimidating to know where to start the diagnostics. The basic engine wiring diagram can provide a clue about this circuit.

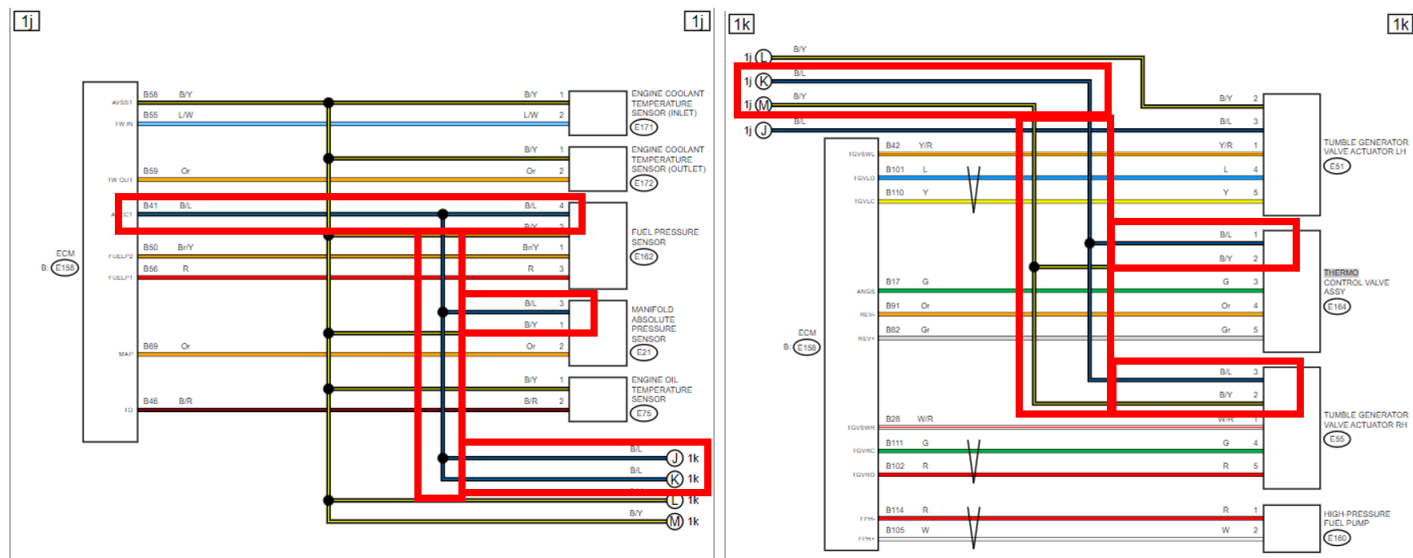
Reviewing the ECM wiring diagram can provide further clues about how all those components are connected. The Thermo valve shares a 5V reference with multiple other sensors including the Tumble Generator Valve's, Fuel Pressure Sensor, MAP etc.

If the Thermo valve shorts internally, it can bring this shared 5V reference down to 0V, possibly causing codes in all the shared components as well as potential drivability concerns. Following the Trouble Tree for the P26Ax DTC's will not find this short as most of them have the ECM and Thermo valve connectors unplugged for circuit testing. When the testing for the harness is performed the short has been removed by unplugging the Thermo valve. To verify the short, install the breakout harness and test the shared 5V reference circuit, it should be 5V, if you find 0V the Thermo valve may be shorted. Unplug the Thermo valve, does that circuit return to 5V? The "easy" answer for diagnosis is to unplug the Thermo valve and scan for DTC's again, do all the codes go to history except for the Thermo valve codes? If so, it would indicate the Thermo valve may be shorted internally. If multiple DTCs are still present, further diagnostics will need to be performed to determine if there is an issue in a wiring harness or somewhere else.

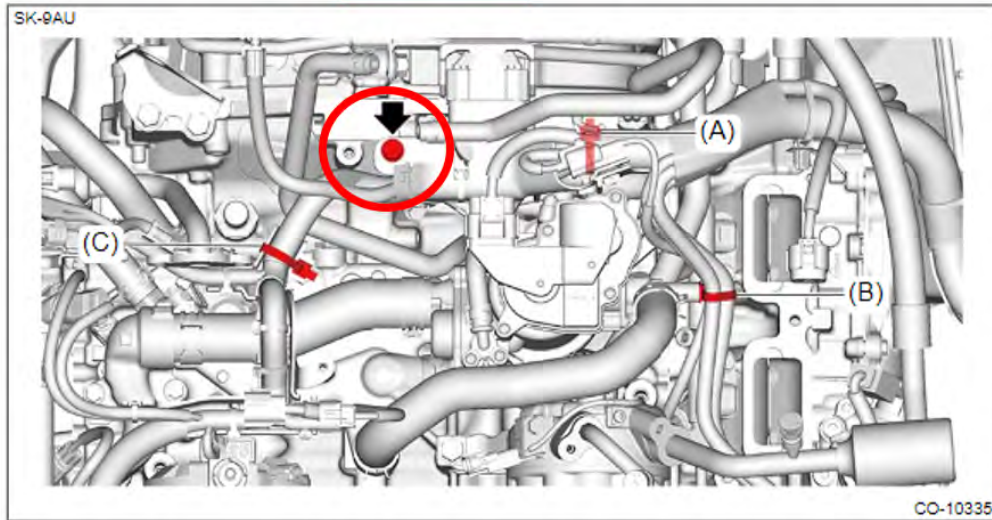
5. Remove the bolt securing the **engine ground** and the harness case and remove the clip (A), clip (B) and clip (C).

This bolt does not just hold the wiring loom in place, it is a main ground for the engine wiring harness, **if this bolt is not reinstalled or torqued to specification it will cause multiple electrical concerns.** Below is a photo of the engine ground “hidden” in the plastic of the wiring harness.
